# Repair of the Sumas River Dike Breach: A Case History

Brian L.J. Mylleville, Ph.D., P.Eng.

**ABSTRACT** In November 2021, during an unprecedented atmospheric river event, the Sumas River Dike was breached resulting in flooding of a large area of the Sumas Prairie in Abbotsford, BC. The site of the Sumas River Dike breach is approximately 4.5 km southwest (upstream) of the Barrowtown Pump Station along the base of Sumas Mountain. This paper describes the main breach that occurred including the failure mechanism and the key geotechnical engineering considerations related to design and construction of the breach repair. A two-staged strategy was adopted for repair of the dike breach that included the initial emergency repair to close the breach followed by the additional remedial work required to restore the temporarily repaired dike section back to a dike with a low permeability core. Details of the two-stage repair strategy are described including the various options considered, as well as the challenges faced during construction. The flood event also created significant challenges during construction in terms of the supply of the materials required to repair the breach, access

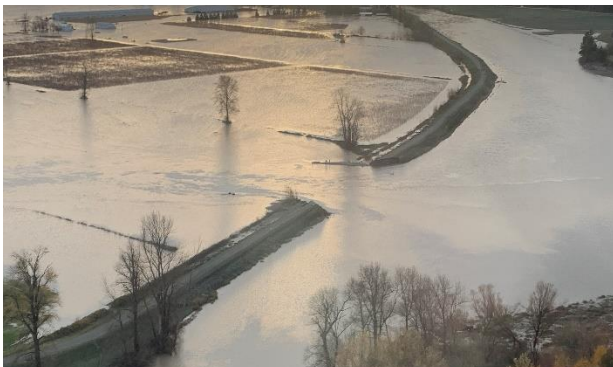
**Fig 3. Aerial image of the dike breach.**

The Sumas River Dike Breach occurred on November 16, 2021, during a series of unprecedented atmospheric river events. The breach occurred as a result of floodwaters from the Sumas River overtopping the dike followed by rapid downcutting of the dike structure allowing floodwaters from the Sumas River to flow into Sumas Prairie. The length of the dike breach was about 150m with scour that extended about 4m below the original ground surface (base of dike) and extended about 150m south into the farm field adjacent to the dike. Google Earth Imagery dated July 29, 2022, clearly shows the extent of the initial emergency repair of the dike breach and scour hole in the adjacent farm field. An aerial photograph of the breach taken on November 17, 2021 (day after the breach), is shown on Fig. 3.

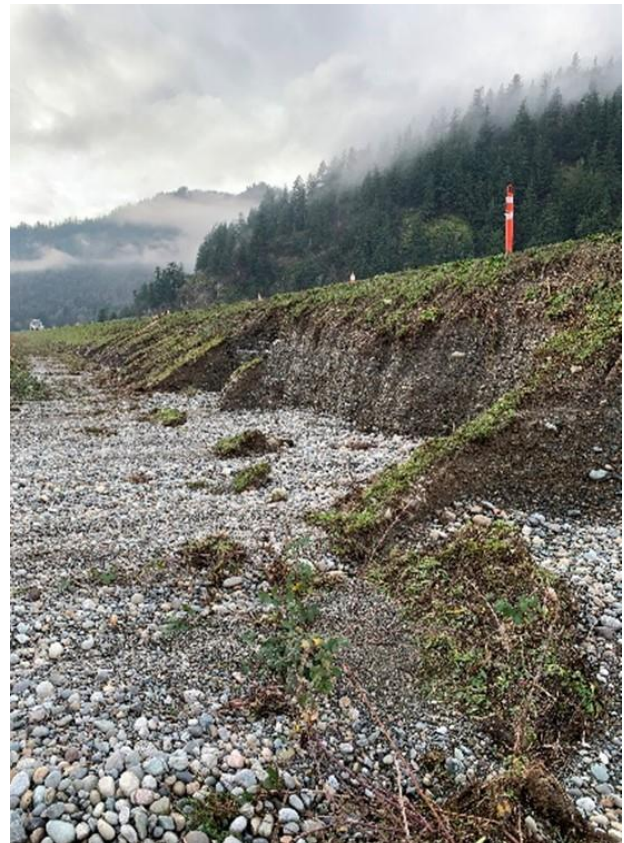
**Fig 4. Erosion on landside slope of the dike.**

Visual observations of the dike near the breach clearly showed evidence of significant erosion and downcutting of

the landside slopes of the dike with several sections of the dike slope eroded to near-vertical configuration near the landside crest of the slope. The exposed near-vertical sand and gravel fill was the material that was added to the landside of the dike in the 1988 upgrade with clear evidence of the well-compacted layers developed during the previous upgrade construction. Deposits (pinnacles) of gravel and cobble sizes extended far into the adjacent farm fields at several locations. Fig. 4 illustrates erosion that occurred along the landside slopes of the dike as a result of overtopping.

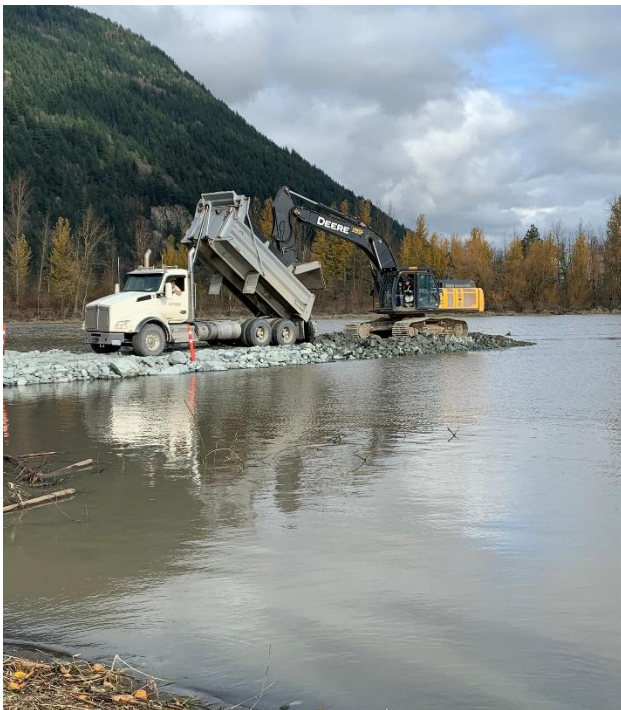
**Fig 5.** Initial Breach Closure.

At the breach, most if not all of the dike structure was lost over a length of about 150m, and in addition, a large scour hole was eroded well below the toe of the dike and beyond, extending some 150m into a farm field to the southeast. The scour hole was about 3m to 4m below the base (bottom) of the existing dike. Ideally, a dike should have a low permeability core constructed of silty and/or clayey soils. However, emergency repair work was carried out during periods of intense precipitation, working initially under conditions of flowing floodwaters and partially underwater, making it impossible and impractical to use fine-grained soils. To attempt to do so would likely have been disastrous. The plan put forward for closure of the breach was to construct an initial crossing (closure) to stop flow from Sumas River, then continue to widen and build up the closure once the open flowing water was stopped. Fig. 5 shows the initial construction of the dike breach closure.

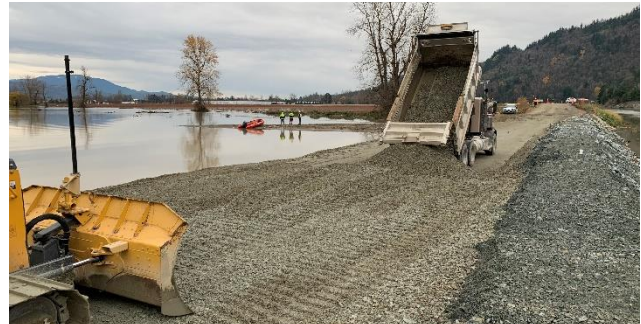
**Fig 6.** Construction of the breach closure.

The entire closure of the breach was constructed using crushed granular fill of varying sizes, with coarser 600mm minus crushed rock specified for the outside (along the side slopes) and finer 75mm minus crushed rock specified within the central portion of the dike. The initial closure was widened to the south and raised using the finer 75mm minus crushed rock to allow for future installation of a low permeability barrier or core. The widening and raising of the breach closure continued using the smaller crushed rock (see Fig. 6). This material was placed in lifts and compacted using a large vibratory compactor. Specifying the use of finer 75mm minus crushed rock to construct the central portion of cross-section for the dike closure was essential in order provide some degree of flexibility in terms of considering options to reinstate a low permeability barrier, without which, the dike would leak.

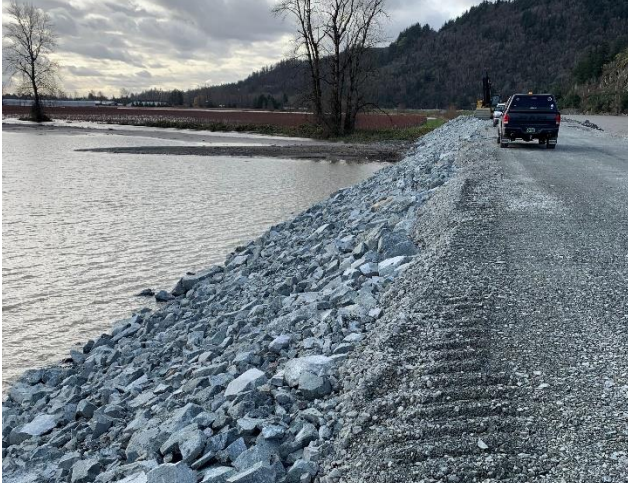
**Fig 8.** Landside slope of the completed dike breach closure.

Once the initial breach closure was completed (cutting off open flow through the breach) and had sufficient width, trucks could then follow a haul route on the dike without the need to turn around at the breach site. Fig. 8 shows the landside slope of the completed dike breach closure with adjacent water-filled scour hole which is on the land side of the dike.

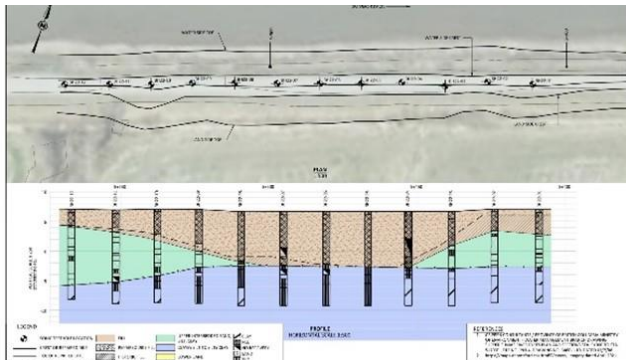
**Fig 9.** Summary of test hole exploration.

After the emergency repairs to close the breach were completed, a geotechnical exploration was completed to check the extent (depth) of the recently-placed crushed rock fill zone, the characteristics of the underlying foundation soils and to confirm the presence or absence of larger rock sizes within the central portion of the repair (constructed of the finer 75mm minus crushed rock) that would present as obstructions to the proposed core construction activities. This information was also used to establish the required extent of the low permeability barrier and to assess suitable options to construct a low permeability barrier required to mitigate seepage through the breach closure. Twelve (12) test holes were drilled using sonic drilling methods to just over 15m depths within the central portion of the breach closure spaced out along the length of the repaired section. A summary plot of the test hole results is shown on Fig. 9. Of note, the geotechnical exploration did detect some larger pieces of crushed rock in that zone that was intended to be 75mm minus crushed rock.

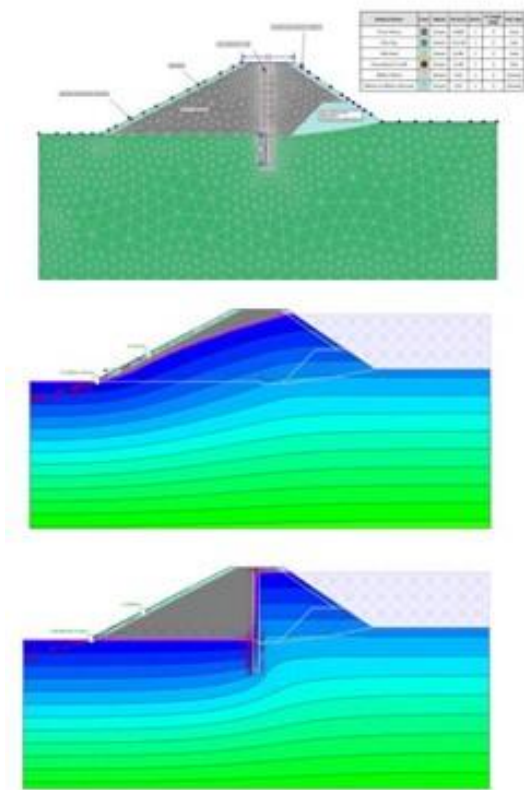
**Fig 10.** Seepage analysis plots.

Steady state seepage analyses were carried out using commercially available computer software Slide (RocScience 2018, ver. 8.032) to confirm the benefit of installing a barrier with low permeability ( $1 \times 10^{-9}$  m/s) to mitigate seepage flows through the breach closure which was constructed entirely of crushed rock of varying sizes (75mm minus material in the central portion and larger, 300mm to 600mm minus on the outside slopes). The findings of the seepage analysis indicated that for the breach closure without a low permeability barrier, the estimated seepage through the closure would likely range in the order of between about 5 and 20 litres/min per metre length of dike closure. This considers conditions in the Sumas River that vary from “normal” to flood level. Installing a low permeability barrier that is 600mm thick and extends 4m into the underlying foundations soils reduces seepage by about two (2) orders of magnitude, or to between about  $1 \times 10^{-2}$  and  $5 \times 10^{-2}$  litres/min per metre length of the dike closure. Fig. 10 illustrates the seepage analysis model and plots of findings under flood conditions.

To maintain flexibility in the barrier, an Unconfined Compressive Strength (UCS) of 1 MPa was specified for the constructed barrier.

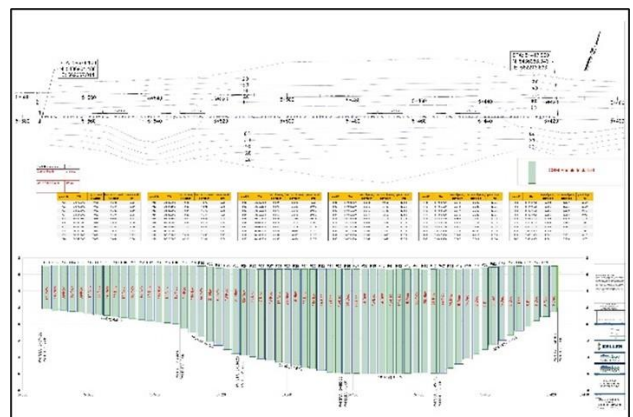
**Fig 12.** CSM panel layout.

The CSM process involves constructing rectangular panels that are 2.8m long by 640mm wide and extend to the target depth. As the cutting tool advances or cuts its way down into the ground, bentonite slurry is continually added to aid as a cutting fluid and to lower the permeability of the mixed soil-slurry mass. When the cutting tool reaches the target depth, Portland cement slurry (required for strength) is then introduced as the cutting tool is slowly retrieved from the ground. Once the Portland cement is introduced into the process, the contractor’s experience and time become a factor as any missteps by the crew or equipment issues could lead to the cutting tool getting stuck in the ground. The contractor tailors the bentonite slurry and Portland cement slurry application to achieve the performance requirements set out in the contract specifications. A total of sixty (60) CSM panels were required to construct the barrier with depths varying between 5.25m and 12.75m. The CSM panel layout is shown on Fig. 12.

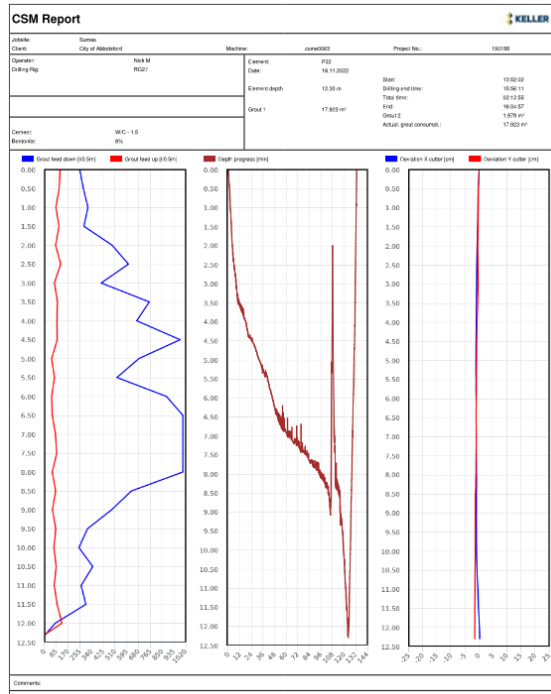
**Fig 13.** Typical CSM report.

The left plot in the CSM report in Fig. 13 is a record of bentonite slurry consumption represented by the right (blue) line as the cutting advances down into the ground and then Portland cement slurry consumption represented by left (red) line as the cutting tool is withdrawn upward. The central plot records the progress of the cutting tool for both advance into the ground and withdrawal (from left to right). It is noted that there is greater time and “noise” on the progress plot between about 6.5m and 9m; this is due to difficulties advancing the cutting tool beyond some pieces of larger crushed rock in that zone within the crushed dike fill that was used to close the breach. For Panel No. 32, shown on Fig. 13, it took about 2 hours, 12 minutes to construct the panel which is considerably longer than might be expected.

Some of the larger pieces of crushed rock being present in what is supposed to be mostly 75mm minus crushed rock is most likely due to some larger material being used on the water side during construction of the initial closure ramp into the breach, some larger pieces mixed in with fill delivered to the site and possibly also due to this material having been placed in flowing water. As much as possible and practical, the operator tried to keep the water side slope of the initial closure as steep as possible to keep the outside larger pieces of crushed rock away from the central portion of the dike closure. A total of about 300 sets of teeth were broken on the CSM cutter tool bouncing and grinding on pieces of larger crushed rock that were encountered.

After a period of breakage and delays, a decision was made to pre-drill the panel locations to try to retrieve some of the larger pieces of crushed rock or possibly loosen them with the hopes that they could be “kicked” aside by the cutting tool. Initial attempts at pre-drilling were carried out with uncased holes; however, due to caving in some of the hole, particularly below the water table, this approach had limited success and was eventually abandoned.

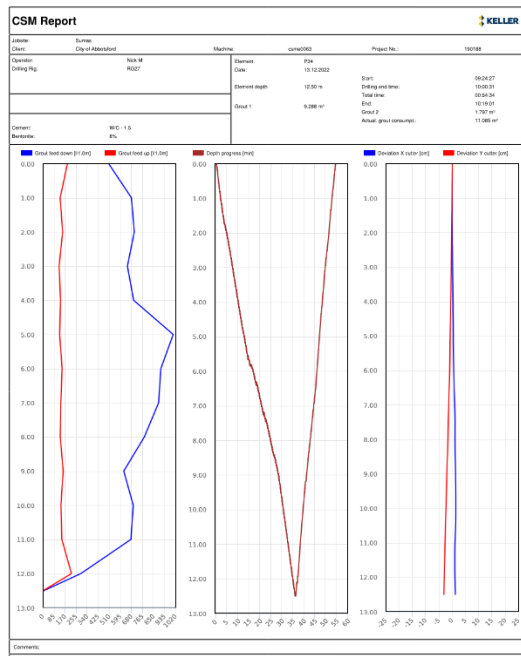
**Fig 16.** CSM Report for Panel No. 34.

The benefit of pre-drilling with a cased hole can be illustrated looking at the CSM Report for Panel No. 34 (see Fig. 16), which is the panel that was installed two (2) panels east of Panel No. 32 (results of which are previously shown above). The time to complete the panel was considerably less, about 54 minutes in this case. As can be seen in the progress (middle) plot on Fig. 16, the cutting tool progress now shows a relatively uniform up and down of the cutting tool without the “noise” associated with bouncing and grinding on larger pieces of crushed rock.

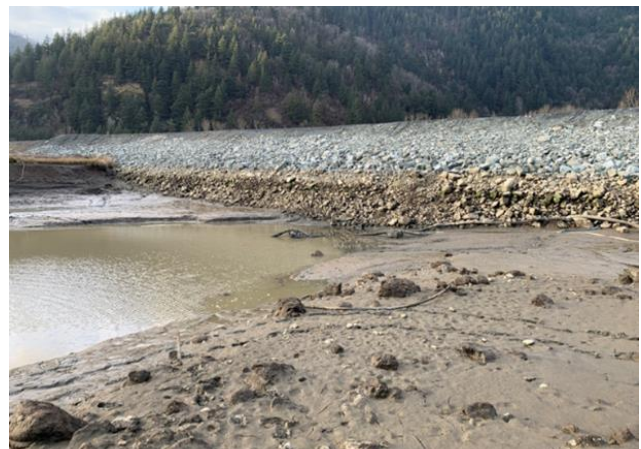
**Fig 18.** Drained scour hole and exposed water side slope of dike breach repair.

Once the water was pumped down, and with fish salvage work still underway, a visual review was carried out along the exposed water side slope of the dike breach repair. At the time of the field review, the head difference between the Sumas River and the scour hole was about 3m. No point sources of flow were observed along the exposed water side slope of the dike breach repair, but several areas of seepage flow were observed along the perimeter of the scour hole with this seepage being groundwater draining from the surrounding farm field. Discussions with the farmer, whose property was directly impacted by the breach, confirmed that the area of the field occupied by the scour hole was always considered a localized wet area. Fig. 18 shows the drained scour hole with fish salvage still underway.

With no observed point sources of flow along the water side slope of the dike breach repair satisfying the final performance criteria, the repair was considered complete.
