# SLIDING FAILURE OF A SOIL COVER ON A PVC LAGOON LINER CAUSED BY HYDRAULIC LIFTING

by  
V.A. Sowa<sup>1</sup>, D.C. Jones<sup>2</sup>, G.A. Stewart<sup>3</sup>

## ABSTRACT

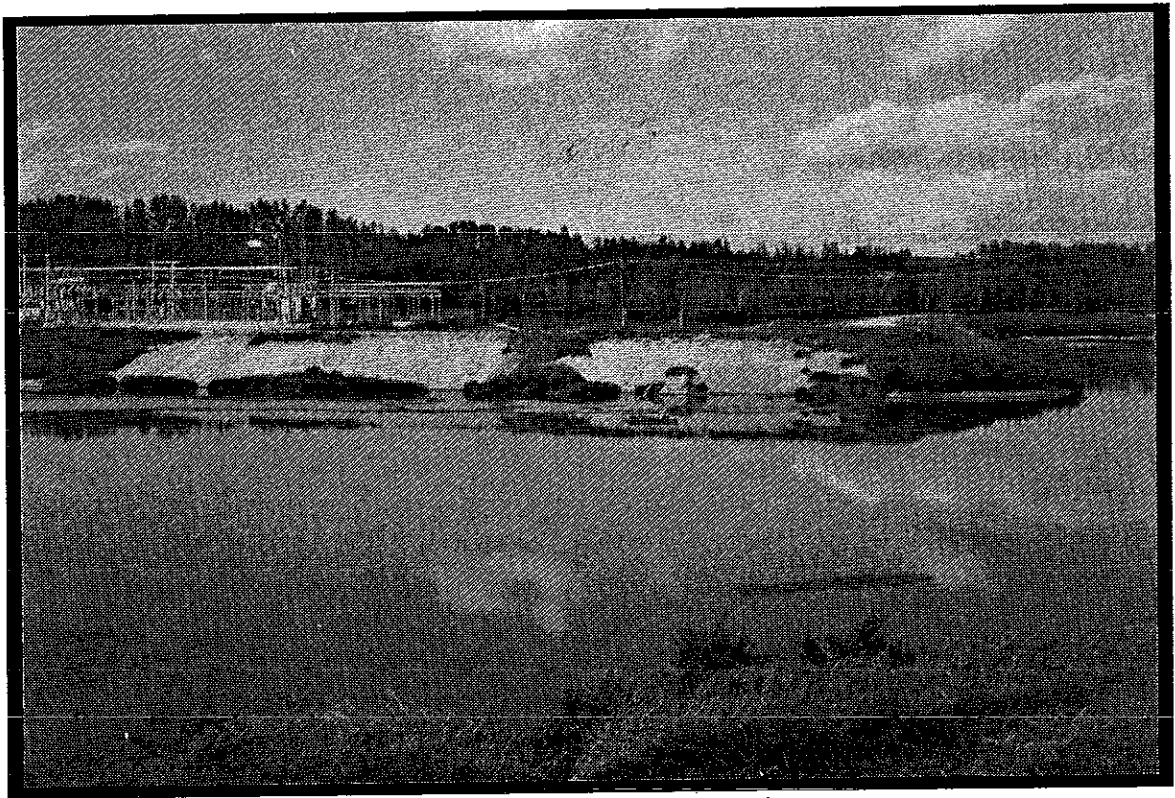
The soil cover on the lagoon slopes of Cell No. 15 after failure is illustrated on Photographs 1, 2 and 3. Observations of the failures at the site, and as shown on the photographs, revealed that there were various degrees of soil cover movement during the failure. In some cases, the entire soil cover, from crest to toe, slid down the 10-m-long exposed slope and displaced the sludge at the toe of the slope. The displaced sludge surface was raised above the lagoon level as shown on Photograph 2. In other areas the soil cover slid several metres and stopped, while elsewhere, the amount of sliding was less, in the range of 0.3 m to 1.0 m. Some areas illustrated a general hummocky appearance with tension cracks 5 mm to 20 mm in width. Finally, for a large portion of the soil cover no evidence of sliding was visible.

**Photograph 1** - *Failed soil cover. View looking north-east at north dyke.*

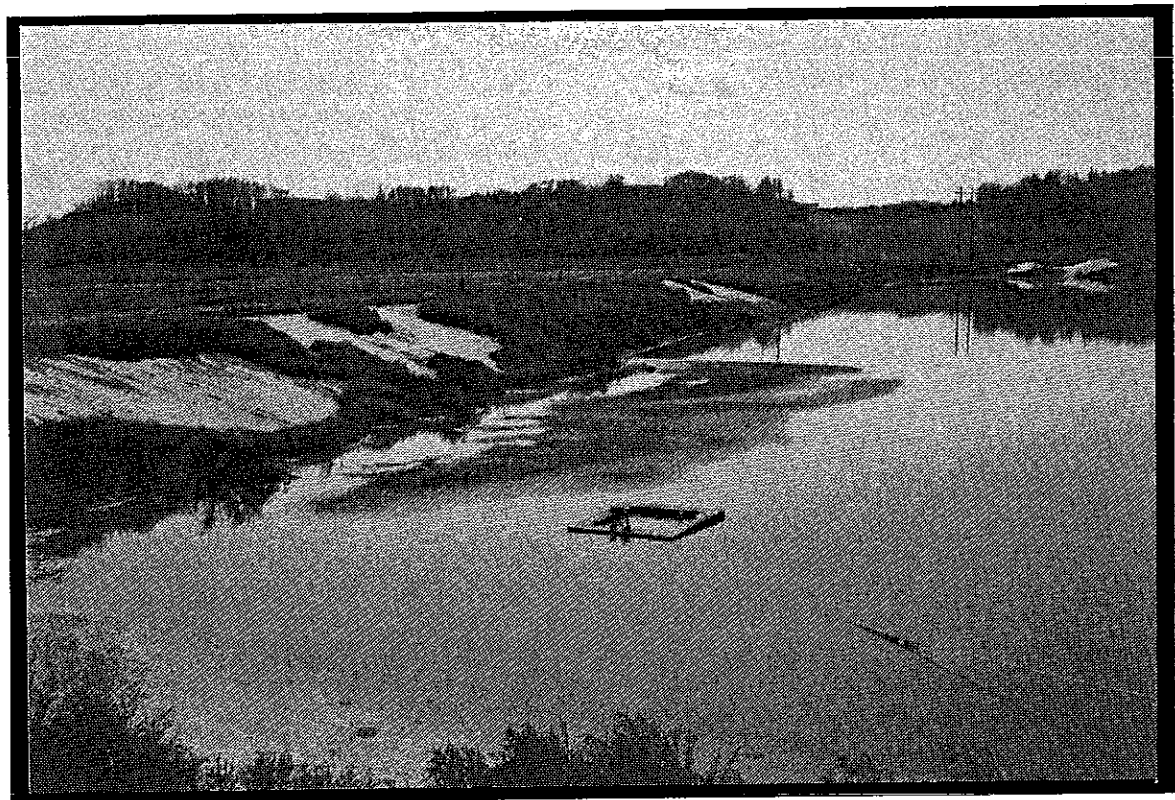
**Photograph 2** - *Failed soil cover. View looking west along south dyke.*

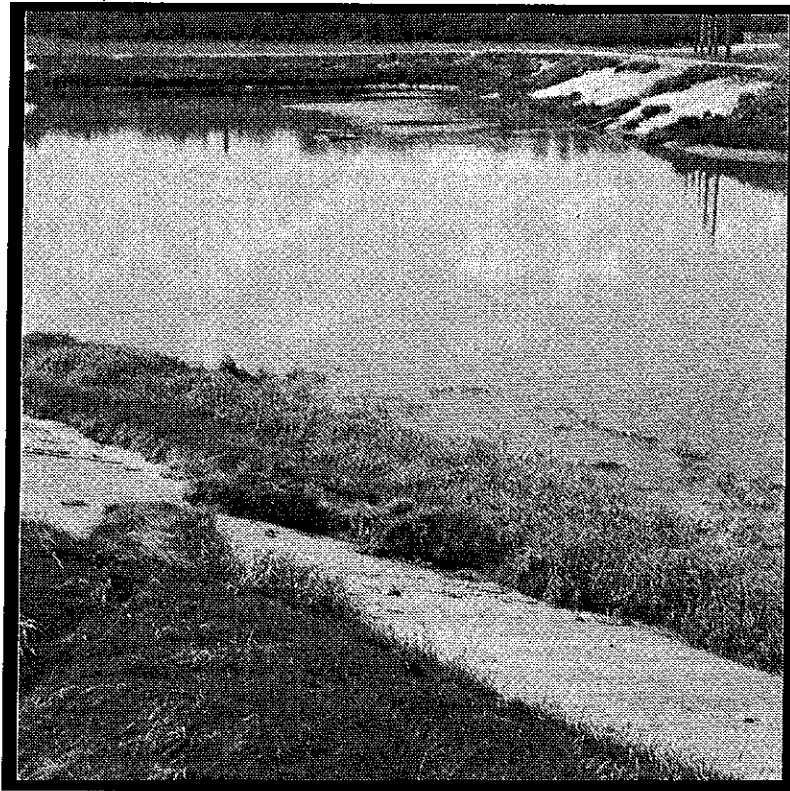
**Photograph 3** - *Failed soil cover. View looking west.*

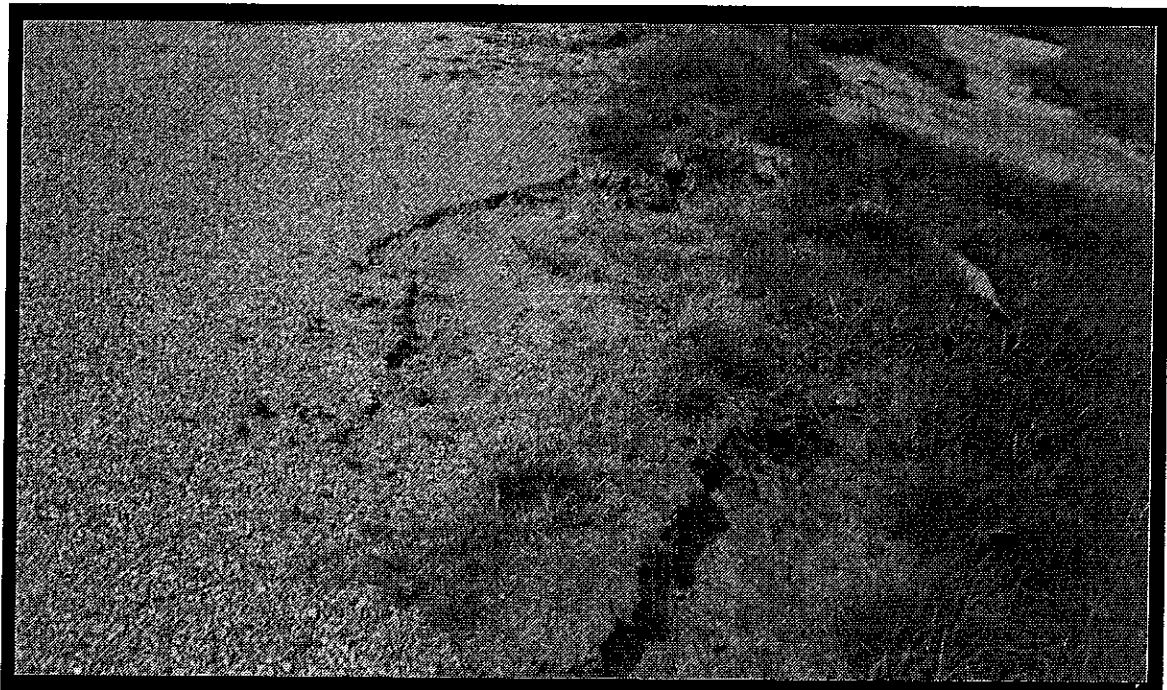
A detailed examination of the sliding failure revealed a few specific features. In several of the larger areas of sliding, there was a general impression that the lower portion of the soil cover initiated the failure and due to the tensile strength of the grass root mat within the soil cover, the upper portions of the soil cover were dragged down by the lower portions. This impression was supported further by the general observation that where only a relatively small amount of sliding movement had occurred, the soil cover was stretched and contained tension cracks but with the larger movement detected on the lower portion of the slope. In some locations the soil cover separated, leaving isolated portions of the soil cover as little islands stranded on the PVC liner (Photograph 1). While no major sliding was detected on the east lagoon slope, some tension cracks were evident along the top of the dyke slope similar to those shown on Photograph 4.

Tension cracks at the crest of the slope are shown on the Photograph 4. The upper limit for the tension cracks approximately coincides with the edge of the grass cover, and the corresponding root mat. The root mat binds the soil cover and when the soil cover was under tension during sliding of the soil cover, the upper limit at which the soil cover failed was the limit of the significant soil root mat. In fact, as can be seen in the centre of Photograph 4, the tension crack extended into the gravel where the grass and root mat invaded the gravelled road surface adjacent to the dyke crest. Some of the PVC liner can just be seen exposed following sliding of the gravel and root matted cover.

**Photograph 4** - *Tension cracks in soil cover at dyke crest.*

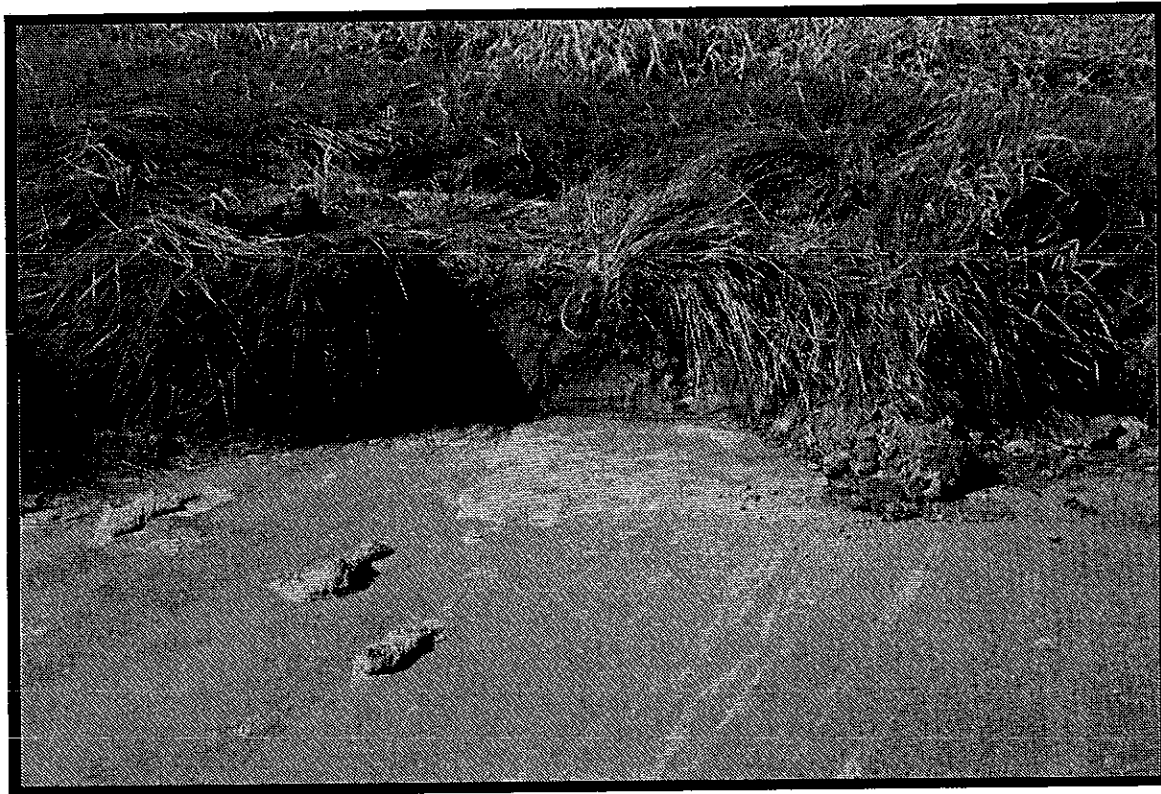
The boundary between the portions of the soil cover that had failed and the remaining soil cover was abrupt and very distinct. Furthermore, the PVC liner surface that was exposed was usually very clean with very little soil debris remaining. Both of these features can be observed in Photographs 1 to 3 inclusive, and in a close-up in Photograph 5. Photograph 5 is a view looking up the slope at the soil cover remaining on the slope.

**Photograph 5** - *Close-up view of edge of intact soil cover and exposed PVC liner.*

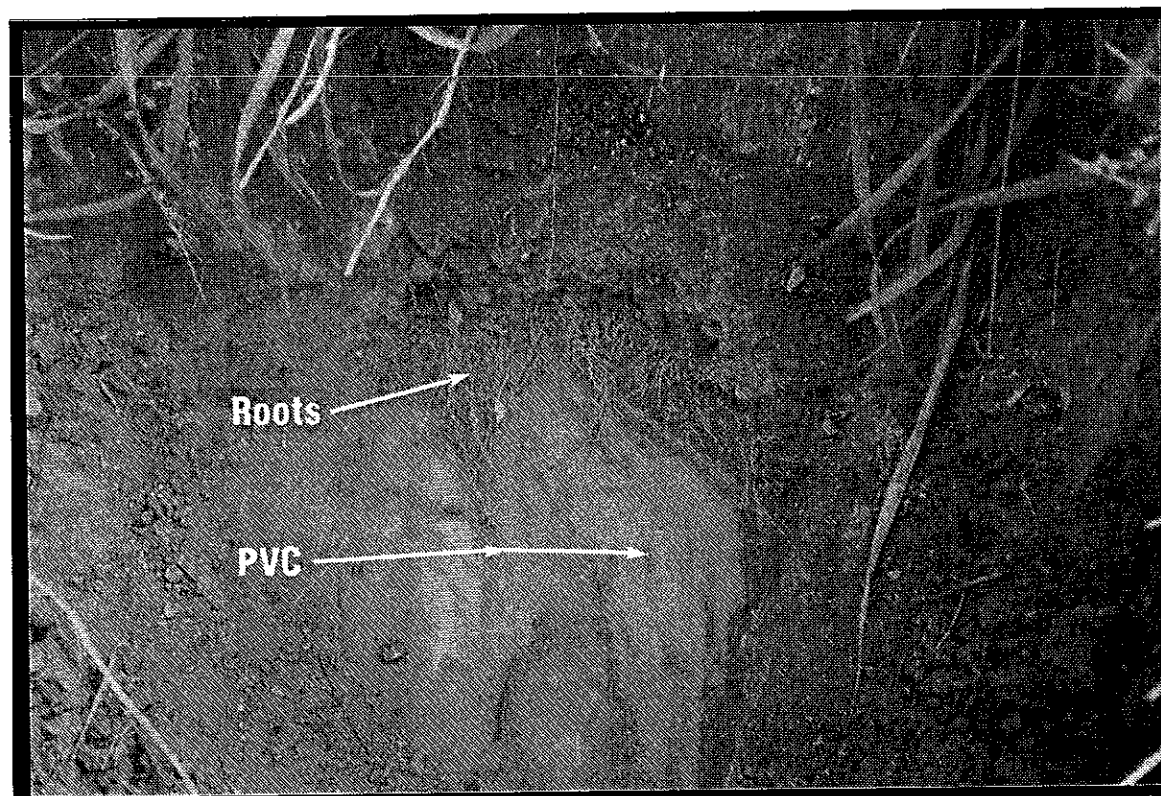
Two types of vegetation were evident on the soil cover on the inside slopes of the lagoon. A thick grass cover extended from the crest to about 2 m below the crest and a thick growth of weeds covered the rest of the slope. The fluctuating lagoon level killed most of the grass on the lower slope because of extensive submergence, but was replaced by weeds. Both the grass and weeds no doubt owed their luxuriant growth to the nutrients in the supernatant. The grass and weed roots extend to the bottom of the soil cover in contact with the PVC liner. Because of the physical PVC boundary, the roots in contact with the PVC liner have become densely matted, similar to that found on the inside of a root-bound pot of a plant that has overgrown the size of pot. An example of the densely matted roots in contact with the PVC liner is shown on Photograph 6.

**Photograph 6** - *Close-up view showing matted root structure at soil - PVC contact.*
