# SOIL NAILING FOR PUBLIC ESTATES IN HONG KONG

Y. A. Ho<sup>1</sup> and H. C. M. Chan<sup>2</sup>

## ABSTRACT

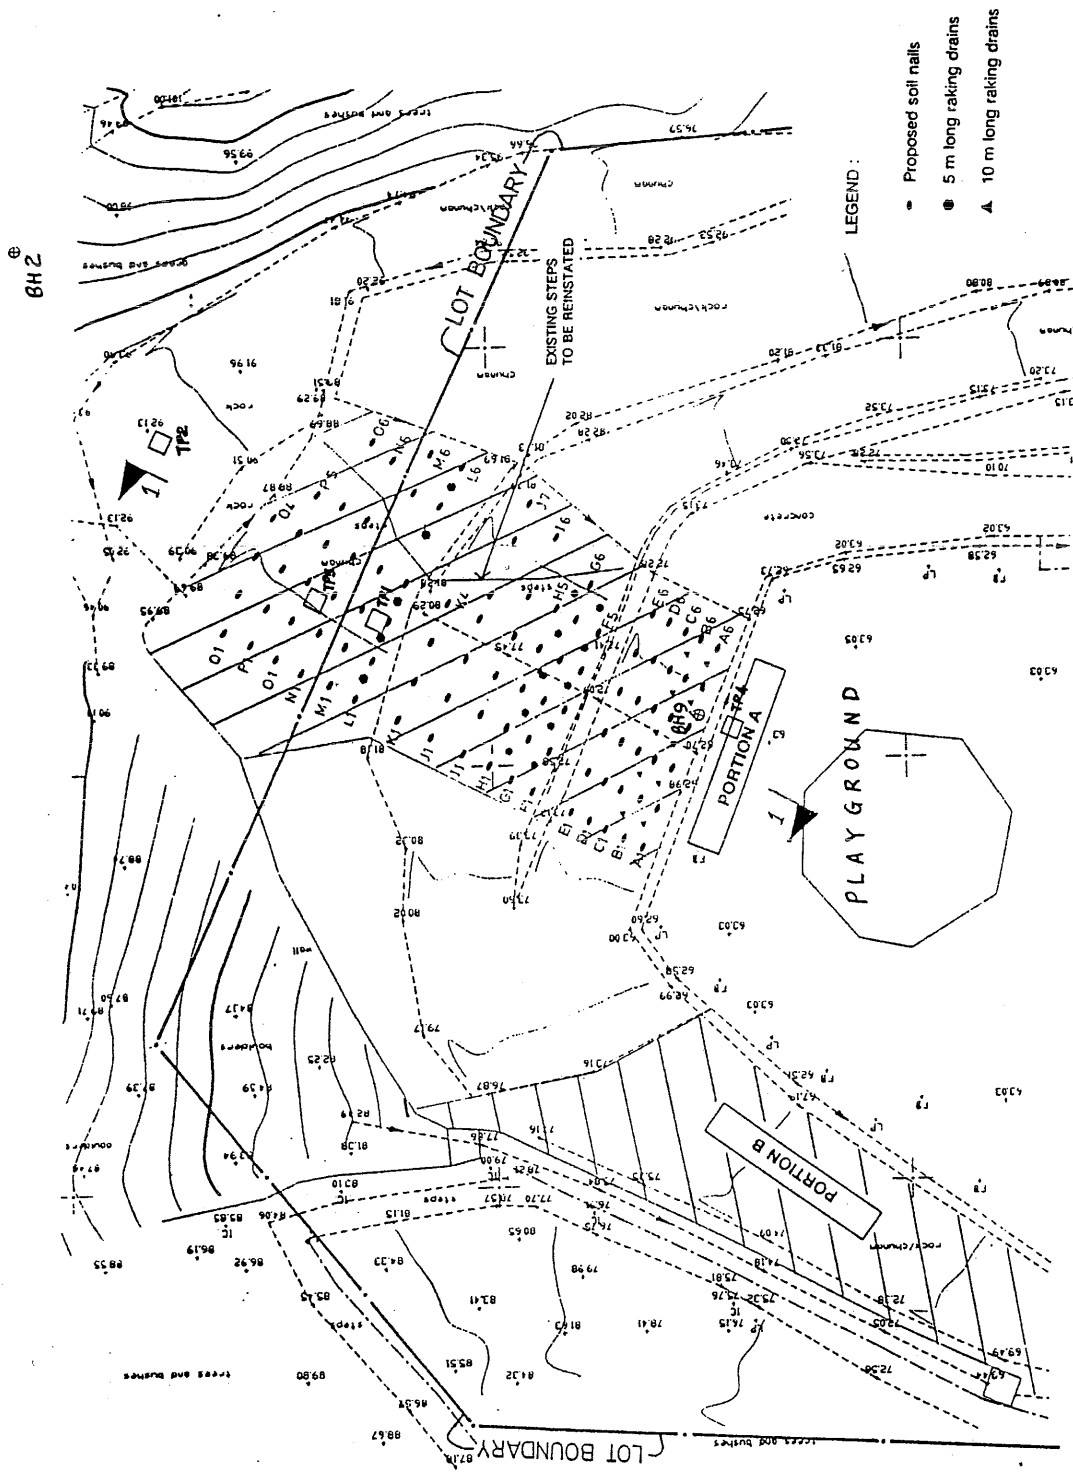
Figure 4. Site plan of slope 11SE-A/C135 at Lai Tak Tsuen Estate.

The slope is horse-shoe shaped in plan, surrounding a playground on three sides, with length of about 62 m and height ranges from 6 to 35 m. The two sides of the slope are covered by chunam (Hong Kong's name for a soil-cement mixture) and rock outcrops at a slope angle of  $70^\circ$  to  $80^\circ$ . The middle section of the slope consists of a 9 m high  $80^\circ$  chunam batter and a densely vegetated 26 m high  $40^\circ$  to  $50^\circ$  cut slope. The nearest building is about 30 m west of the slope, but the playground at the toe of the slope is a major recreation playground for the estate.

The two sides of the slope is consisted of slightly weathered granite while the middle section is consisted of completely to highly weathered rock. The subsurface profile of the middle section is consisted of 2 m of loose, greyish brown clayey silty fine to coarse sand with many large boulders (Colluvium); overlying dense to very dense, light yellowish brown pink, fine to coarse sand, Completely Decomposed Granite (CDG); overlying weak to moderately strong, pinkish grey mottled black, medium grained, medium to closely spaced joints, Highly to Slightly Decomposed Granite. The inferred subsurface stratigraphy of the site is shown on Figure 5. The following soil parameters derived from the laboratory test results were adopted in stability analyses and soil nail design:

No seepage was observed apart from minor seepage noted at a few weepholes at the lowest batter and slope surface was noted to be dry. Records of the piezometer indicated that ground water is about 10 m above the bedrock at the upper part of the slope. The groundwater monitoring records indicate that the groundwater was generally 5 to 7 m below ground level.

The minimum factor of safety against slope failure depends on the level of risk to life and economic losses. Current Hong Kong Government standards require that the minimum factor of safety for existing high risk slopes be 1.2 for groundwater levels associated with rainstorms of 1 in 10 years return periods. A minimum safety factor of 1.4 was adopted for this slope because of the presence of an open playground at the toe of the slope. The analysis revealed that the calculated factors of safety are marginally above unity. Soil nailing with shotcreting cover was therefore recommended to improve the stability of the slope.

The proposed soil nails were spaced at 2 m horizontally and 2 m vertically. Nails of 32 mm diameter and 20 m maximum length were required for the critical section. Soil nails were to be installed directly into 125 mm diameter drilled holes inclined at 10° below horizontal. A total of about 96 nails was required. The slope surface was to be protected with 75 mm

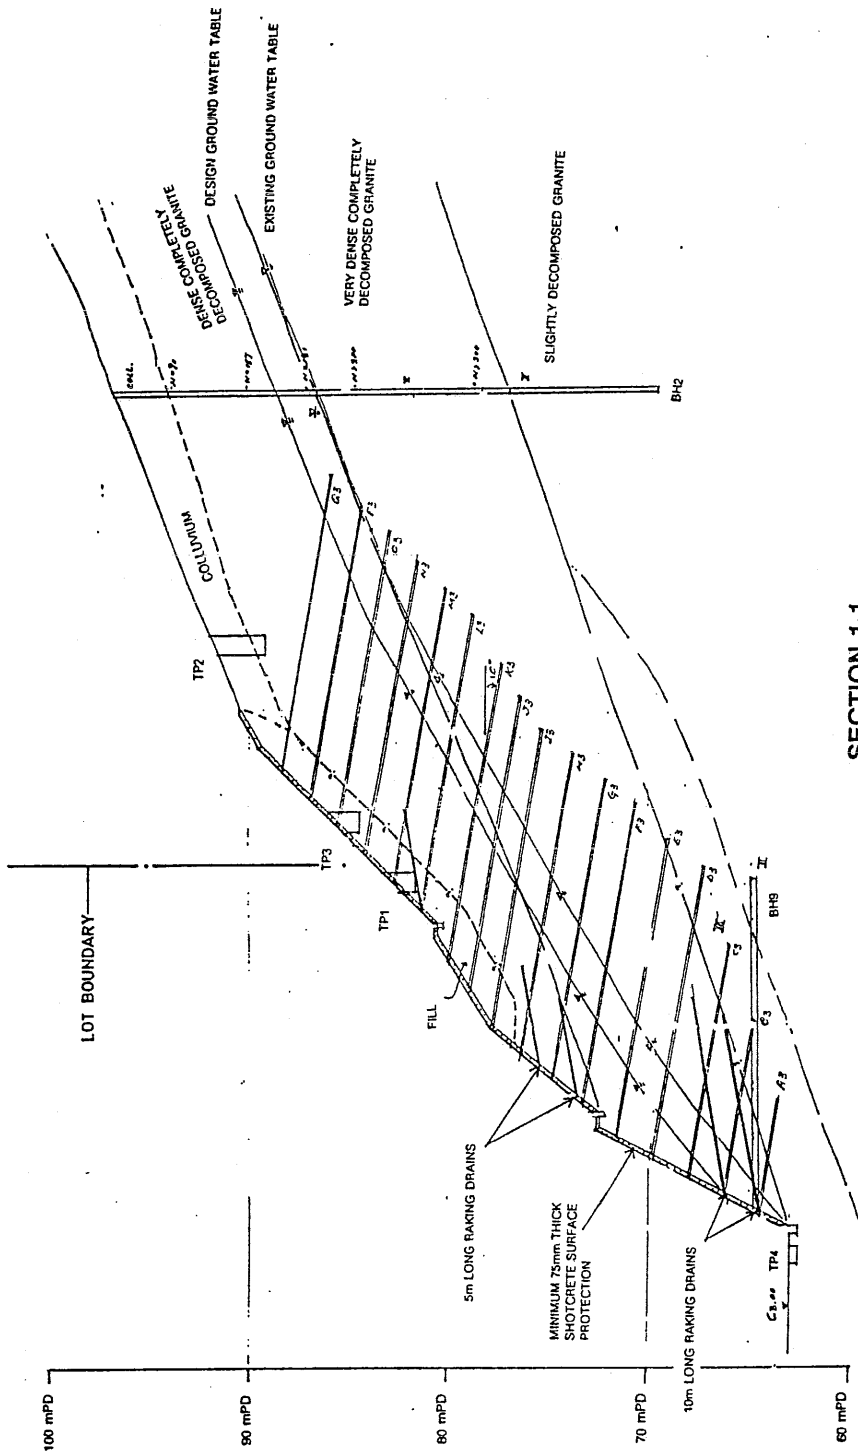
Figure 5. Section 1-1 of slope 11SE-AC135 at Lai Tak Tsuen Estate.

A typical cross-section of the slope reinforced by soil nailing is illustrated in Figure 5. Rotary percussion drilling rigs were used for nail installation were. They are relatively small and mobile and were suitable for this slope with access constraints. Working platforms were provided for nail installation. Drilled holes of diameter 125 mm were formed at spacing of 2 m horizontally and 2 m maximum vertically. The holes were drilled at 10° below horizontal. Casing was not required as groundwater was not encountered and collapse of holes did not occur. All the nails were installed with a minimum of 2 m embedment length within the Slightly Decomposed Granite.

High yield steel with diameter 32 mm were used as nails and grouted into predrilled holes with cement grout (water cement ratio <0.45) under gravity or very low excess pressure. Couplers were used to join the bars together. Centralizers were placed at regular intervals (1.5 m) along the reinforcement to ensure concentricity with the drillhole. The faces of the nails were then formed with 350 mm square concrete pads to locally stabilize the slope face. Twenty five horizontal drains were installed row by row in the central section of the slope. The construction was completed in about 3 months near the end of October 1995.

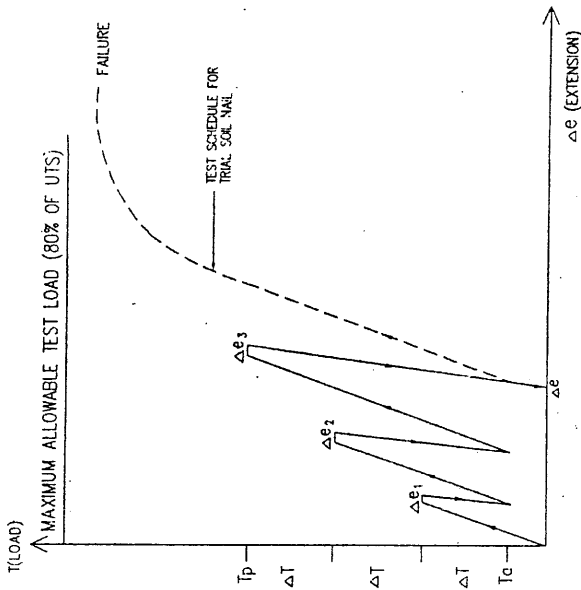
Figure 6. Load test path and typical results of pull-out test.

Pull-out tests were performed on trial soil nails to verify the design parameters and assumptions so that modifications could be made to account for any deviation and change of the existing site condition. A total of 10 pull-out tests, which was approximately 10.4 % of the total number of nails installed, were carried out. The data of test results are summarized in Table 1. A typical graphical presentation of pull-out test results is shown in Figure 6.

None of the tests failed to reach the test load 1.5 times the working load. The soil nail extensions under the test load ( $T_p$ ) were well below the specified acceptance limit (0.3% of the grouted length of the nail). These test results indicate that the bond stress design approach adopted was adequate.

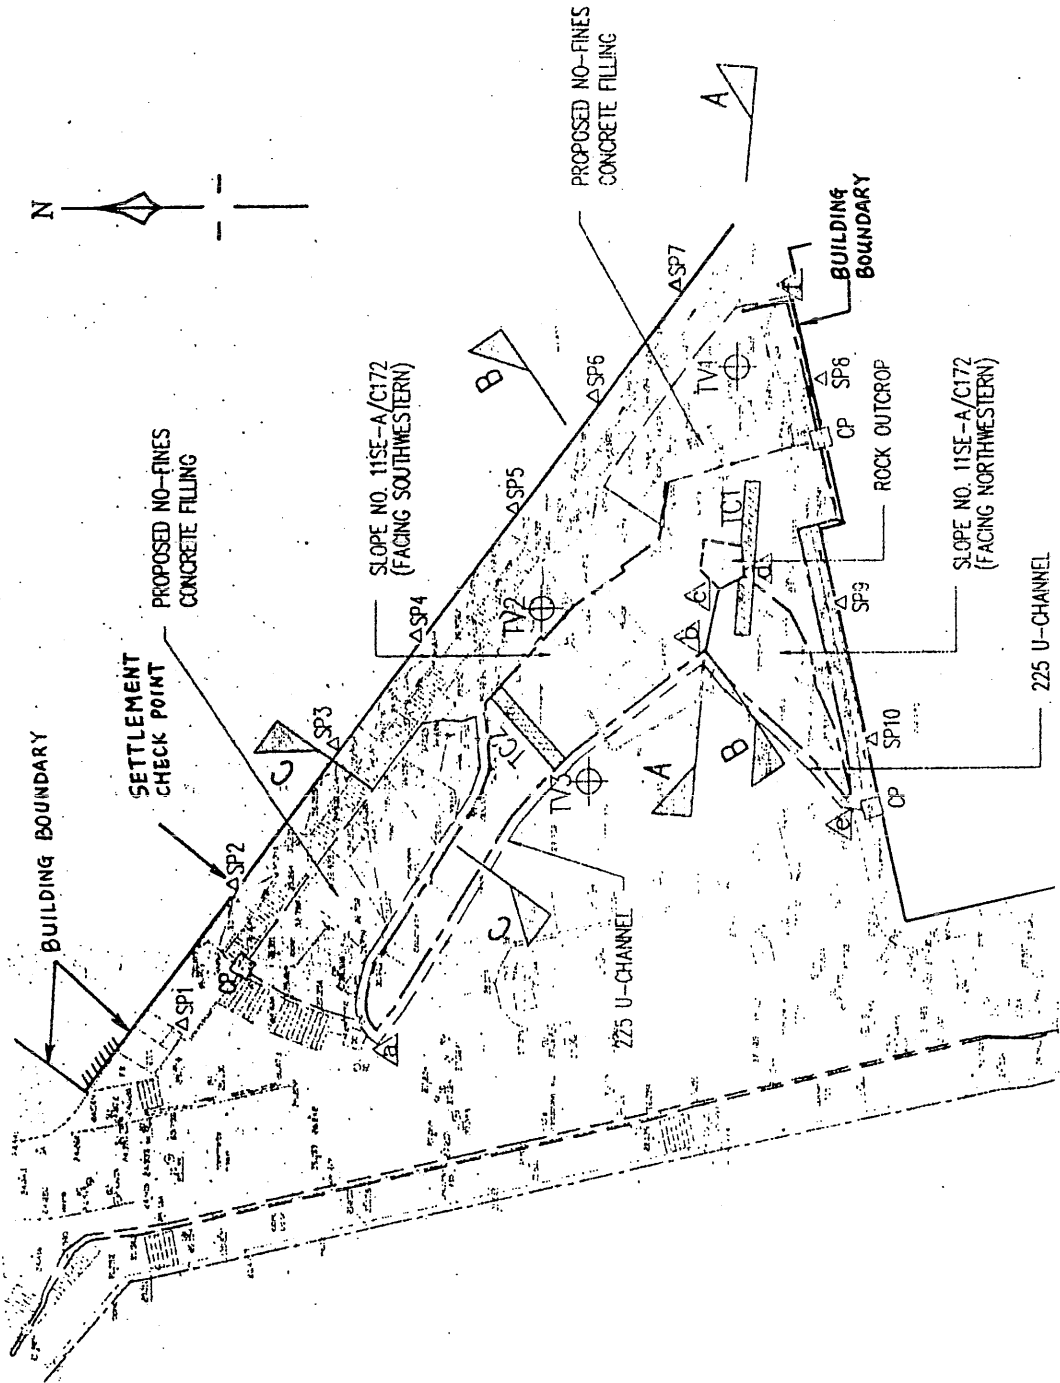
Figure 7. Site plan of slope 11SE-A/C172 at Tanner Hill Estate.

The site is located on Tanner Hill, North Point, Hong Kong. Tanner Hill Estate is comprised of two residential blocks constructed on a series of terraces cutting into the natural hillside. The concerned slope is located adjacent to the two residential blocks as shown on Figure 7. It was covered with chunam ( a soil-cement mixture) with some rock outcrops at the middle section. The slope is about 7 to 17 m high and 40 m long with an average slope angle of 50°. Weepholes of 75 mm diameter were installed at 1.5 m spacing. Stepped channels and U-channels were provided on the slope and at the crest. Bulging and cracking of chunam cover were noted.

A subsurface exploration, comprising three vertical boreholes and two chunam strips, was carried out between 9 June and 5 July 1993. The locations of boreholes and chunam strips are shown on Figure 7. Undisturbed soil samples were taken using Mazier triple tube core barrels and Standard Penetration tests were performed. Observation wells were installed

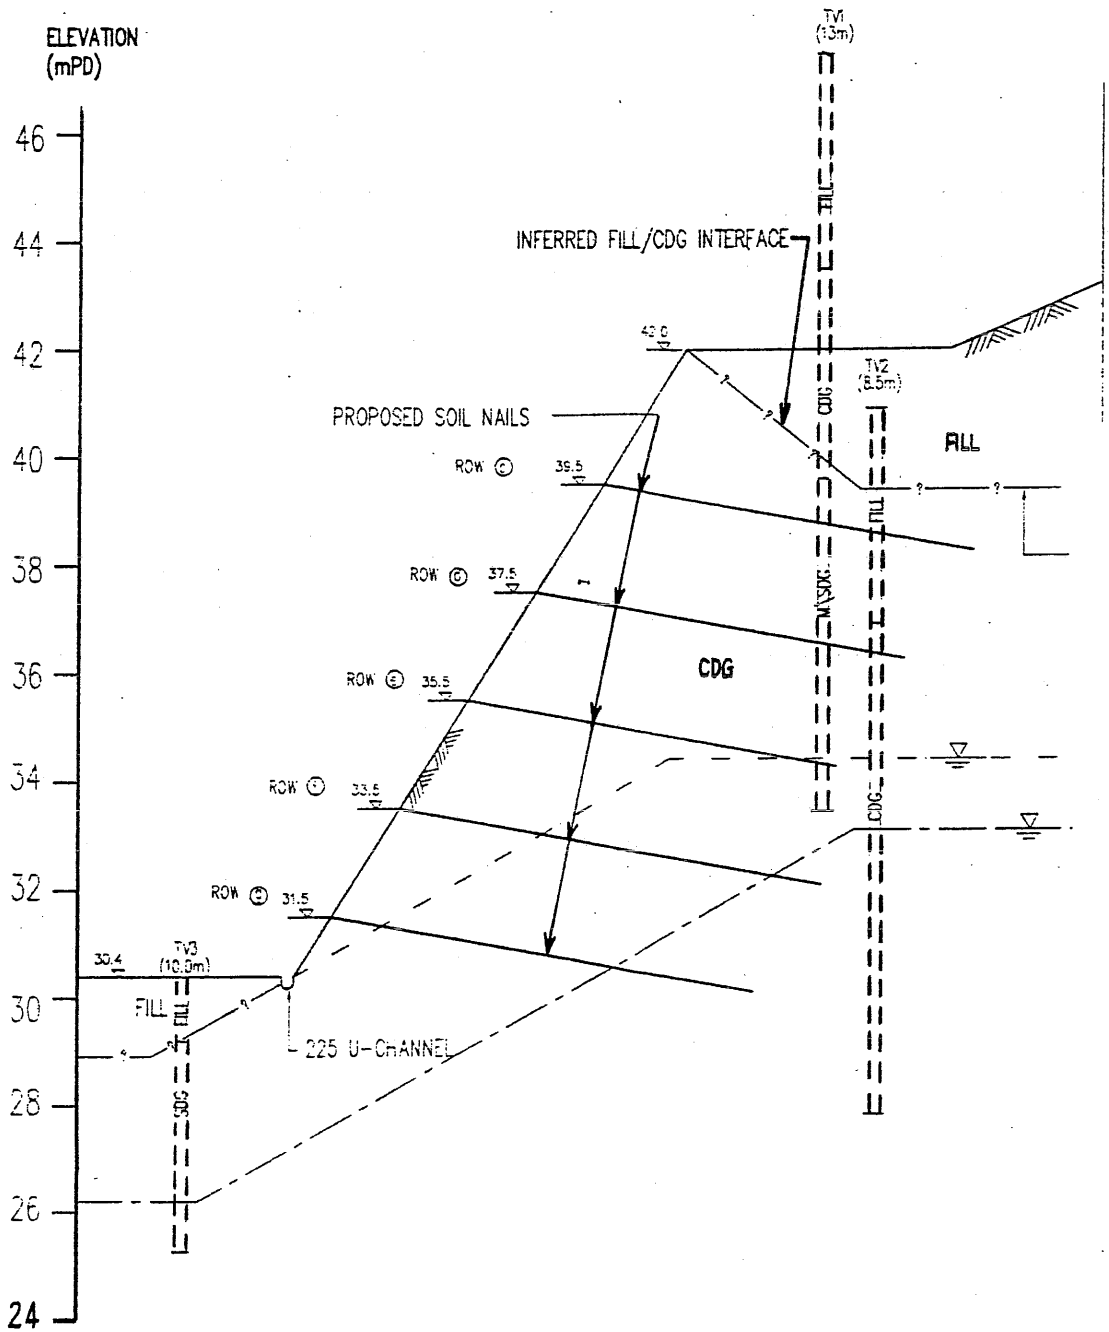
Figure 8. Section B-B of slope 11SE-A/C172 at Tanner Hill Estate.

A minimum safety factor of 1.2 against slope failure with a surcharge of 5 kPa at slope crest were adopted for this slope. Slope stability analysis using the simplified Janbu's method revealed that the safety factor is below unity. Using Janbu's simplified method, the horizontal force necessary to bring the minimum safety factor to 1.20 was calculated and a soil nailing system was designed to provide this resistance.

The proposed soil nails were spaced at 1.5 m horizontally and 2 m vertically. Nails of 25 mm diameter and 6 to 9 m lengths were proposed. Drilled holes of 125 mm diameter inclined at  $10^\circ$  below horizontal were required to accommodate the nails. A total of 77 nails was required. The slope surface was to be protected with 75 mm thick shotcrete applied in at least 2 layers. In two areas, the upper 2 m of the loose fill was required to be replaced by no-fines concrete.

A total of 77 nails were installed for this slope. Soil nails were installed row by row in the proposed slope in panels from top to the base of the slope. High yield steel with diameter 25 mm were used as nails and installed following the same procedure as in Case 1. The faces of the nails were also formed with 350 mm square concrete pads to locally stabilize the slope face.

In the two areas where the loose fill was excessively thick, up to 2 m of the fill was replaced by no-fines concrete. The construction was completed in about 3.5 months near mid-January 1996.
