Failure of a Large Diameter Steel Culvert Located Beneath a Major Forestry Road

*Proceedings of the 11th
V a n c o u v e r
Geotechnical Society
Symposium - Forestry
Geotechnique and
Resource Engineering*

30 May 1997

Victor A. Sowa, Ph.D., P.Eng., P.Geo.¹

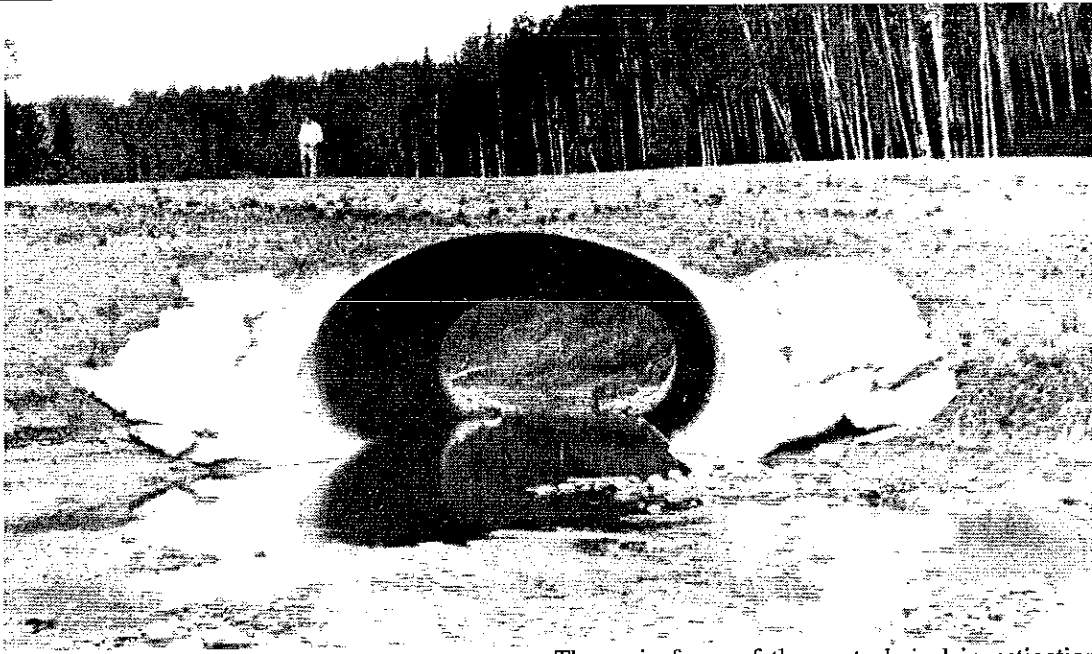
Figure 3. Big Mountain Creek culvert - culvert deformation prior to failure.

The information available from the photographs, such as those shown on Figures 3, 4, and 5, taken of the Big Mountain Creek culvert before and after failure, and the measured deformations given on Figure 14 indicated that the culvert probably failed by excessive deformation similar to the manner illustrated on Figure 15. High horizontal pressures were transmitted to the compacted clay backfill along the sides of the culvert as the culvert deformed vertically. Compacted clay backfill material tends to deform with time under these horizontal pressures, and because of the deterioration of the quality of the backfill with time, the amount of deformation increased. This behavior resulted in downward deflection of the crown of the culvert. Ultimately, plastic hinges developed in the steel walls of the culvert due to the excessive deformation and complete collapse occurred. Providing that the deformation is symmetrical about the centreline of the culvert, plastic hinges will form near the 10:00 and the 2:00 o'clock positions on the culvert.

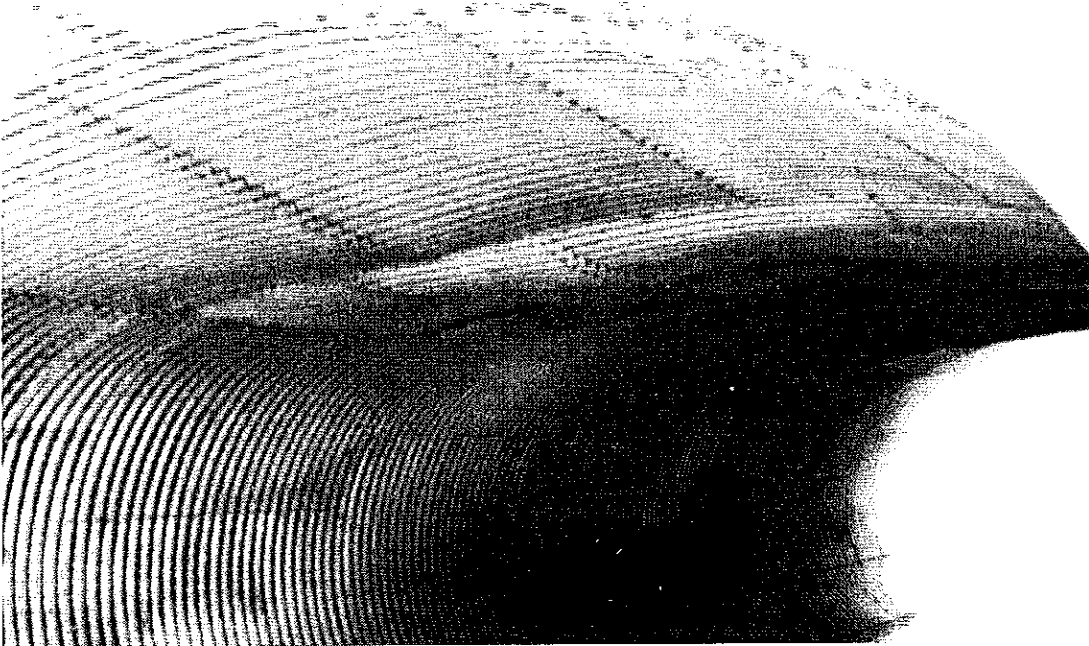
Figure 4. Big Mountain Creek culvert - deformation of crown of culvert prior to failure.

The crown of the culvert also deformed significantly downward as can be seen in the photograph in Figure 4. The amount of deformation was measured inside the culvert by surveyors using boats for access. The collapse of the culvert was a progressive failure, commencing with an initial reverse curvature of the crown of the culvert. The reverse curvature can also be detected by careful examination of the photographs in Figures 3 and 4. The culvert collapse was essentially symmetrical about the centerline of the crown. The collapsed Big Mountain Creek culvert, which was a snap through type of failure, is shown on the photograph in Figure 5.

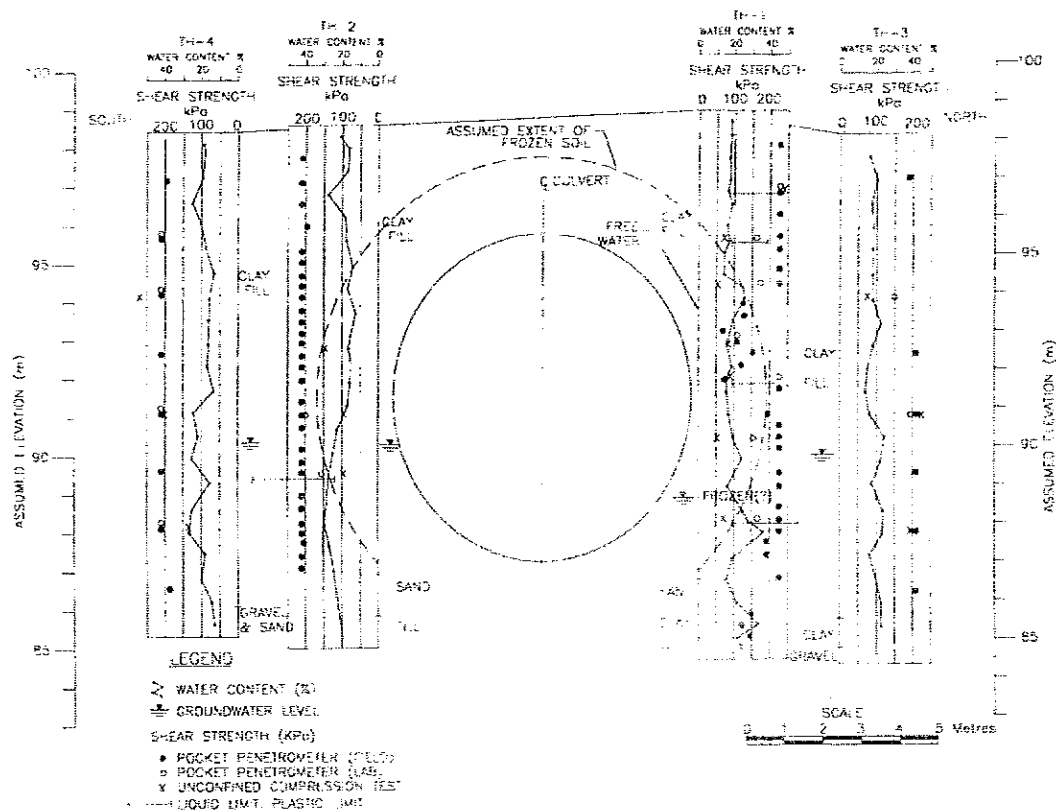
Figure 10. Bald Mountain Creek culvert - Soil stratigraphy, location of culvert and test results.

these test holes measured with the pocket penetrometer in the field were mostly larger than the maximum measurable strength of 216 kPa, given in Table 7 and on Figure 10. The shear strength measured from the unconfined compression tests and pocket penetrometer tests in the laboratory were generally similar, and typically were about 150 to 200 kPa. It was concluded that the general clay backfill located far enough away from the culvert was compacted adequately during construction, and at the time of drilling had not changed much since construction.

The condition of the compacted clay backfill closest to the culvert is of interest since it is the condition of this backfill which governs the performance of the culvert. Test Holes 1 and 2 are located 0.22 and 0.38 m respectively from the spring line of the culvert at the closest point. The central portions of these test holes which are directly opposite the culvert can be considered as being the culvert clay backfill adjacent to the culvert, although the test holes are not as close as the test pits. In view of the close proximity of these test holes to the culvert, probably most, if not all, of the soil samples within the height of the culvert were frozen. Consequently the results illustrated on Figure 10 of pocket penetrometer tests taken in the field on the ends of the

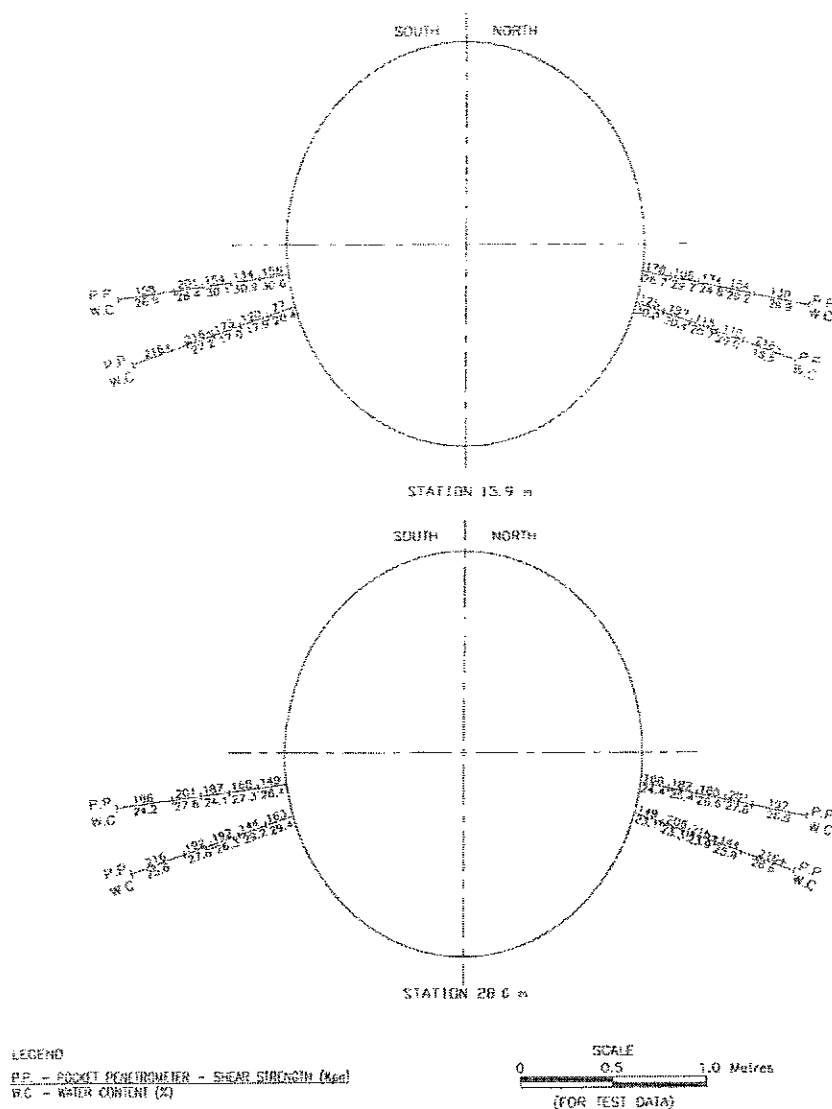
Figure 12. Bald Mountain Creek culvert - Summary of strength and water contents adjacent to the culvert for Sta. 15.9 m and Sta. 28.0 m.

The results given on Figures 12 and 13 for the test pits adjacent to the culvert indicate that even if the soil is frozen or partly frozen, the undrained shear strength obtained from the pocket penetrometer was less than for the unfrozen soil in Test Holes 3 and 4. The undrained shear strength from the pocket penetrometer tests on Test Holes 3 and 4 was generally 200 kPa or larger, while only a few results in the test pits reached 200 kPa. Most of the results in the test pits were in the 100 to 200 kPa range, but there are localized areas where the shear strength was less than 100 kPa. There are other examples when the shear strength determined from the pocket penetrometer tests was so low that the

tent of 26 percent, and the shear strength obtained with the pocket penetrometer was 34 kPa. These results indicate that there has been a significant localized deterioration and reduction in strength.

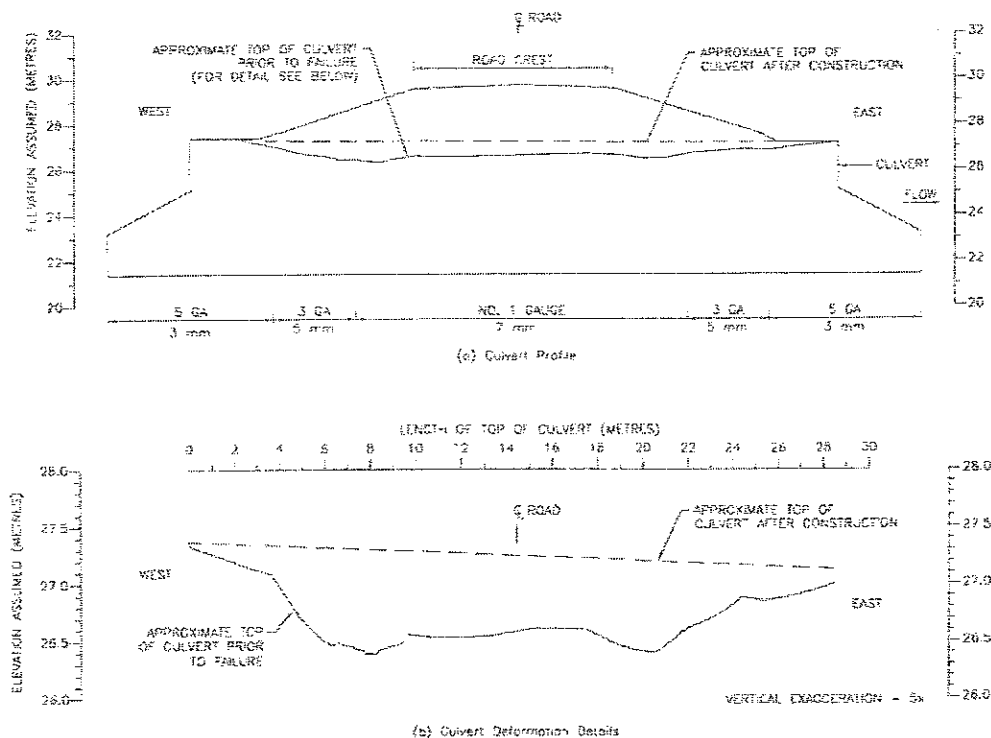
Figure 14. Big Mountain Creek culvert - Deformation of top of culvert prior to failure.

approximate profile of the culvert at the end of construction and the profile of the deformed culvert just before failure. The deformation profile of the culvert is shown to more detail on Figure 14b. As can be seen, the maximum deformation occurred approximately at the mid-point of the road side slope, and the deformation was larger at the upstream end of the culvert. The maximum deformation also corresponds closely to the location where the gauge of the culvert structural multi-plates changes from No. 1 Gauge (7 mm thick) to a thinner No. 3 Gauge (6.2 mm thick).

More specifically, the maximum deformation occurs about 1 to 2 metres just before the transition from the heavier No. 1 Gauge multi-plate sections to the slightly lighter No. 3 Gauge sections, and this occurs at a location where the soil cover on the culvert is less. The increased deformation near the ends of the culvert where the soil cover is less may be an indication of the "end or face effects" as noted by Byrne (1990). Near the ends of culverts, the confining soil restraint is low but the thrust can still be large, and these circumstances may lead to buckling near the end of the culvert.

The measured deformation of the top of the culvert just before failure as shown on Figure 14 ranges from a maximum of 860 mm near the upstream end, to about 650 mm along the middle section of the culvert, and then to another maximum of about 750 mm near the downstream end. The deformations of 650 mm and 850 mm are 10.7 and 13.9 percent respectively of the 6.1 m height of the culvert. These deformations far exceed the original estimated deformation of 58 mm, and also exceed the allowable deformation.
