Emergency geotechnical instrumentation for a burning landfill to monitor the impacts of fire-fighting and post-fire reclamation

Abstract: A state of local emergency was declared at the Delta Shake and Shingle landfill on November 27, 1999. The landfill is situated in Delta, British Columbia within an area referred to as Burns Bog. Surficial soils consist of very soft to soft peats, silts and clays. Two large diameter high pressure gas pipelines as well as a 500KV transmission tower border the landfill to the south while a set of railroad tracks, a 1.0m diameter forced sewer main and a 1.0m diameter high pressure water main border the north side. Previous movements of some of the side slopes of this landfill have shown the sensitivity of the stability of the landfill to the strength and deformation properties of the subsurface soils as well as the landfill materials. One particular event caused the movement of one of the high pressure gas pipelines of the order of 1.5m.

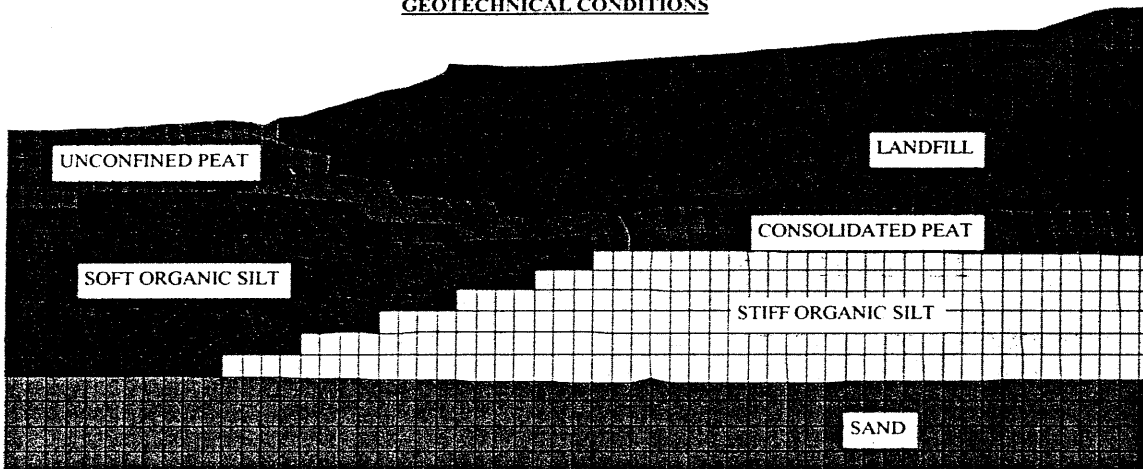
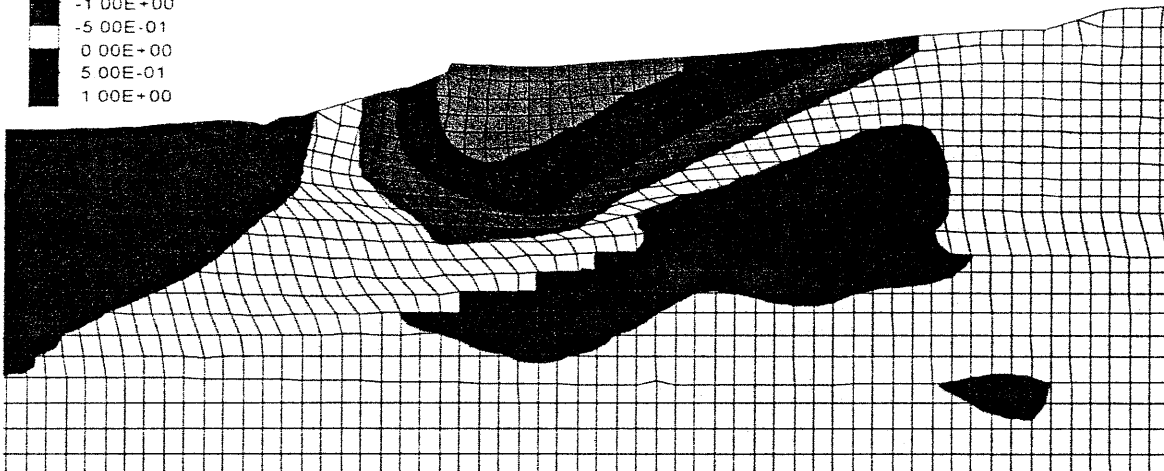
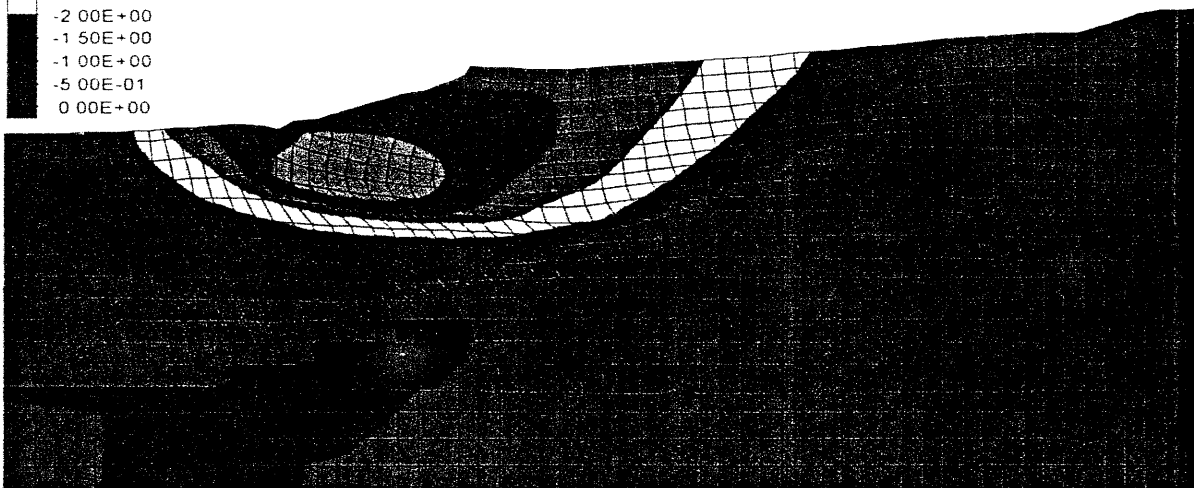
Figure 2. Back analysis of previous slope deformation

silt/clay existing after the movement took place, FLAC analyses were completed wherein the strength of the materials was progressively decreased until the pattern and magnitude of deformation reasonably matched those of the actual slope movement. In this case, large strain logic was used and a reasonable match occurred when the strength of the soft materials was decreased to approximately 6 kPa. Results for this analysis are shown on Figure 2 and Table 5 summarises the results of this case.

Comparison Item	Measured Value	Model Prediction
Vertical drop of the crest of the slope (m)	0.6	1.5
Vertical heave at the toe of the slope (m)	1.5	1.2
Horizontal displacement of the BC Gas pipeline (m)	3	2

CONTOURS OF VERTICAL DISPLACEMENTS

CONTOURS OF HORIZONTAL DISPLACEMENTS

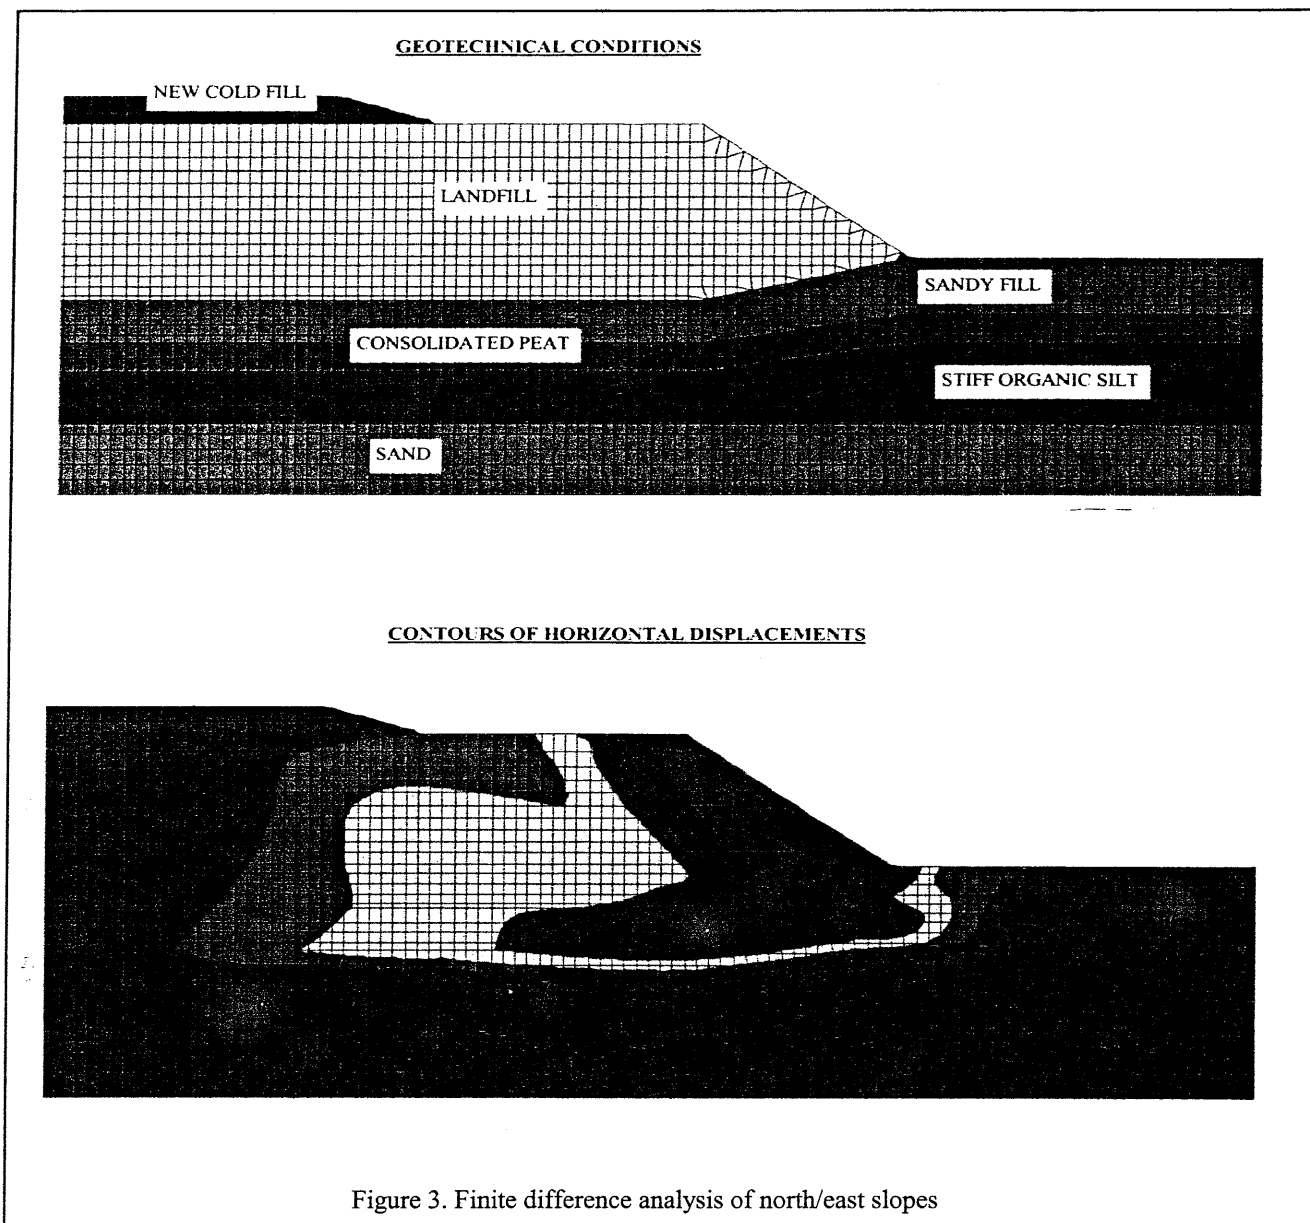
Figure 3. Finite difference analysis of north/east slopes

As time permitted, finite difference analyses were completed for the main landfill to provide more accurate factors of safety as well as predictions of movements due to placement of the cold fill on top of the main landfill. Because of the considerable stiffness contrasts between the various materials in the landfill, finite difference modelling was considered necessary to accurately predict the response of the landfill to the addition of the new Pad No. 2. Using finite difference analyses with peak strength parameters, the factor of safety against a new failure of the north, south or east slopes exceeded 1.3. The failure planes did not extend back to the new cold fill, indicating that failure surfaces involving this new material have a higher factor of safety than 1.3. Figure 3 shows the results of the case for the north slope.

Based on consideration of the results of all the predictive analyses for the main landfill, it was concluded that the addition of the new cold fill to a height of 3 metres and at the proposed set-backs was acceptable. The reconstruction of the horseshoe area would be no higher than its original level before the fire, and to a lower level than the top of the new Pad 2. Hence, reclamation and refilling of the horseshoe area was also not predicted to result in failure.

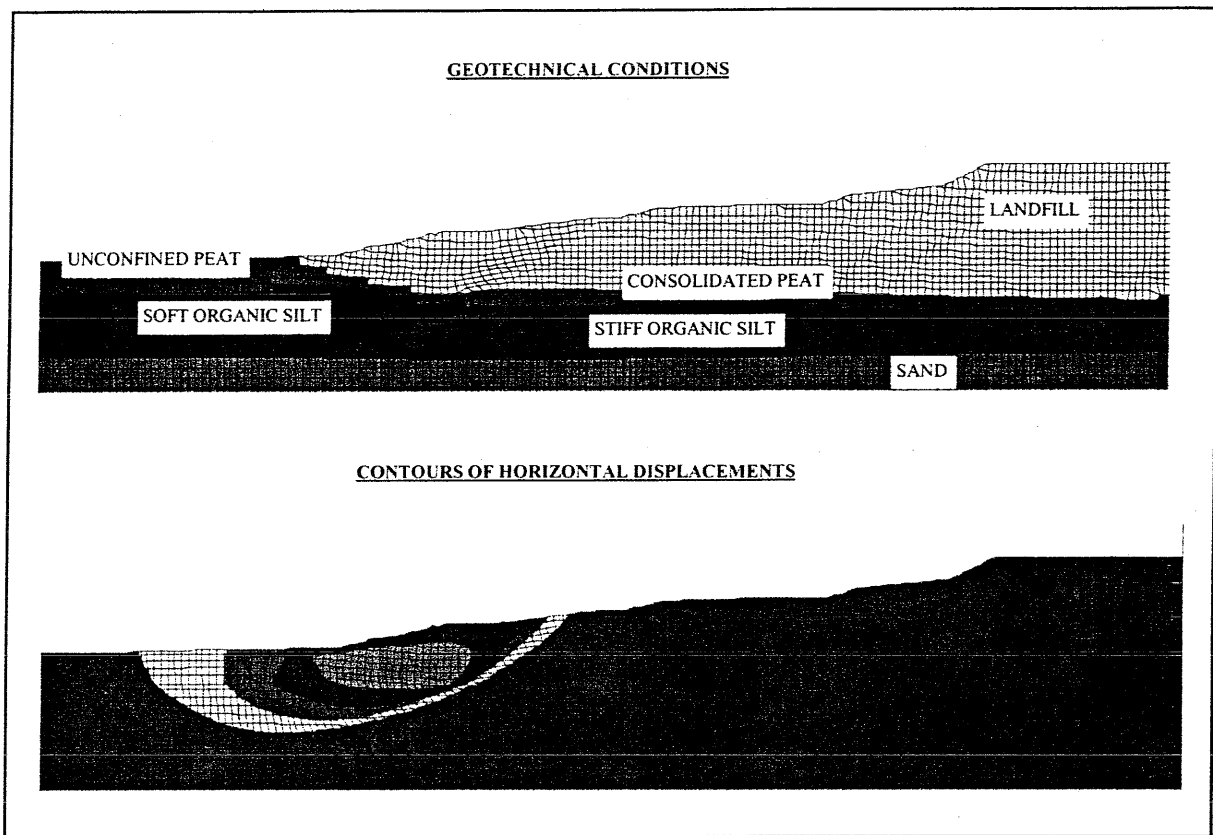
Figure 4. Zone of influence of movement block at the south toe.

A further check was made for re-mobilization of the previous movements at the south toe of the landfill. In this case, large strain logic was used with the residual strength in the soft peat and organic silt/clay (6 kPa). The strengths were reduced in all materials until significant deformation was initiated. Figure 4 shows that these deformations did not extend back to the new cold fill, indicating that the failure block would not be affected by the addition of the cold fill.

For the trigger levels analysis, the entire north-south cross section of the landfill was analyzed using large strain logic. The predicted deformations should be considered short-term movements, as undrained shear strengths and high bulk moduli were used in the low permeability materials such as the organic silt/clay. The results of the analysis are shown on Figure 5. Based on the analysis, trigger levels for the main landfill were set at measured movements of less than 25 to 50 mm. Movements greater than this amount would have been cause for concern. Table 6 presents estimated horizontal deformation values for the landfill and the expected direction of movement. Also shown on the table are the measured deformations and the locations of these points can be found on Figure 1.

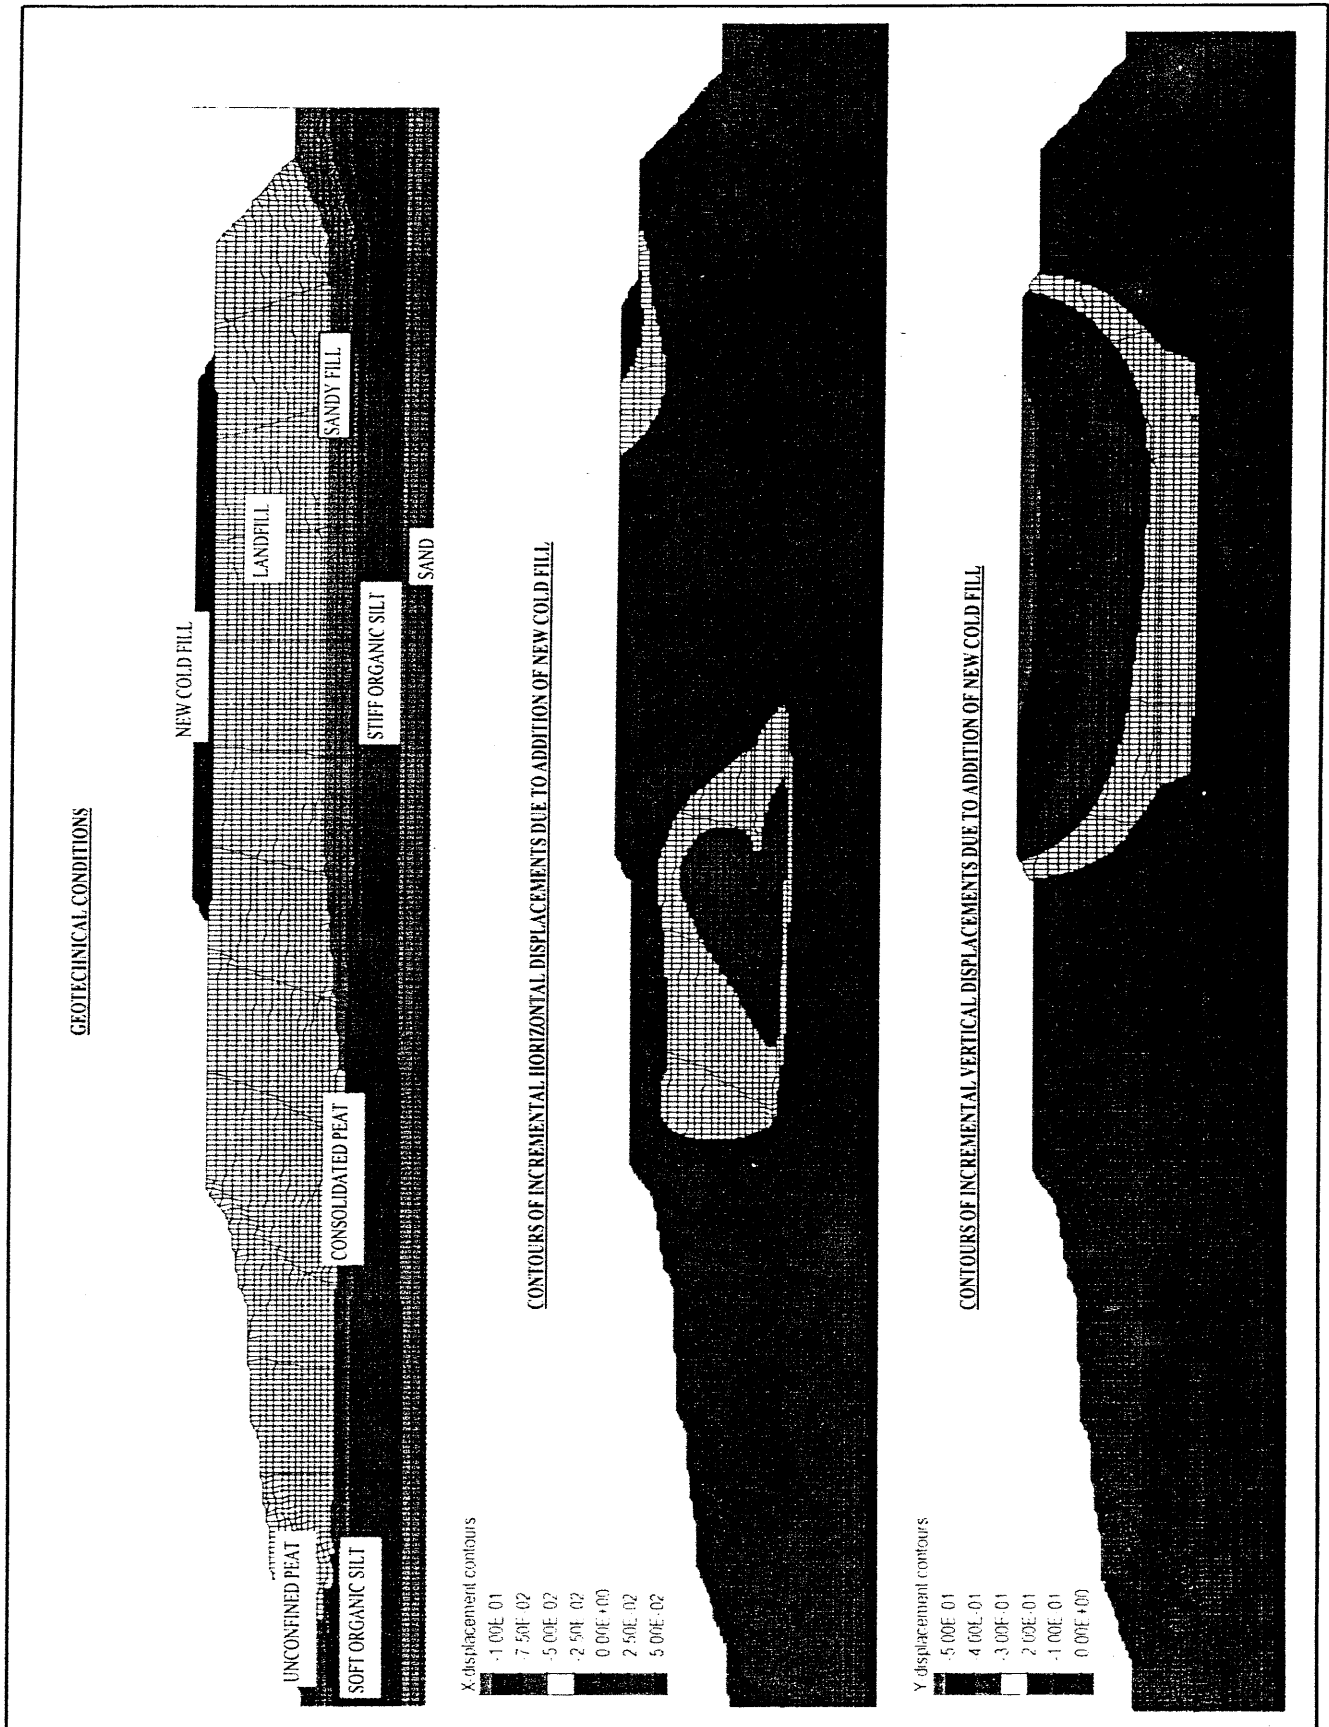
Figure 5. Additional movements due to addition of Pad 2

Survey lines located along the south side of Pad 2 moved in the range of 0 mm to 25mm in a variety of directions with a range of vertical movement 40 mm upward to 50 mm downward. The western portion of the south side of the landfill had the greatest displacements.

Survey lines along the north and east sides of Pad 2 underwent displacements of 10 to 45 mm to the southwest and 15 to 20 mm to the southeast along the north and east side respectively. The change in elevation was between 20mm to 70mm downward and 5mm to 30mm downwards along the north and east side, respectively.

Movement measurements generally indicate that settlement and outward movement resulted from the filling at Pad 2. It appears that removal of the burning material caused displacements towards the Horseshoe area due to stress relief.
