Road deactivation for hillslope restoration: lessons learned on the Escalante Watershed Restoration Project

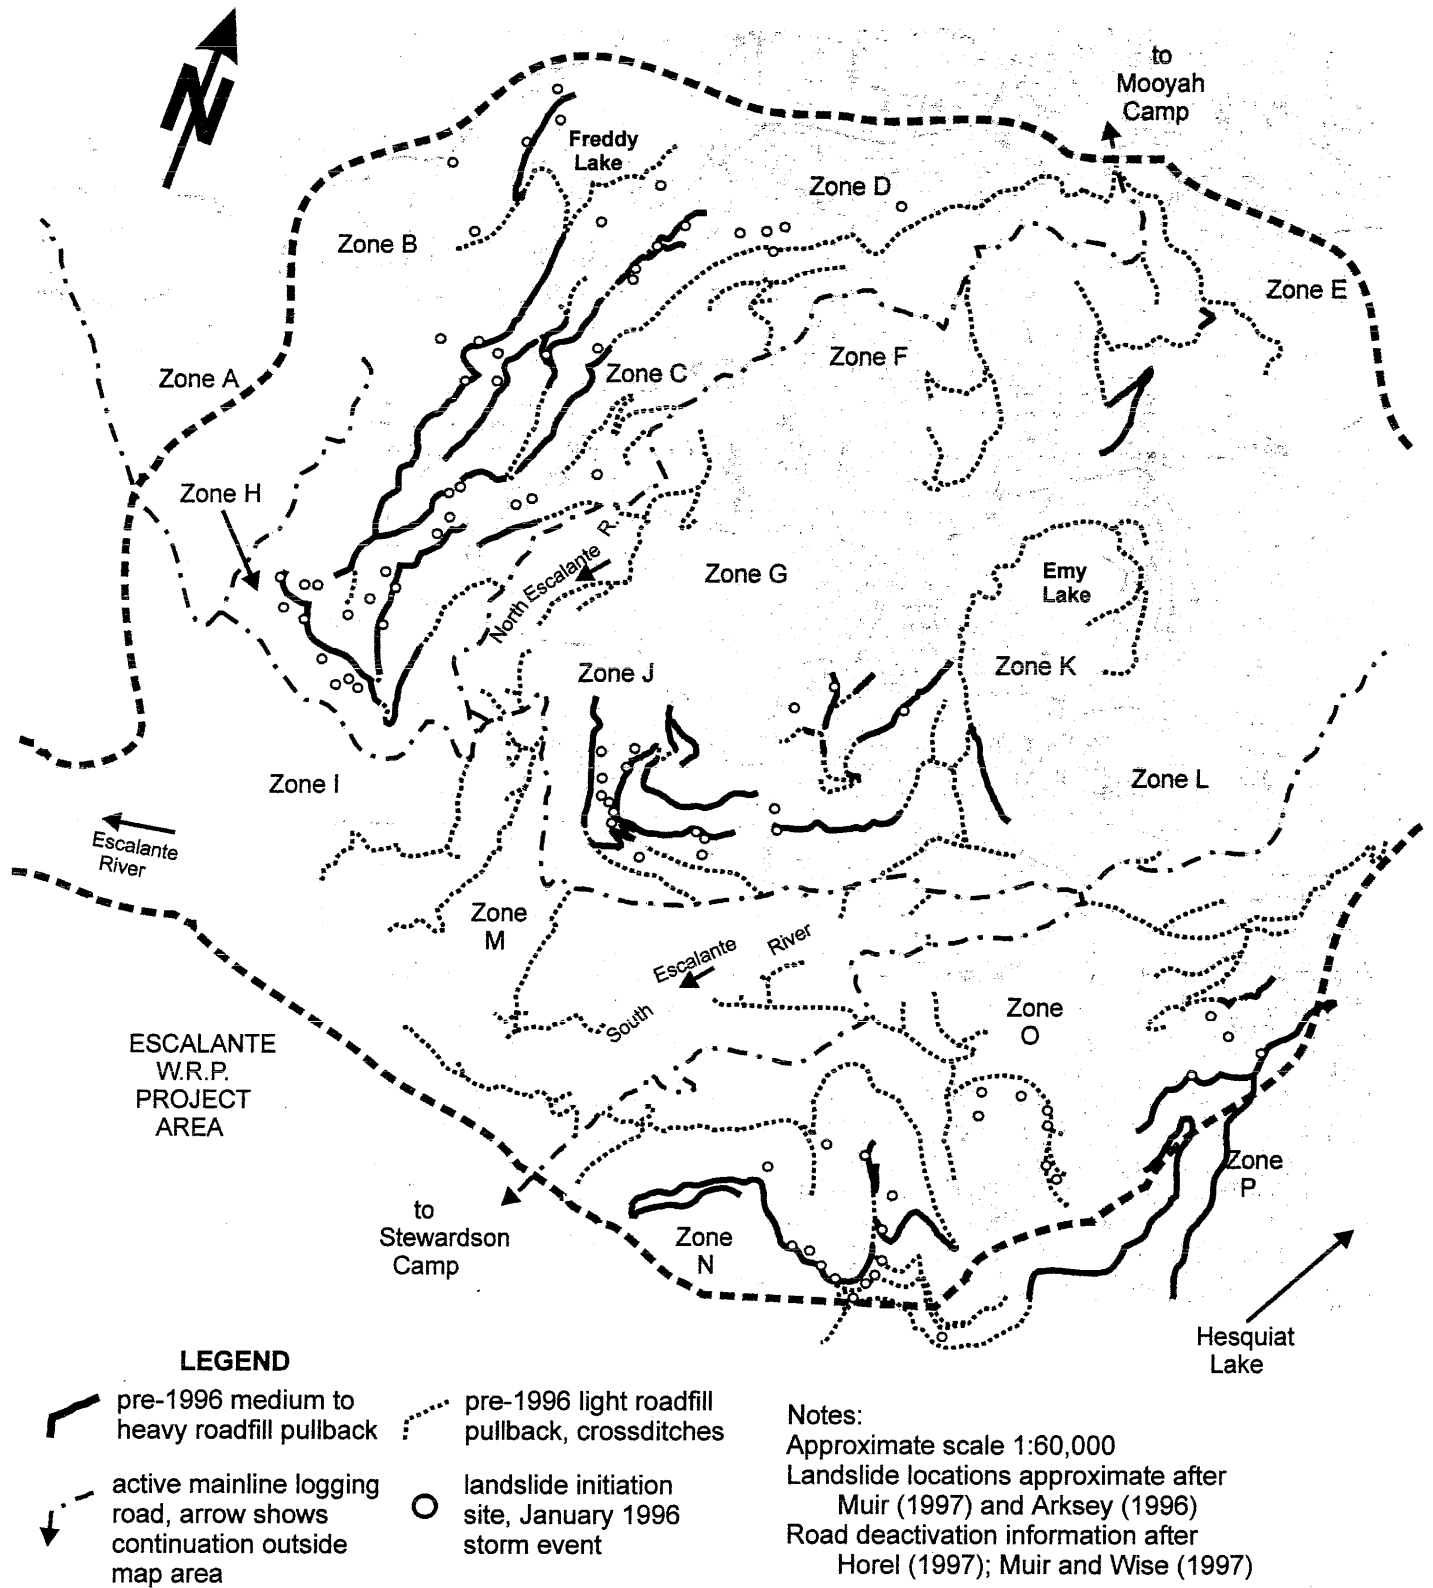
Fig 2: Pre-1996 road deactivation in the Escalante study area and approximate landslide locations from January 1996 storms.

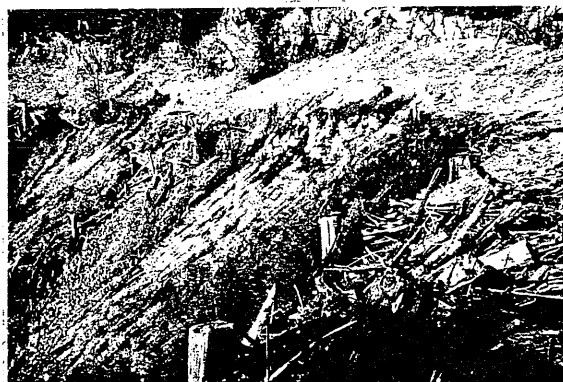
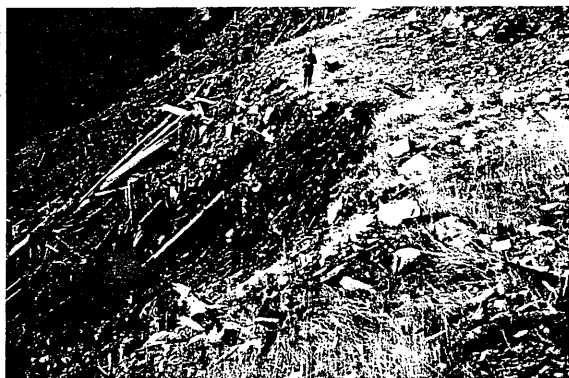
Immediately following the January 1996 storms, the Ministry of Forests conducted aerial reconnaissance to assess the impacts of the landslides throughout Clayoquot Sound and nearby areas. In the Escalante, ground reconnaissance of the roads deactivated with medium to heavy roadfill pullback revealed that about 15% to 25% of these areas had significant tension cracks, signifying imminent failure. Many areas with crossditches and limited roadfill pullback also showed significant tension cracks.

Fig. 3. Example of a landslide along an area with heavy roadfill pullback (upper photo) and light pullback (lower photo), Escalante watershed

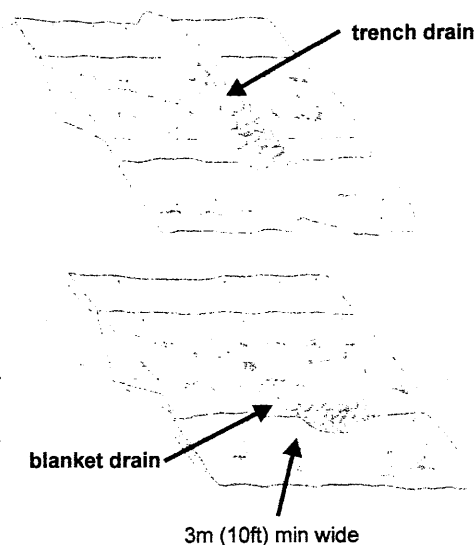
Fig. 4: Trench drains and blanket drains in pullback.

Re-establishing the natural drainage patterns along pullback sections was carried out with trench drains and blanket drains, as well as crossditches where appropriate. The amount of coarse rock near to the site was an important consideration in the cost effectiveness of trench drains and blanket drains.

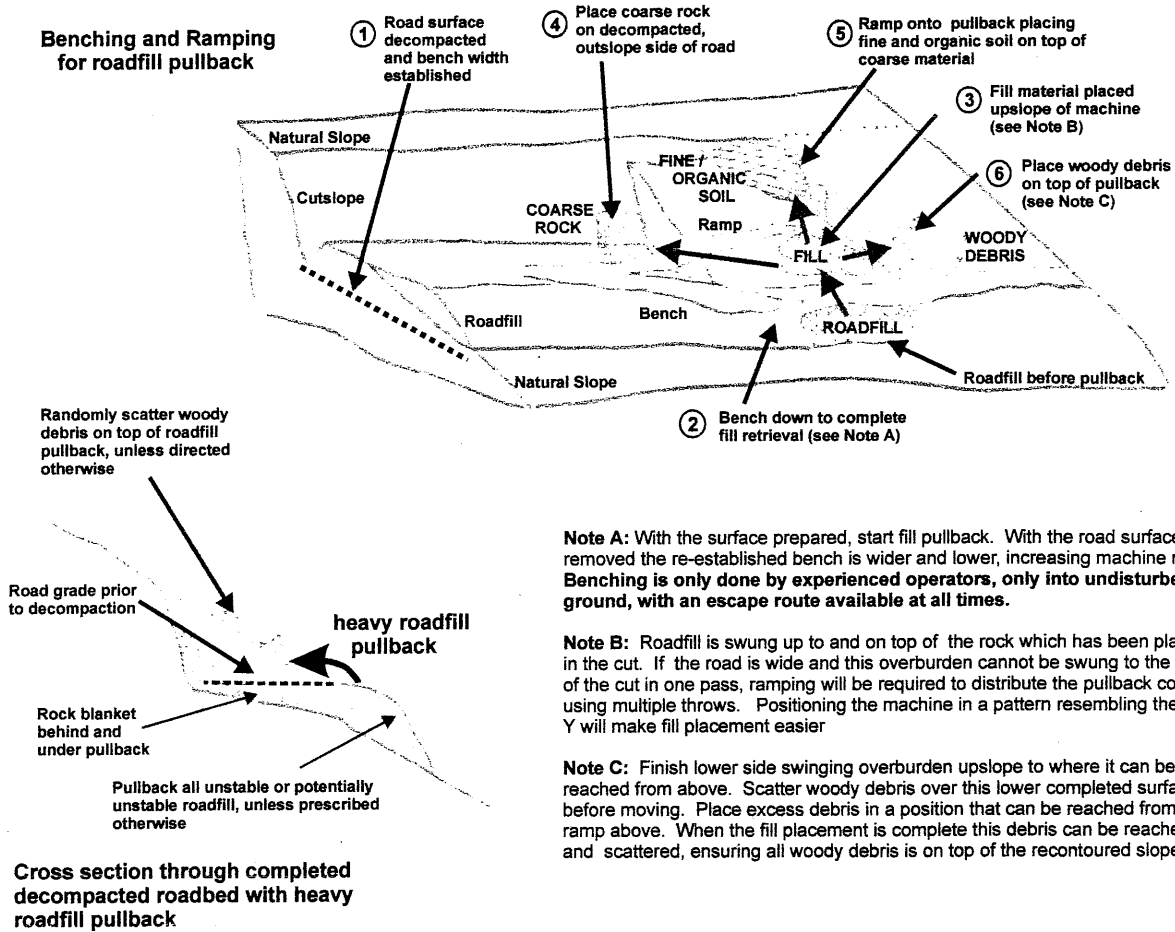
Benching and Ramping for roadfill pullback

Fig. 5: Benching and ramping for retrieval of roadfill during hillslope restoration. Numbers in top sketch indicate suggested sequence for placing material in roadcut.

Decompaction during roadfill pullback, along with benching and ramping, provided three distinct benefits (Fig. 5). Decompaction is the initial step in benching, where the operator excavates about the top one metre of the old roadbed to determine the stable bench width and the amount of roadfill present at the site. Firstly, if the roadfill is more than half the width of the road, and is located in wet or fine textured materials, then the site may present a safety hazard and the operator would adjust his machine positioning accordingly or postpone work. It was important for the operator always position his machine on undisturbed soil or very stable roadfill. Excess roadfill may also mean that end-hauling is needed to reduce the amount of potentially unstable roadfill left following deactivation.

Note A: With the surface prepared, start fill pullback. With the road surface removed the re-established bench is wider and lower, increasing machine reach. **Benching is only done by experienced operators, only into undisturbed ground, with an escape route available at all times.**

Note B: Roadfill is swung up to and on top of the rock which has been placed in the cut. If the road is wide and this overburden cannot be swung to the top of the cut in one pass, ramping will be required to distribute the pullback correctly using multiple throws. Positioning the machine in a pattern resembling the letter Y will make fill placement easier

Note C: Finish lower side swinging overburden upslope to where it can be reached from above. Scatter woody debris over this lower completed surface before moving. Place excess debris in a position that can be reached from the ramp above. When the fill placement is complete this debris can be reached and scattered, ensuring all woody debris is on top of the recontoured slope.
