# Identifying Pre-Existing Shear Surfaces and Slope Stabilization - A Case History Spanning Almost 30 Years

**ABSTRACT** The Bear Creek Village in Grande Prairie, Alberta is located adjacent to the east crest of Bear Creek valley. The apparent problem was related to the location of top-of-bank line and building foundation setbacks from the slope crest running along the western half of the development site and assessment of the risk of slope instability and its potential impact on the safety of the residents at Bear Creek Village. However, the main problem was later identified to be something much more critical. Closer look and review of some of the boreholes that were drilled for previous studies, prior to 1995, showed evidence of slickensides within the clay deposits. An extensive geotechnical borehole investigation program and CPT testing was initiated to confirm the extent of pre-existing shear zones and/or failure surfaces. The investigation program confirmed the presence of pre-existing shear zones and failure surfaces, which were later incorporated into slope stability analysis that indicated instability was along a non-circular slip surface. Setback distances corresponding

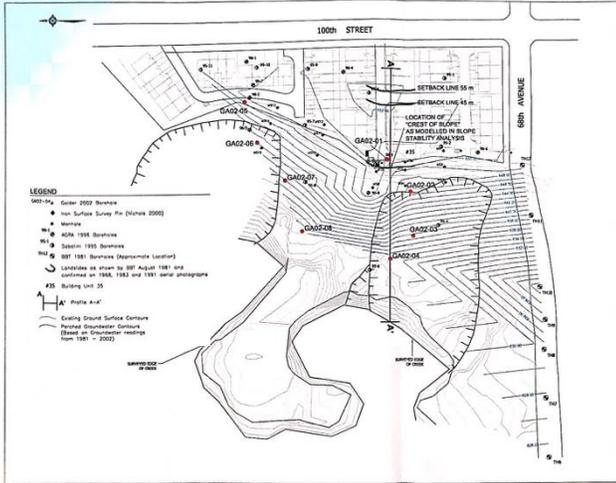
**Fig. 2. Site Location Plan**

The two old landslides shown on Figure 2 were depicted from the information on the 1968, 1983 and 1991 air photos. A review of the air photos illustrated that landslides have been retrogressive over the period 1968-1991.

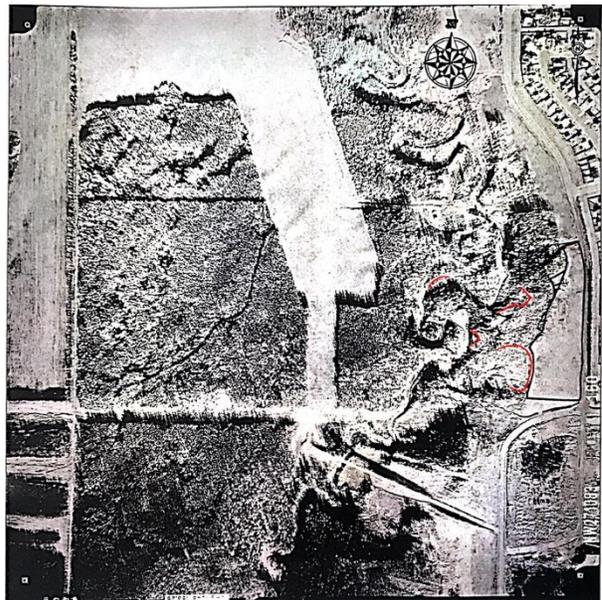
**Fig. 3. Air Photo 1983**

Stockpiles and construction material are removed from the site but the two buildings remain on the northern portion of the site. The site appears re-graded and leveled. There is an approximately 30 m wide landslide in the southern portion of the site. Bank instability and a small landslide are observed on the east creek bend near the northern boundary of the site. 68 Avenue right-of-way and a strip of land parallel to 100 Street have been cleared; see Figure 4.

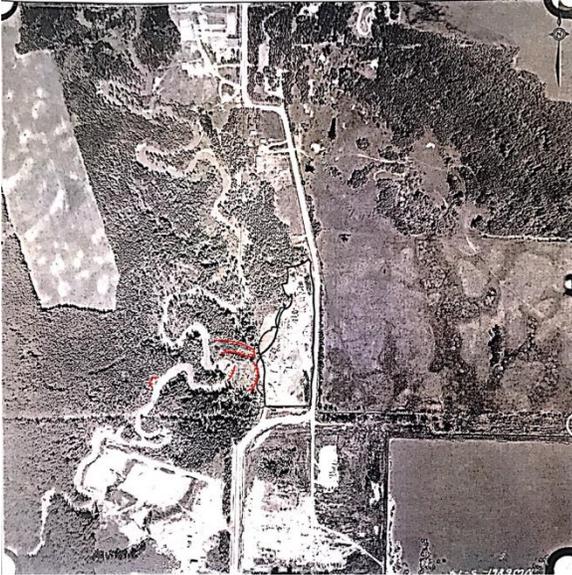
Fig. 4. Air Photo 1968

The subject site appears to be used for stockpiling construction material and equipment storage. Fill has been placed on top of the slope crest for the full length of the subject site. A 60-m wide landslide, which initiated at the crest of the slope, is visible near the south boundary of the property. The 1968 air photo is used as the baseline creek configuration for the comparison with the following air photos; see Figure 3.

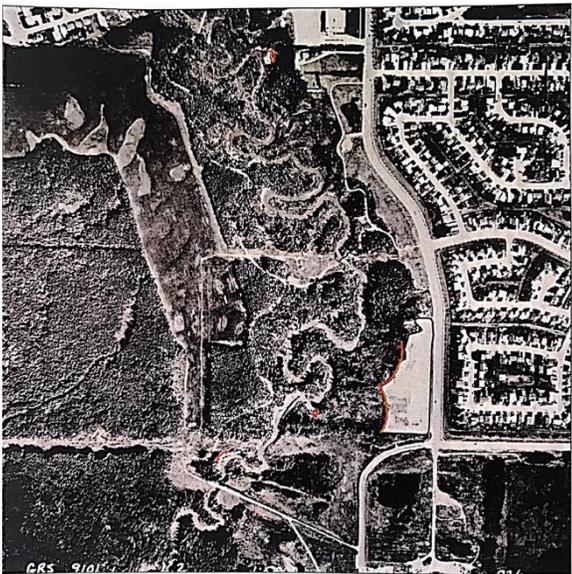
Fig. 5. Air Photo 1991

The site is completely graded and leveled with few buildings remaining at the northern tip of the site. Two landslides covering approximately the full width of the site are visible on the slope below the site; see Figure 5. Creek configuration has been changed due to the landslide as a meander has been obscured and a new channel is formed.

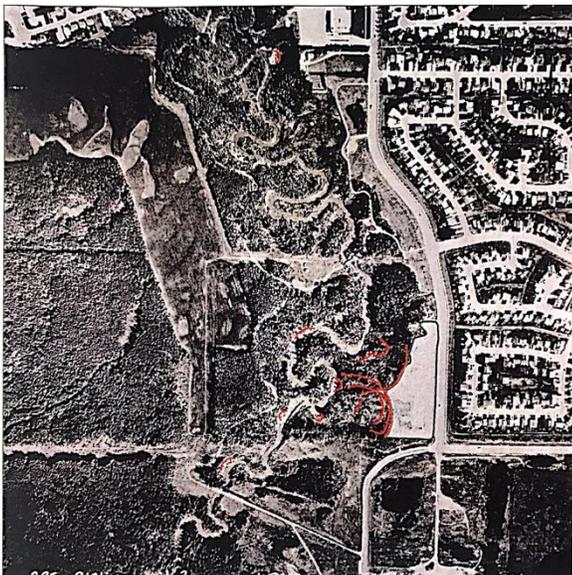
Fig. 6. Historical Landslides 1968-1991

Figure 6 is a summary of major features shown on Figures 3-5. Figure 6 illustrates retrogressive behaviour of landslides over the period 1968-1991.

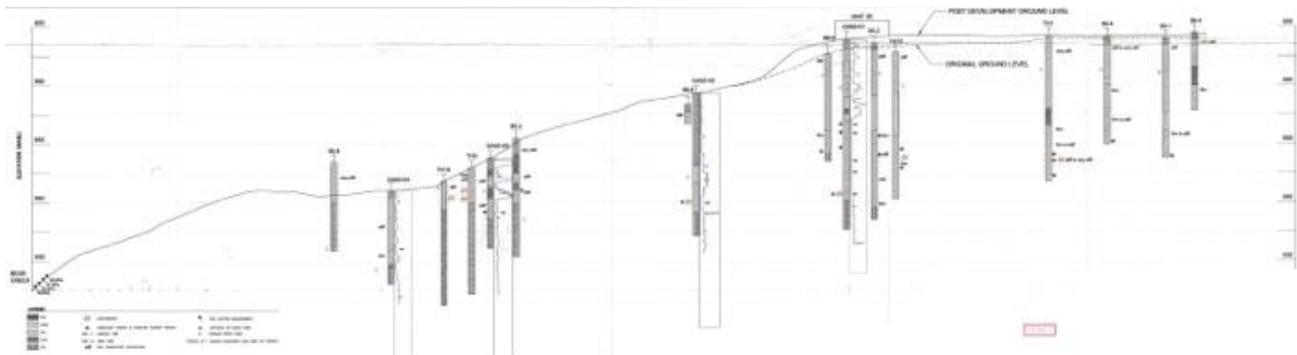
**Fig. 7. Profile A-A'**

Borehole logs indicate the presence of slickensides within lacustrine clay deposits in a new development north of Bear Creek Village Condominiums (refer to Figure 1). Figure 7 is a stratigraphic cross-section of subsurface conditions at the site. The slickenside depths are included in Figure 7.

A stratigraphic profile A-A' is shown on Figure 7. It includes previous borehole information along with the results of CPT soundings and borehole information gathered in May 2002. Significant changes in moisture content values, locations of slickensides, softened zones, shear zones, and groundwater profile are included on Figure 7.

Existing (as at 2002) groundwater conditions based on perched water table and the regional groundwater table were gathered from previous measurements in previous reports. The "current" perched water table corresponds to profiles shown in Figure 7. This profile runs at depths 4.5-5 m below the development site.

High perched groundwater conditions were based on the highest water table recorded at depths of 2.7 m across the slope. Profile of the high perched water table is shown in Figure 7. This profile runs 2.3 m below the development site and continues towards the crest and downslope to the flat bench; perched water table then drops to a depth of about 7 m along the flat bench.
