MASSIVE LANDSLIDES IN SOFT COMPACTION SHALES

E.W. Brooker*

INTRODUCTION

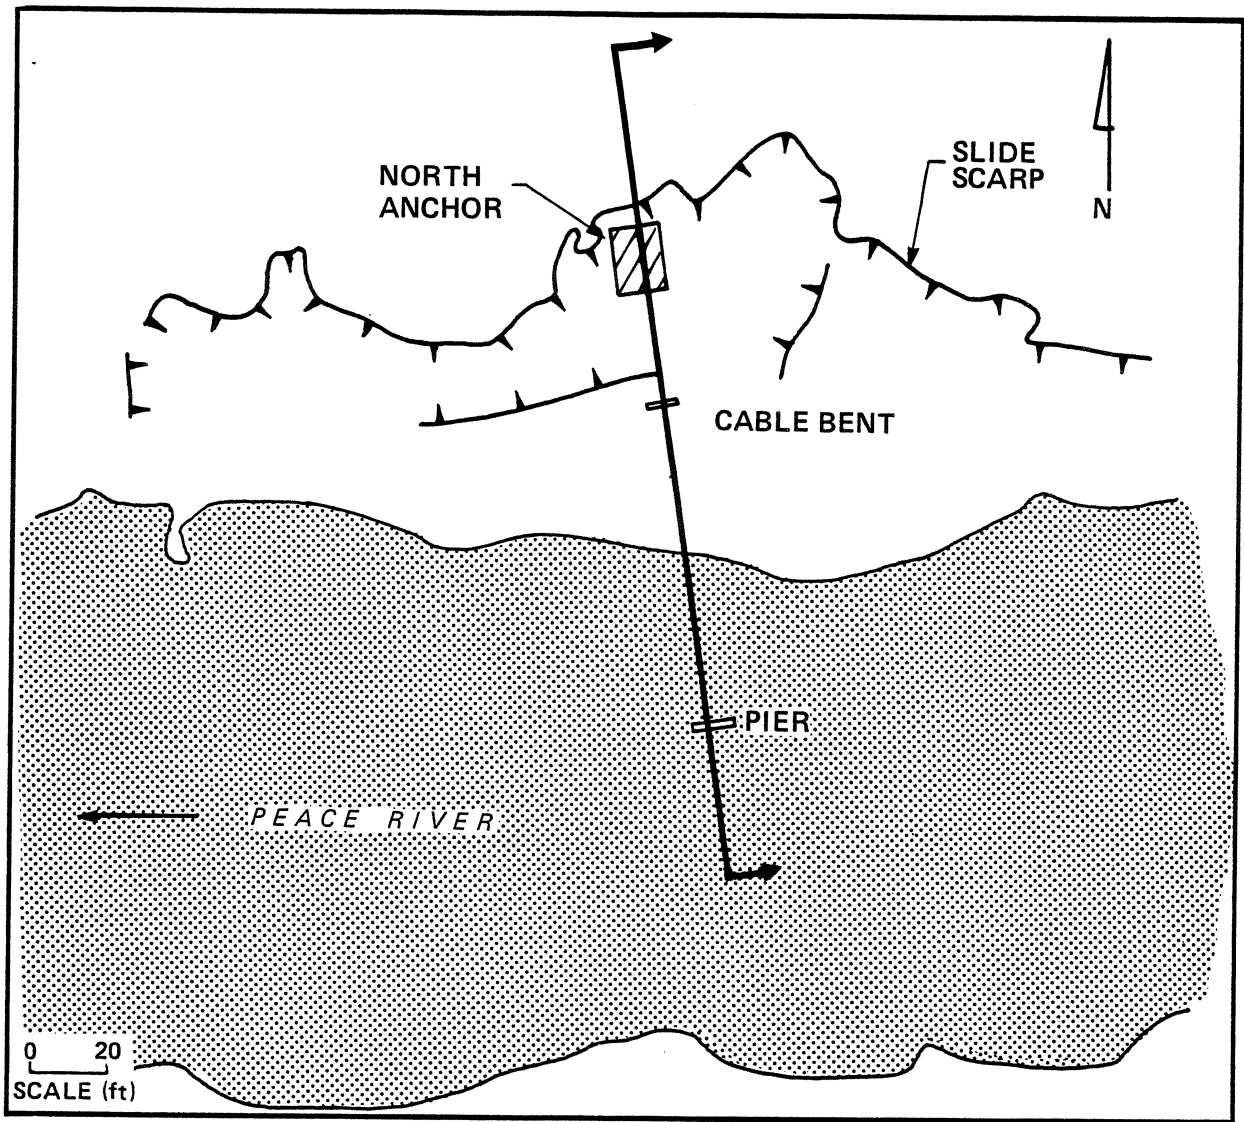
FIGURE 1 PEACE RIVER BRIDGE FAILURE – PLAN

In 1942, during war emergency circumstances the United States public roads administration on behalf of the U.S. Corps of Engineers constructed a suspension bridge across the Peace River at Taylor Flats, B.C. near Fort St. John. During 1956 remedial measures were carried out to correct scouring on foundations of the north suspension tower. During October 1957 after an exceptionally rainy season movements of the north anchor were noted and on October 16th, 1957 the movements accelerated with the north anchor moving riverward the north cable bent tilting forward together with collapse of the stiffening trusses (Thompson 1958, Hardy 1965). A plan of the Peace River slide area is shown in Figure 1 and a cross-section along the centre line of the bridge on the north side shown in Figure 2. Sub-surface exploration identified a zone of remolded material in the compaction shale. This evidence together with cracking noted in the ground adjacent to the north anchor and mud flows in the river provided an insight into the character of movement (Brooker 1958).

A significant factor in the development of failure was erosion in the river channel and particularly at the toe of the slope. This had been a continuous process since the construction of the bridge. Toe erosion and exceptional precipitation along with the failure of a water supply pipeline near where the cable bent are believed to be the factors responsible for the final failure.

Emergency measures to restore traffic first involving a ferry service followed by the construction of a Bailey bridge by the Canadian Corps. of Engineers were undertaken. A new bridge was finally built. At this time in Canada, exploration, testing, and analytic capabilities were relatively primitive as compared with today's methodology. Nevertheless, a reasonable picture of the failure surface was established, a record of movements was developed.

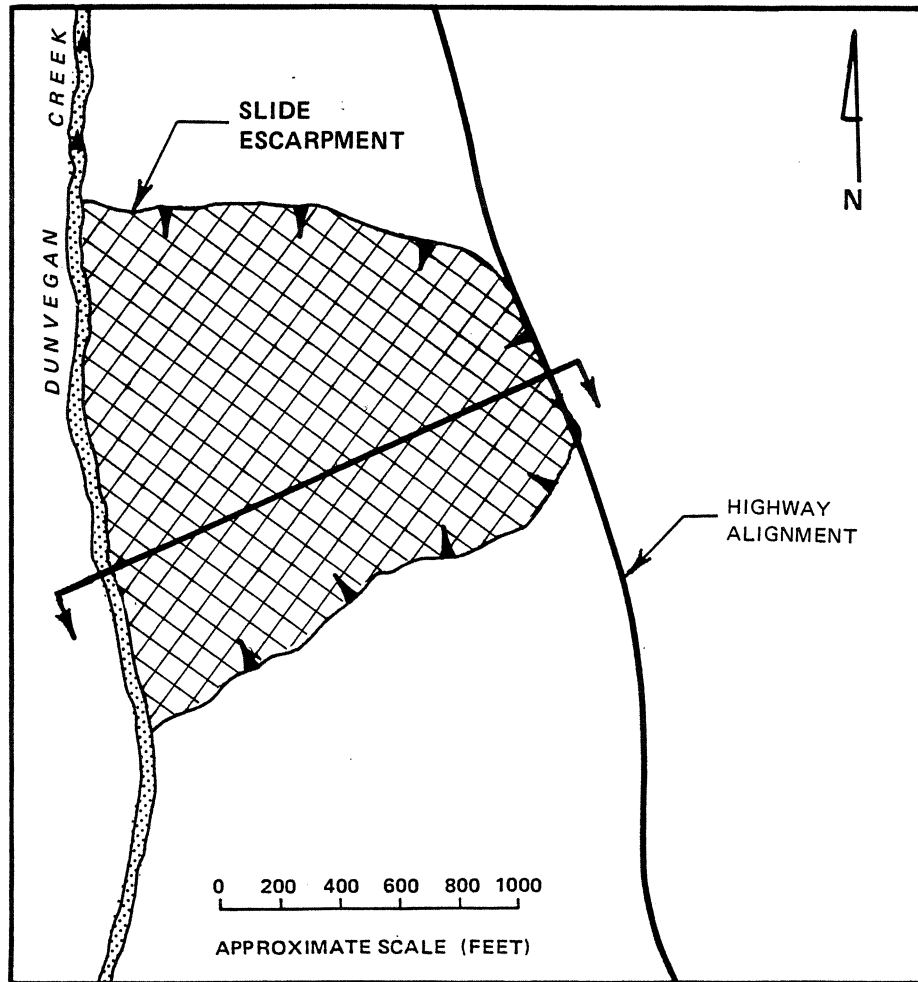
FIGURE 3 DUNVEGAN HILL – SITE PLAN

In 1957 a highway link between the towns of Grande Prairie and Peace River, Alberta was undertaken requiring the crossing of the Peace River at Dunvegan. The approach to the bridge involved a sidehill cut and fill rising from the Peace River to the south uplands along slopes of the Dunvegan Creek valley. The terrain comprised numerous historic landslides. During the construction of one portion of the fill a massive landslide occurred in August of 1958. The slide area is outlined in Figure 3 and a cross-section through it shown in Figure 4. Because the approach crossed

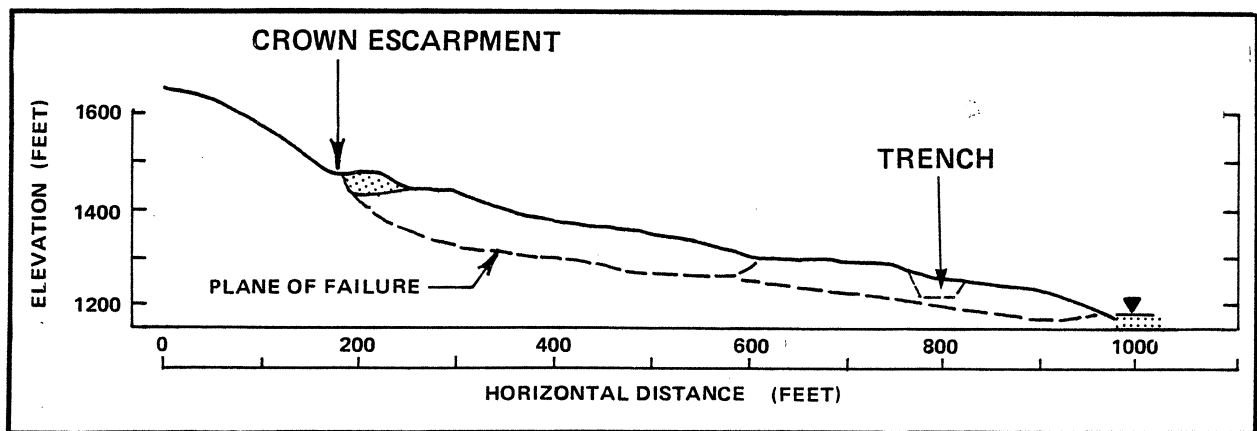
FIGURE 4 DUNVEGAN HILL – CROSS SECTION OF SLIDE AREA

historic slide topography, observations were maintained during construction. Cracks were noted at one location in the fill and in the undisturbed material of the site. For reasons which remain unknown, a deep trench was excavated near the toe beneath the threatened area. Cracking of the ground accelerated with construction of the trench and precipitated a major landslide. (Brooker, 1958, Hardy, R.M., 1962).

Exploration in the area involved the acquisition of thin walled tube samples. However, the sample quality was poor. Open standpipes had been placed in a number of holes and produced inconsistent evidence in respect to piezometric conditions. However the standpipe casings served in determining the seat of movement acting as very crude slope indicators. Observations over the mass demonstrated movement commencing near the toe and retrogressing towards the top. Geologic observations demonstrated the Dunvegan Creek had been eroded as a tributary to the Peace River entirely in the Dunvegan formation a high plasticity compaction shale.

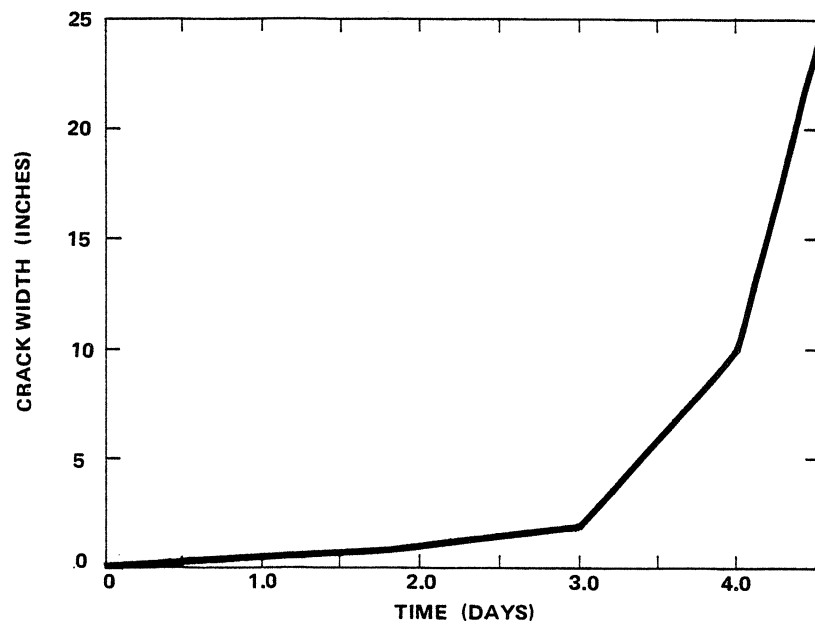
FIGURE 5 MASSIVE LANDSLIDES
CRACK MOVEMENTS AT FAILURE (DUNVEGAN)

Compaction shales in their undisturbed state are brittle. As a result increase of stress produces only small deformations until the peak strength of the material is approached. As strain softening occurs the rate of strain increases. The character of movements associated with failures in these shales is demonstrated by the record of crack widening noted at Dunvegan and as developed for the Peace River Bridge. Cracks are first noticed when they are approximately one-half inch wide. Over several days they increase in width to 1 or 2 inches and then commence to accelerate rapidly over the following 24 hours. Once a crack has reached a width of approximately 6 inches the rate of crack widening is immediately observable and failure is underway. The final rate of movement in a landslide area has been noted as approximately 1 foot per hour lasting for several hours (Thompson 1986). Major portions of the movements take place in approximately 12 hours. Figure 5 demonstrates the general character of movements where the seat of movement is within compaction shale. The character of these movements is consistent with the development of peak strength followed by strain softening resulting in the development of a lower residual strength (Wroth et al 1986).

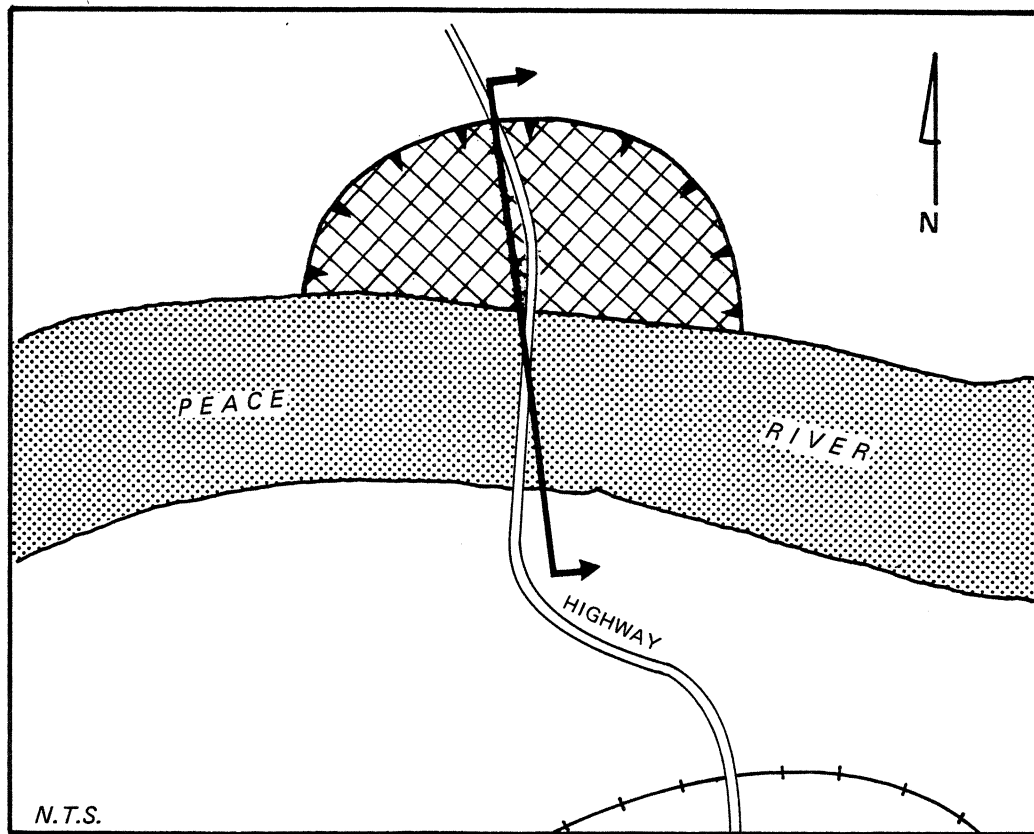
FIGURE 6 PLAN OF AREA – SMITH

The bridge crossing the Athabasca River at Smith was constructed in 1944. In 1949 movements of the north abutment were noted. Records of these movements were maintained from 1949 to 1957. A plan showing the boundary of the landslide area is given in Figure 6 and a cross-section of the slide area is given in Figure 7. Record of movements of the north abutment are shown in Figure 10. The generalized stratigraphic sequence at the site comprises till over compaction shale. It will be noted on Figures 6 and 7 that the north bank of the Athabasca is subject to erosion which has resulted in an oversteepened toe. The toe area is loaded with the abutment of the bridge. The significant information from this site is a record of movements and a significant amount of movement which has occurred over the years. This circumstance is characteristic of several river crossings in the area.

Adjustments are made in the abutments and approaches to accommodate the movements.

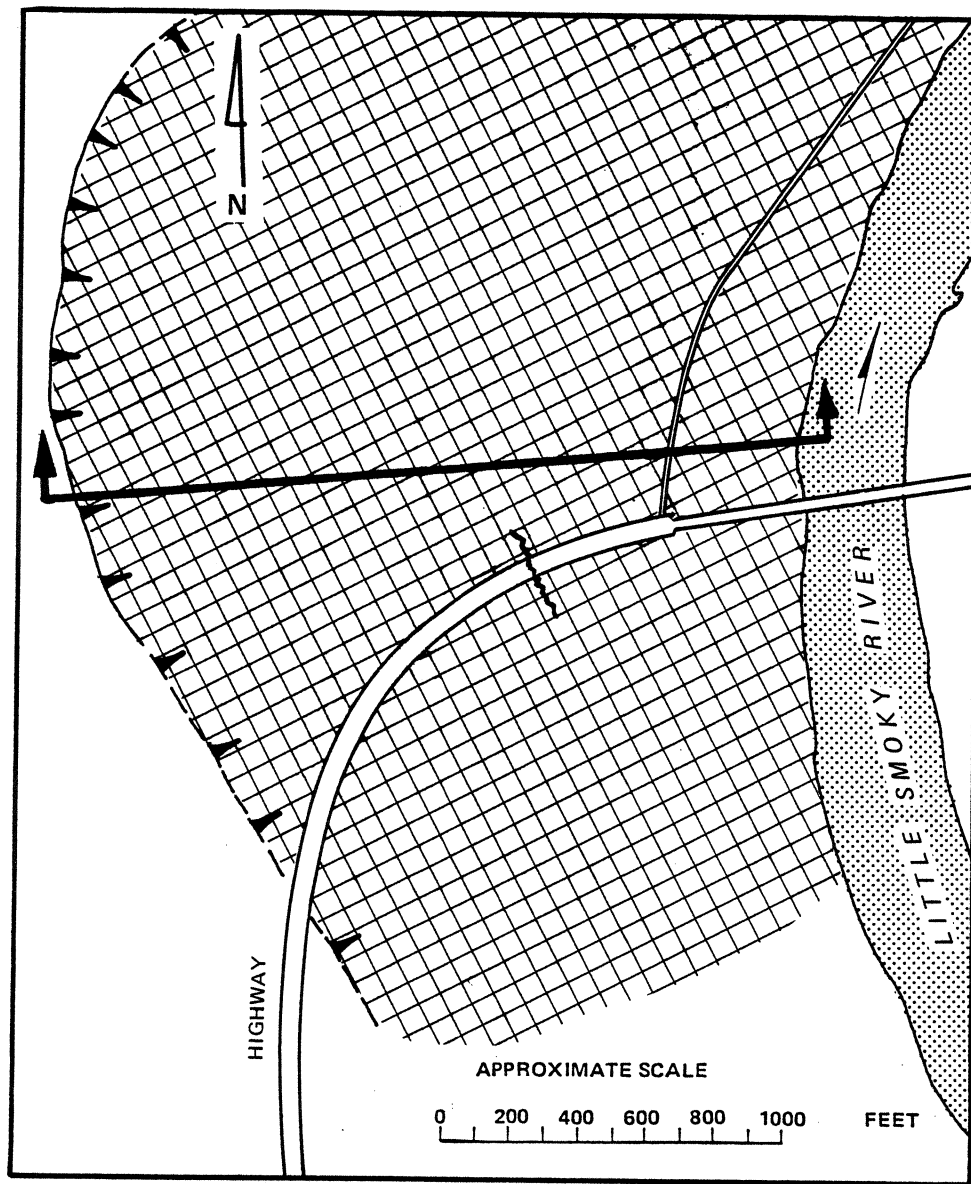
FIGURE 8 LITTLE SMOKY SLIDE AREA – SITE PLAN

The bridge across the Little Smoky River was completed in 1957. It was soon observed that the abutment of the bridge was persistently moving. (Hayley 1968, Thompson & Hayley 1975). Remedial measures were taken to accommodate these movements.

Investigation of the area demonstrated that the pier was in a massive slide area. A plan of the site is given in Figure 8 and a cross-section of the slide area given in Figure 9. This case is important because it is the first in the history of landslide studies in Northwest Canada that adequate instrumentation was installed. Instrumentation consisted of surficial movement gauges, slope indicators and piezometers. The slope indicator data together with surface movement observations demonstrated that the seat of the failure of the slide was within compaction shale and that the failure mass comprised successive blocks retrogressing from the river towards the crown. (Hayley, 1968, Thompson & Hayley, 1975, Morgenstern, 1986). It was further established that the erosion at the toe was the triggering mechanism in the slide area. The rate of movement in the slide area is approximately 150mm per year. Stability studies have demonstrated that an effective stress analyses with residual strength produces a factor of safety close to one when applied to a toe block. The toe block is the first block in the uphill chain of retrogressive movements. This case record is one of the most important because of its thorough instrumentation, laboratory testing and observations. It marks substantial advance in the technique and knowledge available in a case of the Peace River Slide.

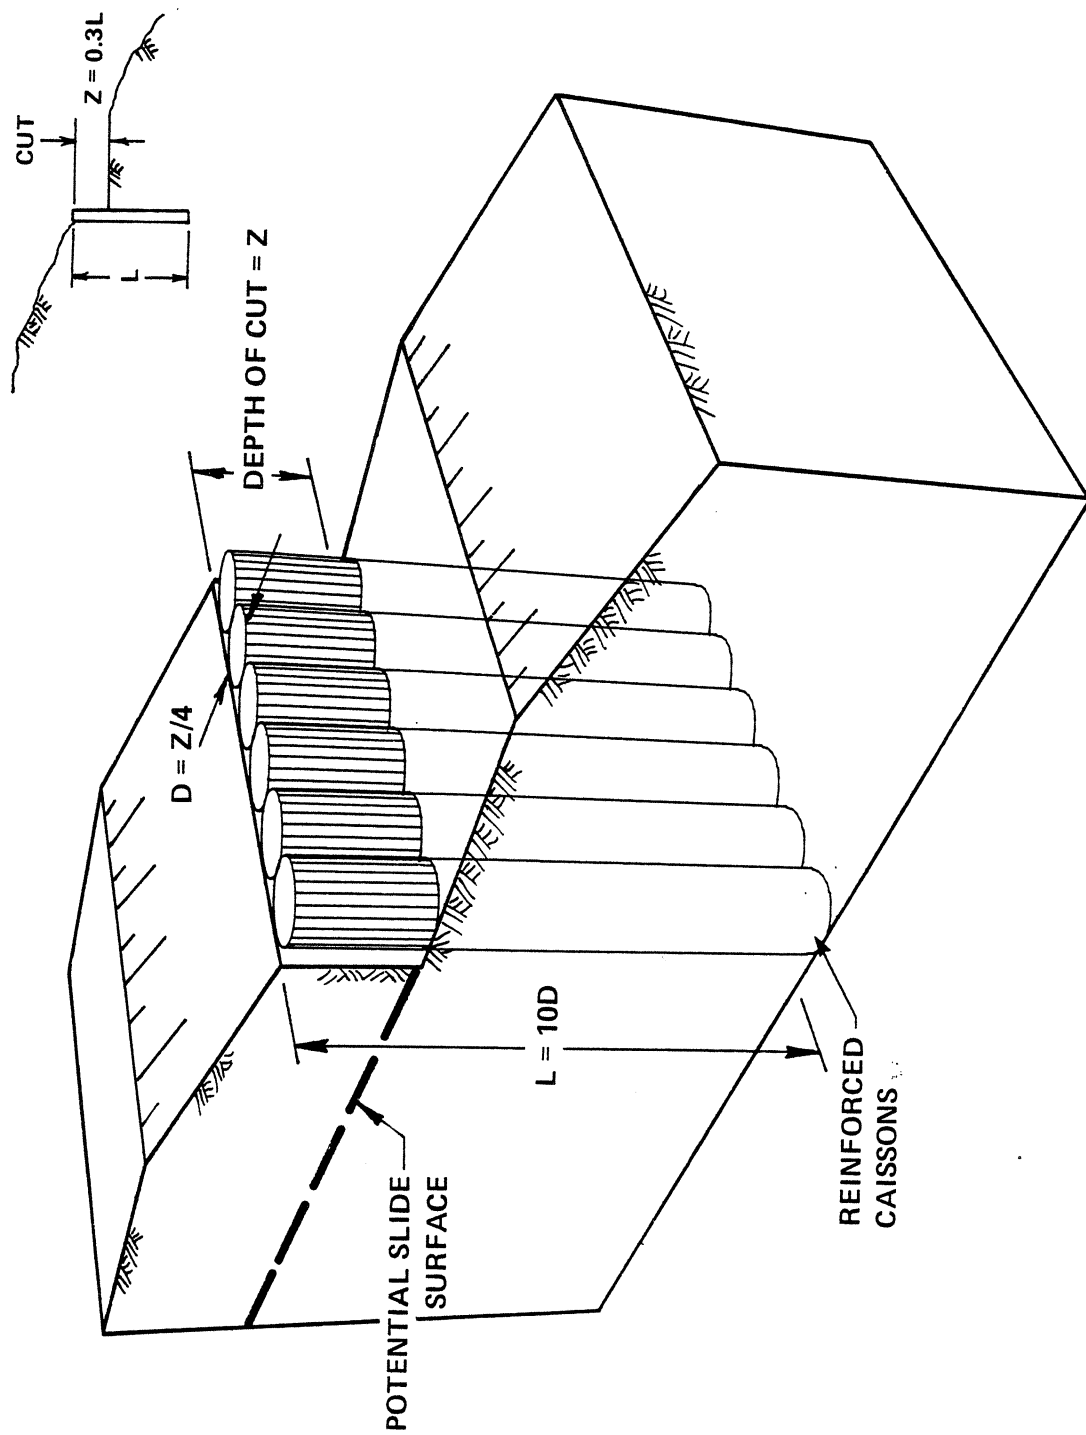
FIGURE 15 STABILITY MAINTENANCE BY TANGENT CAISSON WALL
(SEATTLE-TACOMA)

During construction, the freeway from Seattle to the Seattle-Tacoma Airport crossed slopes of preconsolidated materials (Shannon & Wilson, Peck). It was acknowledged that load relief or addition by fills or cuts on the slope may initiate movements resulting in massive failure and enormous costs due to adjacent highrise developments. A unique solution was devised by "wishing a retaining wall into place". A tangent caisson wall was first constructed consisting of large sized caissons excavated tangent to each other forming an in-place wall as illustrated in Figure 15. A wedge of material was removed from in front of the wall to form the highway. The strength of the wall was designed so as to resist uphill earth pressures and prevent movements. Prevention of movements maintain the integrity and strength of the material. The wall was constructed in 1965 and is in service today showing no visible movements in either the wall or the adjacent ground. This is an example of an active design which prevented strains which could cause weakening on selected planes and potential failure.

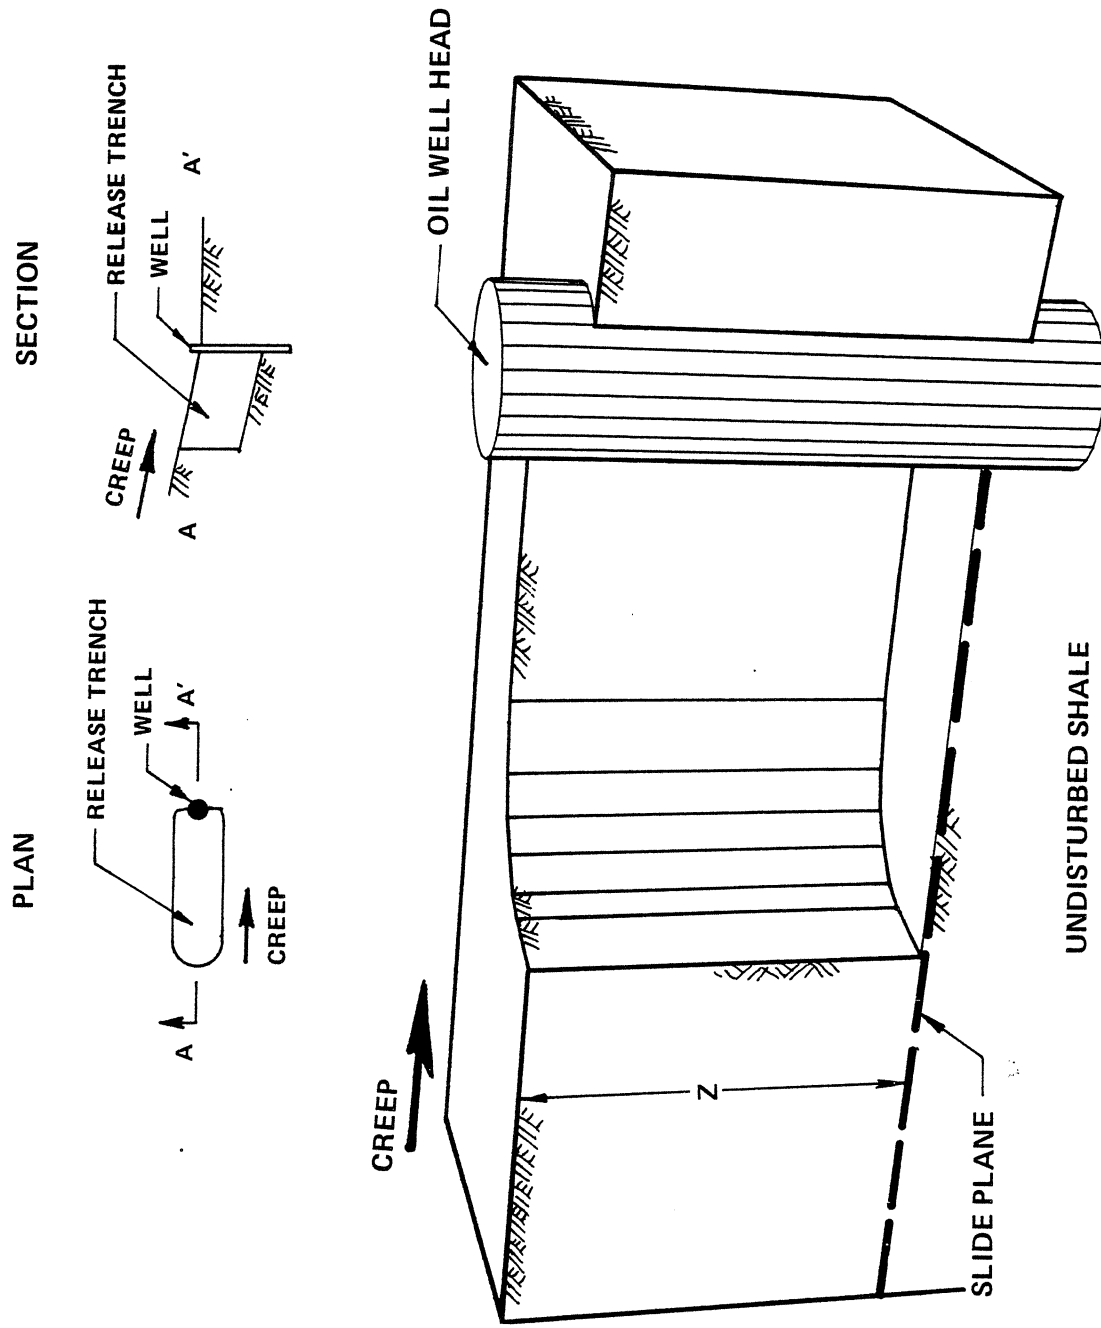
FIGURE 16 LOAD RELIEF BY SLURRY TRENCH
(SWAN HILLS)

In the Swan Hill area in northern Alberta oilfield development has resulted in wells on the slopes of preconsolidated materials overlaid by tills. This combination is subject to creep as described in the Little Smoky and the Athabasca River cases. Creep of the materials bent the oilwell caissons to a point where continued production was threatened. The depth and rate of movement of soils was established by slope indicator installations. A slurry trench slot was constructed uphill of the well caisson that the surrounding ground could creep by the caisson. Oilwells have a definite life span and the slot has been constructed so as to accommodate movements over the economic production life of the well. This is an example of a passive solution to the landslide problem. In most cases, once movement has begun, the forces involved in restraining movement are so massive as to preclude economic solution.

NOTE:
CREEP RATE AND DEPTH OF CREEP MASS
ESTABLISHED BY SLOPE INDICATOR OBSERVATIONS

In these circumstances the movements are accepted and a design produced to accommodate the movements. Many instances of transportation development in valleys involve historic landslide terrain. This is inherently dangerous and difficult to deal with. Engineering technique now provide the bases for relating geologic observations with sub-surface exploration and subsequent analyses on to define critical features of the mass. Engineering solutions may reside in an active design, passive design or rerouting completely. The options are usually limited by practical considerations.
