**REVIEW AND CASE EXAMPLES OF ROCKFALL PROTECTION MEASURES  
IN THE MOUNTAIN REGION OF  
CANADIAN NATIONAL RAILWAY**

**Michael H. Theodore**

**Construction Department, CN Rail, Edmonton**

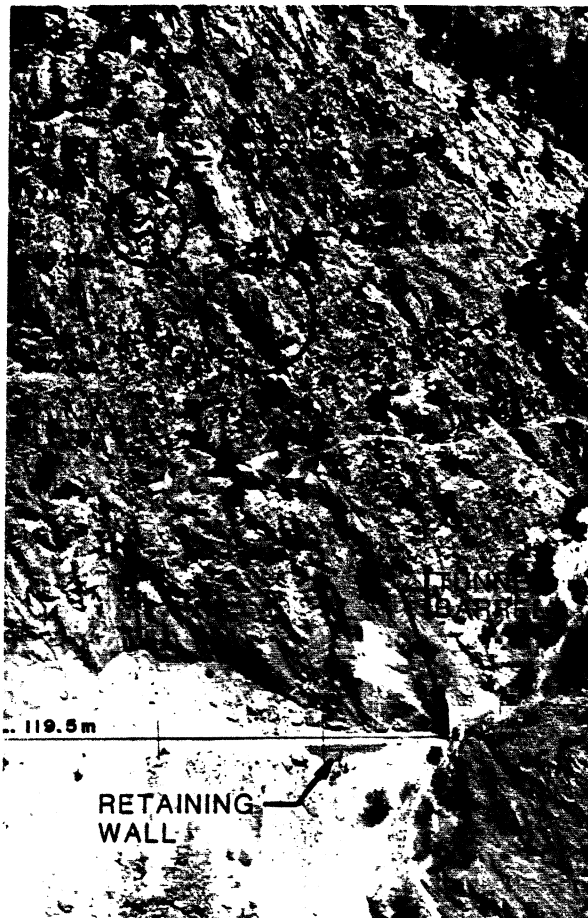
Continual rock fall activity of the blocky granodiorite rock conditions and frequent activation of the slide fence prompted further assessment of the rock conditions to determine the areas responsible for rock fall. A further inspection was made in 1984 during which 2 major areas were identified as the sources of rock fall, one of which was considered extremely hazardous.

Photo No. 1 indicates the areas of concern designated Area No. 1 and Area No. 2 which are situated approximately 120 m. above the track which is partly supported by a retaining wall.

Photo 2. View looking south at Areas No. 1 and No. 2 - Km. 13.8 Yale Sub.

Since stabilization of the rock was not considered viable, a decision was made to remove the unstable rock conditions by controlled drilling and blasting methods.

Contract work commenced in May 1985 with the drilling of Area No. 1. Drilling of horizontal 41 mm diameter holes was carried out on 1.3 m x 1.3 m, burden and spacing, for a total of 435 m. of drilling carried out with Atlas Copco benchers feeds BMP32 and BBC 24D rock drills. Drill holes for Area No. 2 were vertical and drilling was carried out with the hand-held Atlas Copco BBC24D rock drills. Drill holes in both areas were loaded with semi-gelatin explosives (Cilgel 70%, 400 x 32 mm) and with Nonel millisecond detonators (delay periods #0 - #5).

The rock volumes to be blasted in Areas No. 1 and No. 2 were calculated from drilling data to be in the order of 650 m<sup>3</sup> AND 200 m<sup>3</sup> respectively and in order to achieve the required fragmentation and to control rock throw an explosives factor of 0.56 kg/m<sup>3</sup> was specified. Although the powder factor was considered optimum, there were concerns that the affects of blasting would loosen rock conditions above Area No. 1. Thus, as a precautionary measure, 25 - 6 m. grouted rock bolts were installed in blocky rock conditions above Area No. 1.

All hazardous rock was removed from Areas No. 1 and No. 2 and no damage was caused to the railway plant. The amount of fly-rock reaching the river was within the acceptable limits.

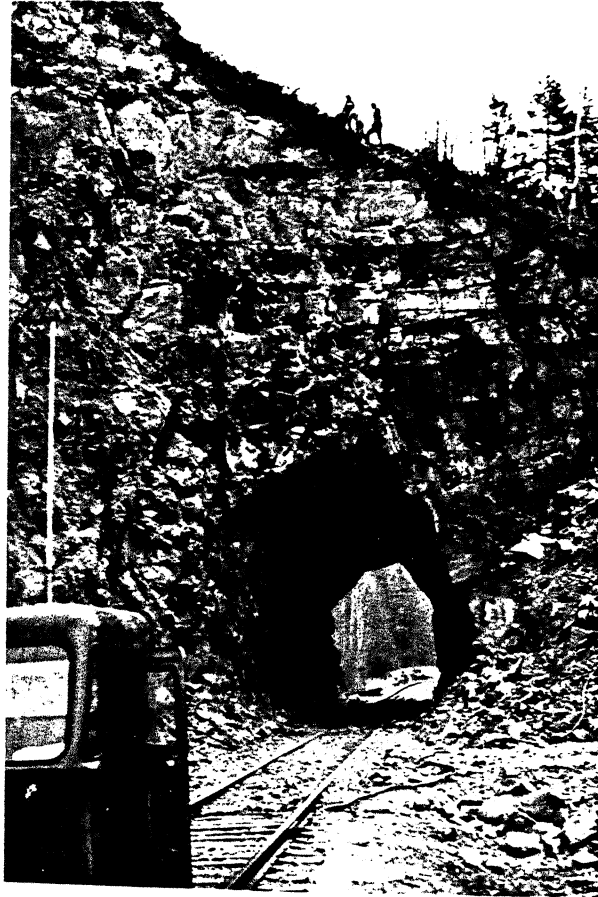
Km. 145 Bulkley Subdivision - Tunnel

Rock conditions in the vicinity of a 42 meter long tunnel about 66 km. north-east of Terrace, B. C. were known to be only marginally stable. The siltstone, argillite and greywacke rocks at the tunnel site are gently folded and appear to be partially metamorphosed. The least stable conditions at the site were associated with the bedding planes along which shear movement had occurred as a result of folding. This has produced varying thicknesses of graphitic gouge along the bedding plane surfaces to form narrow shear zones. The orientation of the bedding planes, approximately  $010^{\circ}/25^{\circ}W$  compared to the tunnel alignment orientation of  $054^{\circ}$ , and the weathering of joints perpendicular to the tunnel were responsible for occasional sloughing along the tunnel walls and minor rockfall from the crown area.

A few months before the site was scheduled for stabilization a failure along the bedding planes at the south approach of the west portal resulted in rock fall which reached the tracks and caused a train derailment. The derailed train then hit the tunnel wall causing collapse of approximately 5 m. of the tunnel and causing further damage to the tunnel crown and south wall beyond the failed area.

Photo 3. West portal view

Initial remedial action consisted of installation of rock bolting and shotcrete work inside the tunnel at the west portal and mesh over the west portal area. To provide support to the tunnel crown and south wall at the west portal 37 - 2.4 m. Swellex bolts were installed. Structural support with  $11 \text{ m}^3$  of shotcrete was planned, however, a drop in temperature to minus  $35^{\circ}C$  dictated the suspension of shotcreting work after  $6 \text{ m}^3$  of shotcrete had been applied.

In order to provide protection against further loose rock reaching the track from the west portal location, the entire portal area was covered with  $360 \text{ m}^2$  of mesh suspended by steel cable attached to steel pins installed on the slope above the tunnel portal. The mesh was held in place as it covered the portal area by means of rock bolts installed on 5 m centres. These bolts pinned the mesh to the rock face so as to entrap any loosened rock. The 2.4 m friction bolts also provided a limited amount of support to the ravelling siltstone and sandstone bedding. More extensive stabilization measures were scheduled for the following spring in better weather conditions.

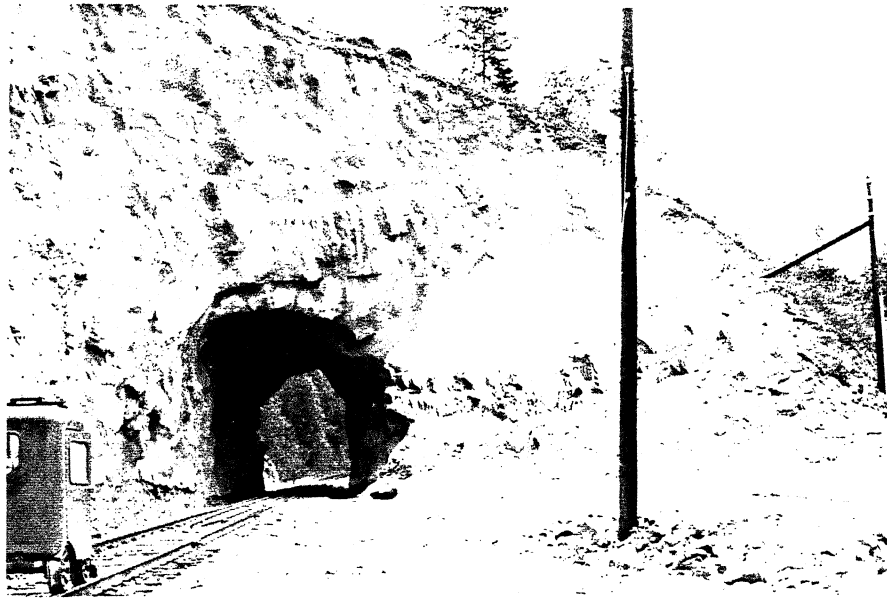
Photo 4. West portal after stabilization measures

In the spring the temporary mesh installation was removed and the west portal area was thoroughly scaled to remove rock loosened by frost action. Following scaling work 26-6 m. grouted bolts (15 mmØ) were installed above the tunnel opening on 3 m. centres. Around each bolt a 1 meter square steel fibre shotcrete bearing pad (100 mm thick) was applied followed by a galvanized washer plate and hexagonal nut. A final application of plain shotcrete was used to cover the entire west portal area so as to provide a structural membrane and protect the rock from further deterioration by weathering. Photograph 4 shows the west portal location after stabilization.
