Earthquakes and Vancouver Tunnels

Duncan C. Wyllie, P.Eng.

Stephen V.L. Barrett, P.Eng.

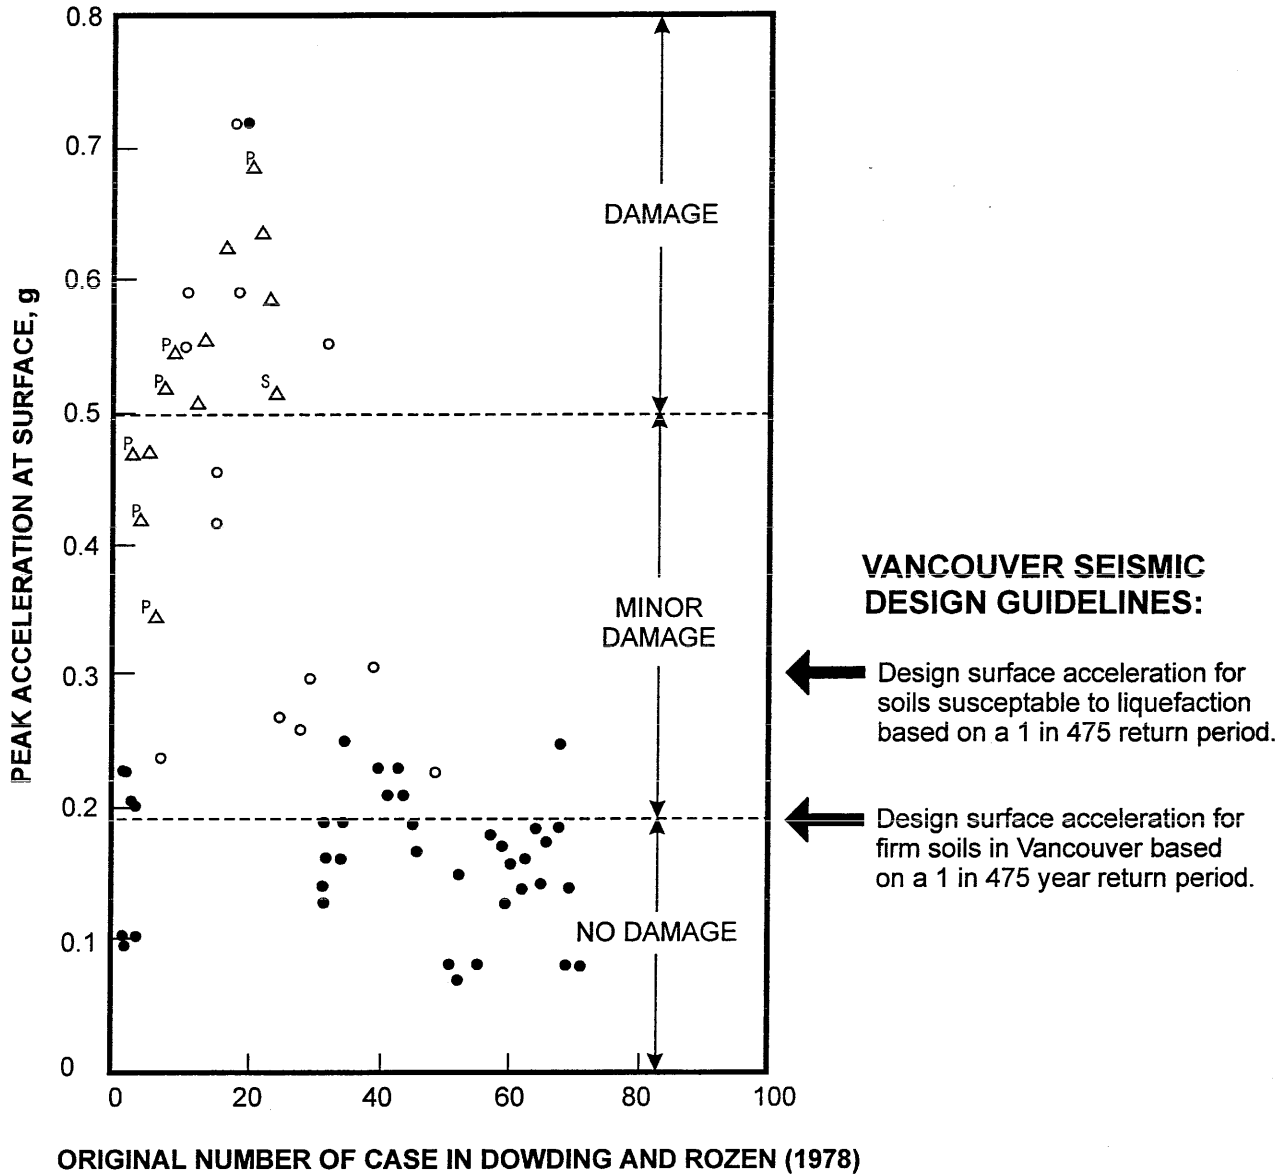
Figure 3

Earthquake Damage in Tunnels Related to Surface Acceleration

Examples of these types of failures are given in Figure 2, all taken from the 1995 Hyogoken-Nambu Earthquake. In addition to the types of damage, general statements can also be made regarding the likelihood of damage given the magnitude of the event and distance of the tunnel from the epicenter. The data collected by Dowding and Rozen (1978) suggests little damage will occur to rock tunnels for ground surface accelerations less than 0.4 g, and very little or no damage will occur below 0.2 g (Figure 3). In a similar study by Yoshikawa (1981), it was concluded that damage to tunnels within 10 km of the epicenter was likely for a Magnitude 7 event and within 30 km for a Magnitude 8 event on the Japanese Meteorological Agency (JMA) scale.

The current design horizontal peak ground acceleration for Vancouver is 0.2 g for firm ground (National Building Code, 1990), which is usually upgraded to 0.3 g in soils prone to liquefaction. These peak ground accelerations are based on a 1 in 475 year event frequency. Based on the damage thresholds shown on Figure 3, it would appear that the likelihood of severe damage to Vancouver tunnels situated in rock is low for such events.

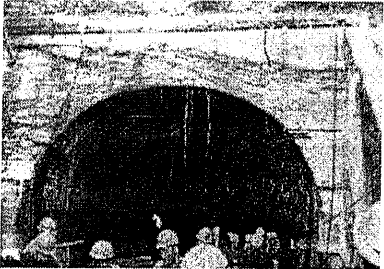
<p><i>Cracks in Higashigama Tunnel portal. The cracks are believed to be extensions of existing features. The portal was originally constructed in 1928.</i></p>
<p>Ground Movement Near Surface</p>

- **Voids behind linings** - prior to about 1940, tunnels with concrete linings were free-standing structures, with timber or loose masonry packing in the void space between the rock and the lining. Over time the packing can rot or loosen, resulting in loss of support to the rock surrounding the tunnel. This condition can result in rock falls impacting the lining, particularly at the portals where the ground motion is greatest. This was an issue on the downtown Skytrain tunnel, which was originally constructed in the 1930's as a rail tunnel, and in 1983 was converted for use by Skytrain. Here the voids behind the original lining were grouted

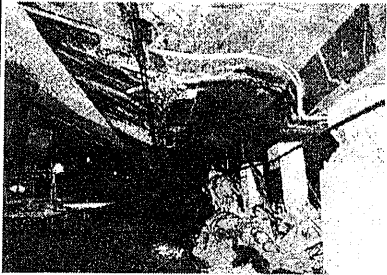
<p><i>Collapse of the Daikai Station Cut and Cover Box. Up to 2.5m of vertical settlement occurred when 35 of the center columns collapsed.</i></p>

The collapse of Daikai Station is believed to have been caused by a large horizontal force acting transversely across the box. It is postulated that the source of the horizontal force was differential ground movement between the top of the box at a depth of 4.8 m and the base of the box at a depth of 12 m (Iida et al, 1996). The stratigraphy of the site consisted of loose sandy silts, overlying coarse sands, soft marine clays and dense gravels. The depth to the top of the dense gravel was approximately 17 m at the location of the collapse.

- **Horizontal ground loading** - based on the Daikai Subway Station collapse, it appears near surface underground structures such as portals, shaft collars and cut and cover boxes, which are situated in loose soils prone to liquefaction can suffer severe damage in a large earthquake event. In Vancouver, loose soils situated in low lying areas adjacent to river courses are the most likely to liquefy in a magnitude 7 or 8 earthquake (Fitzell et al, 1995). Underground structures located in these soils therefore need to be able to resist the large differential horizontal loads which can be applied to the structure during such an event.
