Design and construction of mine waste rock pile rehabilitation works at Cirque Mine, Mackenzie, British Columbia

Abstract: Underground exploration work conducted at the Cirque Property, located some 280 km northwest of Mackenzie, B.C. between 1977 and 1991, created a stockpile of about 22,000 m³ of acid generating waste rock. Originally two neutralization ponds were constructed immediately down gradient of the waste rock pile to allow collection, monitoring and treatment of acidic seepage and runoff. Cirque Operating Group wished to rehabilitate the waste rock pile and the treatment ponds as part of a rehabilitation plan for the property. A study was carried out to assess various options. A lined and covered containment cell option was selected on the basis of a Net Present Value analyses and consideration of other collateral benefits. The cell was constructed in two months during the summer of 2000. Fusion welded 1.5 mm thick PVC panels sandwiched between layers of non-woven geotextile were used for the cell liner and cover. A mixed organic cap was installed to cover the cell and promote revegetation. The finished cell measured approximately 105 m long, 60 m wide and 6.5 m deep.

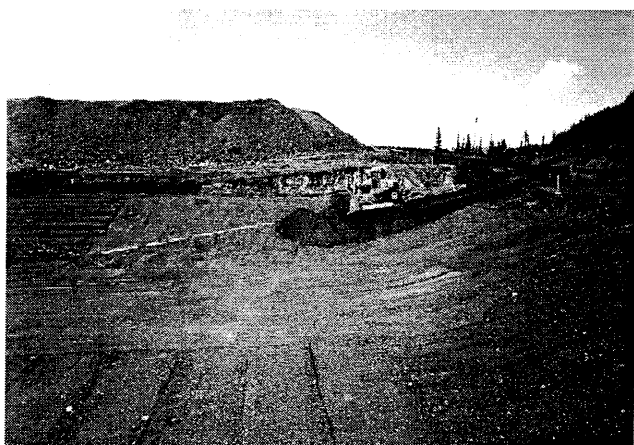
Fig. 1. Ramp Construction

Ramps were therefore incorporated into the northeast and northwest corners of the cell, with a grade of 8H:1V. The ramps caused a minimal reduction to the capacity of the cell. Ramp construction is shown in Fig 1.

The very low friction angle between the geotextile and the PVC geomembrane meant that trafficking down the internal 3H:1V slopes with any of the equipment would exceed the shear resistance of the geomembrane and tend to drag and tear it.

It was also unacceptable to end dump waste rock from the embankment crest as the pile included a significant proportion of coarse rock that could puncture the geomembrane.

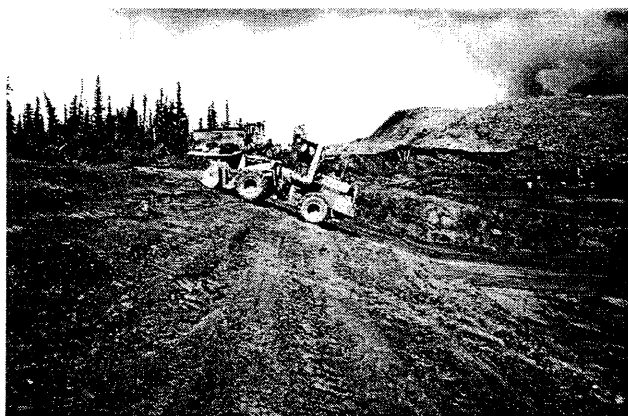
Fig. 2. Preparing Subgrade by Backblading with Front End Loader

Foundation preparation involved surface compaction with the dozer, excavator, or front-end loader. The wheel

loader was then used to level the surface by backblading, as shown in Fig 2.

A 4WD pickup truck was then used to track and smooth the surface, and final trimming and removal of sharp particles was performed by hand.

The entire floor area was then covered with a layer of 1.5 mm PVC to contain seepage and further improve the foundation conditions for the liner. The edges of adjacent panels were overlapped by about 300 mm. This secondary floor layer enabled placement of the geotextile and geomembrane in comparatively dry conditions, facilitating the welding of PVC panels.
