Highway embankment performance on compressible clay at Highway 1/ 200th Street, Langley, British Columbia

Alex Sy, Ph.D., P.Eng.

Klohn Crippen Berger Ltd., Vancouver, BC.

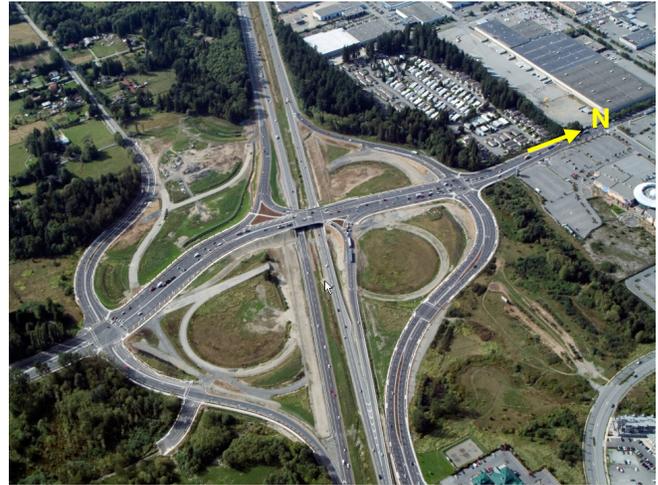
Fig. 9. Air photo of new 200th Street Interchange in 2004

The new 200th Street interchange is a six-lane north-south overpass over Highway 1. The new single-point interchange was completed in 2004. An air photograph taken shortly after construction in 2004 is shown in Figure 9. The new interchange is located 65 m west of the old interchange structure that was demolished shortly after
