# George Massey Tunnel Pile Load Test Program

**ABSTRACT** As part of the George Massey Tunnel (GMT) Replacement Project, Golder was retained by The Ministry of Transportation and Infrastructure (MoTI) to perform a full scale, instrumented static pile load test adjacent to the George Massey Tunnel's southern portal. The aim was to obtain site specific measurement data on the effects of pile driving on sensitive adjacent structures and site-specific measurement data on pile load-deflection response, displacement and pile load transfer during execution of the static pile load test which would potentially reduce uncertainties and risk for a future design-build contractor for the proposed replacement bridge. The work included design and implementation of automated noise, displacement, settlement, vibration and robotic survey systems to monitor the effect on the adjacent structures and existing tunnel to pile driving in real time. Five large diameter (2.0 m) steel pipe piles were installed to a depth of approximately 67m, followed by the construction of a load test reaction frame weighing over 100 metric tonnes, which was used to conduct a static load test capable of exerting over 60MN

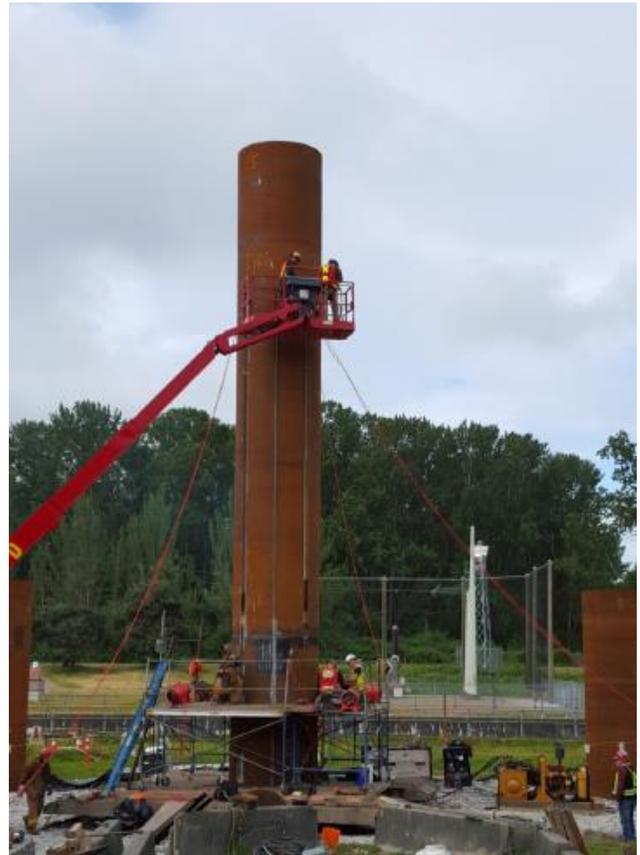
**Fig. 2.** Test pile sections being spliced together while strain gauge cables being installed above.

The test pile was comprised of seven sections of open ended structural steel pipe with nominal dimensions of 2000 mm by 32 mm, welded at designated splice locations. The steel sections were approximately 11.9 m in length (except for one approximate 3.6 m section) and contained both longitudinal and transverse production welds. A total of six 11.9 m long sections were delivered to the site along with a shorter 3.6 m section (76 m approximate length of steel pipe prior to pile driving). The test pile was installed between May 16, 2016 and May 31, 2016. Pile Driving Analyzer (PDA) testing was carried out on the test pile on May 31, 2016 (End of Initial Driving, EOID), June 1, 2016 (One Day Restrike) and June 7, 2016 (Seven Day Restrike).

Please see figure 2 on the opposite side of the page for a picture of the test pile installation in progress.

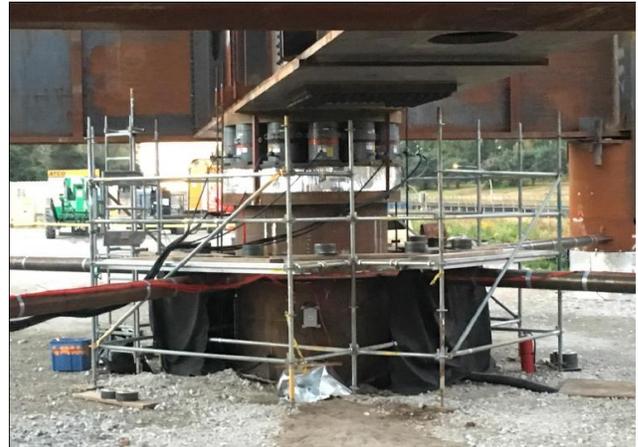
**Fig. 3.** Jacks and load cells on top of test pile, with strain gauge instrumentation installed.

loading/deflection scenarios that could potentially occur during the Static Load Test. A total of twelve hydraulic jacks were used in the jacking system that were aligned in a symmetrical, circular layout between the test pile and load frame and twelve load cells were placed immediately below the hydraulic jacks and a steel spacer plate. To maintain stability of the jacking and load cell arrangement and to adequately reduce bearing loading on the load frame and test pile, three - 2.34 m diameter solid steel load plates were provided including areas between the load cells and test pile (152 mm thick plate), the load cells and the hydraulic jacks (38 mm thick plate) and the hydraulic jacks and load frame (152 mm thick plate). The hydraulic jacks and load cells were arranged in a circular pattern at/near the outside of the steel plates at 30 degree intervals.

Twelve (12) load cells were mounted directly on top of the test pile load plate, in line with each of the hydraulic jacks. The load cells were mounted evenly around the circumference of the test pile, at 30 degree intervals, approximately in-line with the wall of the test pile.

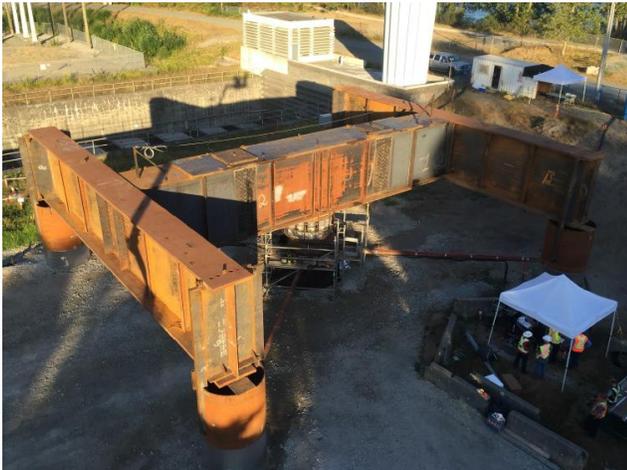
**Fig. 4.** A view of the Load Test Frame on the piles on the day of the Static Load test.

All twelve hydraulic jacks were utilized with the test loads applied by alternating sets of six jacks. Three hydraulic pumps were utilized concurrently to achieve the maximum test load of 29.1 MN during the third loading sequence at 257 mm pile head deflection. It should be noted that the vertical pile head measurements were zeroed at the start of the third loading sequence and, therefore, do not represent the full pile displacement for the three combined loading sequences. The Phase 3 loading sequence was terminated at this pile head deflection with the approval of MoTI. The unloading phase immediately followed a 15-minute hold period at 29.1 MN. A picture of the Load frame sitting on top of the piles, along with associated jacks, pumps, load cells and other instrumentation on the first day of the static load test, is presented in the figure 4 below:
