Undrained Shear Strengths derived from Pile Load Tests for use in designing Helical Screw Piles and Stelcor Piles in Sensitive Clay Soils

Mahmoud Mahmoud, PhD, P.Eng., FEC

President, GES Geotech Inc., Vancouver, BC.

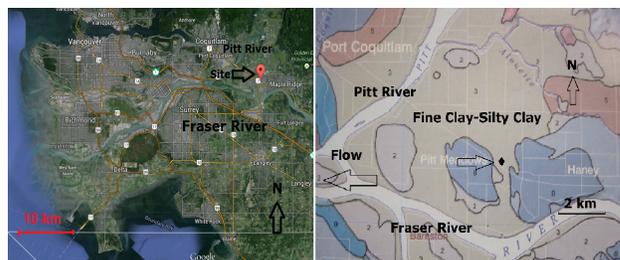
Being located in the conjoinment of Fraser River and Pitt River in a very low altitude, almost sea level, geologically the area is covered with sedimentation of Fraser River and Pitt River, which comprise fine clay and silty clay deposits; see Fig. 2.

Figure 2: Site Geology

The Barnston pump station is located at the end of 120A Avenue on the Pitt Meadows - Maple Ridge boundary in the conjoinment area of two branches of Fraser River; see Figs. 1 and 2. The elevation of the site at the time of our pile load tests ranged from +2.0 to +3.6 m. The Barnston Maple Ridge pump station is a key component of Metro Vancouver's Langley Water Supply program to meet increasing water demands in Maple Ridge, Surrey and Langley, and to replace the existing obsolete pump station.

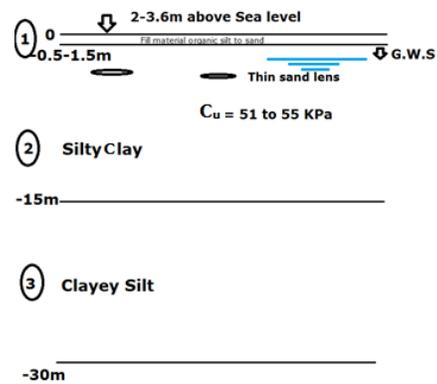
Figure 3: Subsurface Geotechnical Model

Fill material varying in composition from organic silt to sand had been encountered in all boreholes. Clayey fill had also been encountered in some auger holes, while there was wood waste within the fill material in one auger hole. The thickness of fill ranged from 0.46 m to 1.52 m at the locations of the auger holes; see Fig. 3.

The surficial fill layer was underlain by native deposits of clayey soil in all auger holes. A grey clayey soil layer ranging in composition from clayey silt to silty clay with trace sand was encountered from +1.2 to +2.4 m elevation. Furthermore, thin sand lenses or layers were encountered at elevations ranging from -3.1 m to -4.2m. In general, the strength of the clayey soil encountered above the groundwater table was identified to be stiff to very stiff. Based on the auger hole data, a stiff crust generally extended down to about zero (0m) elevation. Based on the observations made during drilling as well as the in-situ vane test results and data obtained from the SCPT, the clayey soil deposit below the groundwater table was identified as firm. The peak undrained shear strengths obtained from in-situ testing ranged from 51 to 55 kPa; see subsurface geotechnical model in Fig. 3. Geotechnical consolidation tests carried out on the relatively undisturbed piston-tube samples of the silty clay obtained at depths of between 5.2 and 5.8 m gave a compression index C_c of 0.27 and a rebound index C_r of 0.07. Based on review of the void ratio-stress plot, the silty clay is considered to be slightly over-consolidated. The SCPT sounding shows the native clay stratum had cone tip resistance values ranging from 8 to 13 bars, with sleeve friction resistance of less than 0.25 bars.

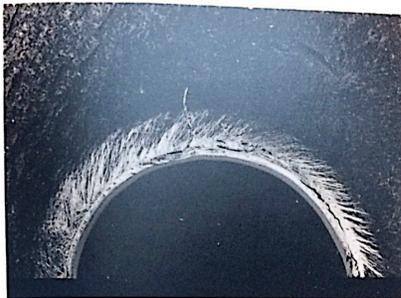
GES' design was based on the undrained shear strength values of 40-50 kPa recommended by Golder (2011). Pile load tests were carried out in compression and tension for both the Stelcor 500 pile and the Helical SS175 pile. The piles were installed in August 2012, with the pile load tests carried out about 14 and 28 days following pile installations. The Stelcor pile was fully grouted whereas the helical pile was grouted only above the highest helix and along the length of the pile shaft. The "effective" diameters of the piles were adopted as 10.5" (268mm) for the Stelcor pile and 8" (200mm) for the helical piles. The "effective" pile diameter, as defined by Mahmoud (1989), is the region of soil disturbance as a result of pile loading (rotation) through approximately one revolution, and is shown in Fig. 4. The effective diameter is determined from the following formula:

$$\text{Effective pile diameter } (D_e) = 2 (0.15D) + D$$

Figure 4: Region of Disturbed Soil Around a Pile

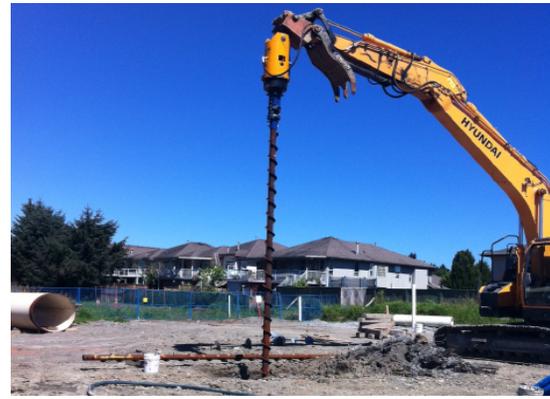
Fig. 5 shows the installation of a Stelcor pile; the latter were manufactured and supplied by Ideal Manufacturing Inc. of Webster, New York. As can be seen from Fig. 5, Stelcor piles essentially consist of a pile having helixes along its entire length.

Figure 5: Stelcor 500 Pile Installation

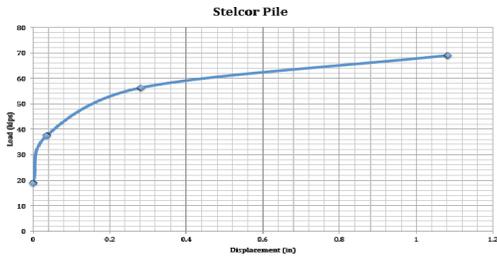
Graph.1

One of the objectives of the pile load testing program was to determine the "mobilized" undrained shear strength (c_u) of the firm silty clay zone through back-analysis. For the piles in compression, the measured ultimate load for the Stelcor pile was recorded as 310 kN (69 kips), corresponding to a back-analysed c_u value of 22 kPa; see Graph 1. The measured ultimate load for the helical pile was recorded as 320 kN (71 kips), corresponding to a back-analysed c_u value of 18 kPa; see Graph 2. Graph 3 shows the tensile load-displacement relationship corresponding to the maximum pile load that was recorded in tension (45 kips = 202 kN) for the Stelcor pile; giving the back-analysed c_u value of 19 kPa.

The back-analysed undrained shear strength values obtained from the pile load tests on the Stelcor and the helical piles were approximately 2.5 times smaller than the recommended design values.

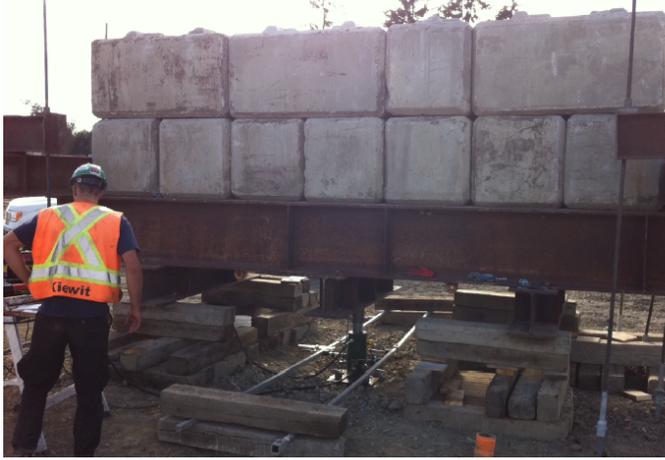
Figure 6: Pile Load Test Setup by GES-Vickars

C3 Integrated Solutions (2013) also carried out pile load testing at the Barnston pump station site to determine which helical screw pile type was best suited for this project. Loads were applied in increments of approximately 30 kN. The restrictions on the C³ Integrated Solutions tests were that a) the jack had a maximum stroke of 6", b) gauges took readings up to 2" and c) the jack had a capacity of 660 kN. The test was continued until one of the restrictions was reached or until the pile failed by continuous pull-out; see Fig. 6. Characteristics of the pile load tests carried out by C³ Integrated Solutions are shown in Table 2.

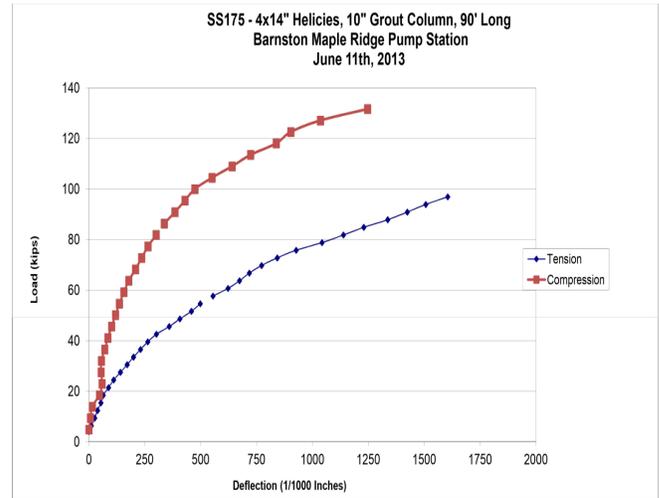
Golder (2011). Graph 4 shows the load-deflection relationship for the compression and tensile pile load tests by C³.

Graph 4: Load-Deflection Relationship for the C³ Compression and Tensile Pile Load Tests

The objective of tests was to determine the undrained shear strength (c_u) for the SS175 and SS200 helical screw piles. For the piles in compression, the measured ultimate load for the SS175 helical pile was determined to be 585 kN (131.5 kips) corresponding to c_u of about 9 kPa. The measured ultimate load for the SS200 helical pile was determined to be 272 kN (61 kips) corresponding to c_u of about 20 kPa. Thus, the back-analysed values of undrained shear strength for the C³ Helical piles were about 2.5-5.0 times smaller than the original design recommendations by
