# Repair of the Sumas River Dike Breach: A Case History

Brian L.J. Mylleville, Ph.D., P.Eng.

**ABSTRACT** In November 2021, during an unprecedented atmospheric river event, the Sumas River Dike was breached resulting in flooding of a large area of the Sumas Prairie in Abbotsford, BC. The site of the Sumas River Dike breach is approximately 4.5 km southwest (upstream) of the Barrowtown Pump Station along the base of Sumas Mountain. This paper describes the main breach that occurred including the failure mechanism and the key geotechnical engineering considerations related to design and construction of the breach repair. A two-staged strategy was adopted for repair of the dike breach that included the initial emergency repair to close the breach followed by the additional remedial work required to restore the temporarily repaired dike section back to a dike with a low permeability core. Details of the two-stage repair strategy are described including the various options considered, as well as the challenges faced during construction. The flood event also created significant challenges during construction in terms of the supply of the materials required to repair the breach, access

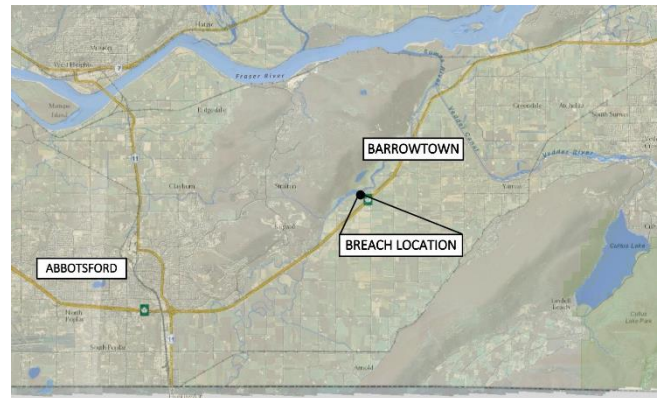
southwest (upstream) of the Barrowtown Pump Station (see Fig. 1) between about Chainage 5+400 and 5+550.

**Fig 1.** Sumas River Dike breach location.

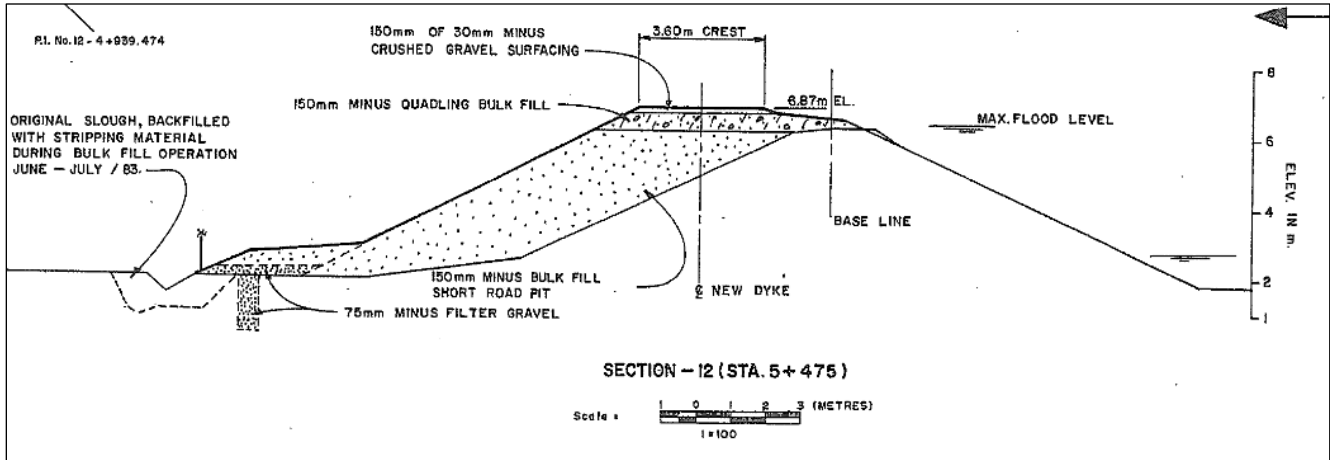
The most recent upgrade occurred in the late 1980's as part of the Abbotsford Flood Control Program and included adding a granular filter layer to the land side slope of the dike. The dike bulk fill was sourced locally from the nearby quarries including the Short Road Pit and the Quadling Quarry, located adjacent to Barrowtown Pump Station. The land side and water side slopes of the original dike section vary from 2 Horizontal to 1 Vertical (2H:1V) to 3H:1V, with toe to crest height between about 4m to 5m and a crest width of about 4m. A typical section of the original dike section for the reach of dike that was breached (taken from the "As-Constructed" Drawing Set No. 5460-1-10, Rev. A, Sheets 7 to 15, dated 1988 and prepared by Crippen Consultants) is shown on Fig. 2.

**Fig 2. Original Dike Section.**

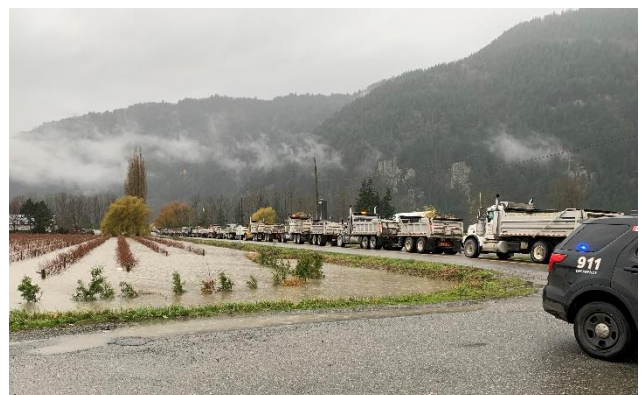
During initial construction of the dike breach closure, spatial constraints at the breach site did not allow for more than one excavator and one dump truck at a time with just sufficient space for the dump truck to turn around and leave once it was emptied. With the dike only being wide enough for one standard dump truck, trucks were continually being advanced forward to the breach moving from pullout to pullout along the dike between the empty trucks returning from the breach site. Loaded dump trucks were lined up waiting to access the dike at times that extended over one kilometre in length (see Fig. 7).

**Fig 7.** Loaded trucks waiting to access the dike.

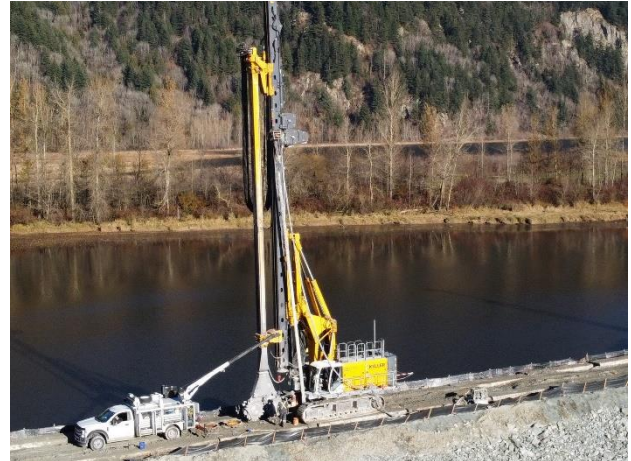
the cutting tool is attached. The cutting tool is comprised of counter-rotating drums that are fitted with cutting teeth with a configuration that is specifically designed for cutting and mixing in-situ soils with bentonite and Portland cement slurries. The CSM rig is supported by an excavator, loader, and a batch plant that produces the bentonite and Portland cement slurries. The bentonite slurry and Portland cement slurry are prepared in the batch plant (set up and located adjacent to the work site) and pumped through hoses to the CSM rig. Fig. 11 shows the CSM rig used for construction of the barrier.

**Fig 11.** CSM Rig.

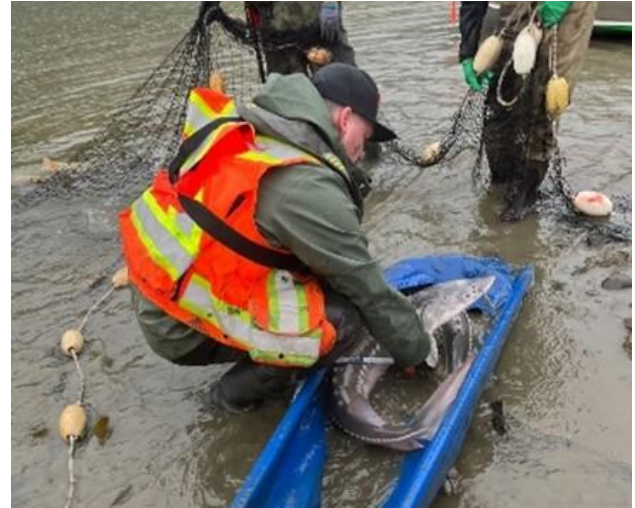
included several sturgeon some up to 2.1m long, a pair of coho salmon, and numerous other fish. These fish were flushed through the breach when it occurred and then were effectively trapped in the water-filled scour hole for a period in excess of one year. Fig. 17 shows one of several sturgeon that were recovered.

**Fig 17.** Sturgeon recovered from the scour hole.
