# SLIDING FAILURE OF A SOIL COVER ON A PVC LAGOON LINER CAUSED BY HYDRAULIC LIFTING

by  
V.A. Sowa<sup>1</sup>, D.C. Jones<sup>2</sup>, G.A. Stewart<sup>3</sup>

## ABSTRACT

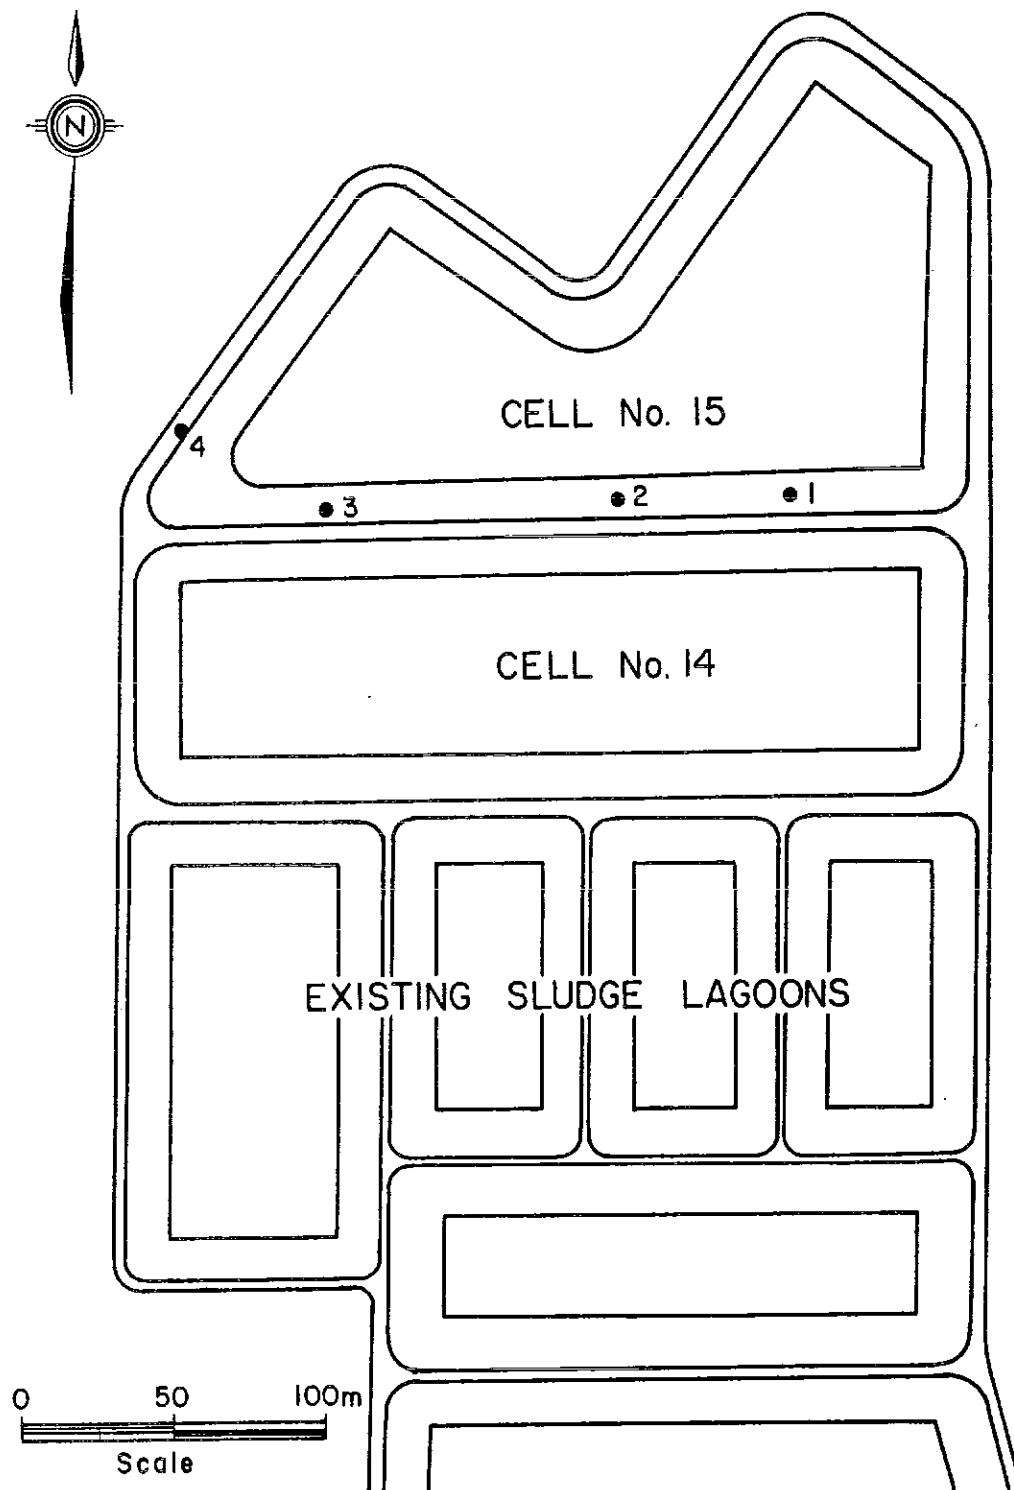
**Figure 1** - *Relative location of sewage lagoon cells.*

The investigation of the soil cover failure included hand excavation of several shallow test pits into the failed soil cover. Soil samples were taken at four of the test pits at the locations illustrated on Figure 1. The soil cover was nominally 300-mm thick and the upper 50 mm to 100 mm consisted of topsoil with the remainder being inorganic sandy silt with some clay. The results of the grain size analyses on the inorganic soil are shown in Figure 4. As can be seen, the grain size of the soil samples were very similar, and the combined silt and clay content (passing No. 200 sieve) ranged from about 57% to 75%. The soil samples were selected at locations where the soil cover had slid various amounts, ranging from very little movement to movement up to 6 m. There was no correlation between the magnitude of movement and the soil type.

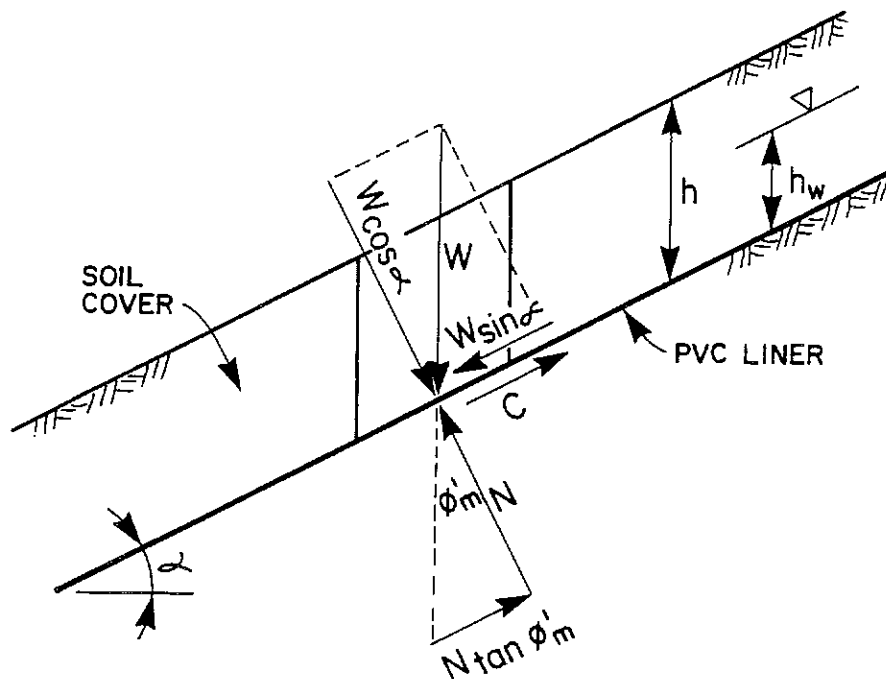
**Figure 3** - Schematic diagram of forces involved in evaluating soil cover stability.

Initially, the soil cover is stable on the PVC liner due to the frictional sliding resistance between the soil and the PVC liner. The stability of the liner is analyzed in terms of the soil-PVC liner model illustrated on Figure 3. The factor of safety of the imaginary block of soil of unit width on the PVC liner is given by the following familiar equation for an infinite slope.

In terms of the soil model given in Figure 3 and Equation (4), the hydraulic lifting described in the preceding paragraphs occurred when the water pressure beneath the soil cover in any given area equals or exceeds the corresponding saturated bulk unit weight of the soil cover. When this occurs, the effective stress becomes zero and the term  $(\gamma h - \gamma_w h_w) = 0$  in Equation (4), and the corresponding factor of safety would become zero if  $C = 0$ . Failure will not occur, however if the  $C$  term includes the strength of the fibrous grass root mat and this strength is sufficient.
