Failure of a Large Diameter Steel Culvert Located Beneath a Major Forestry Road

*Proceedings of the 11th
V a n c o u v e r
Geotechnical Society
Symposium - Forestry
Geotechnique and
Resource Engineering*

30 May 1997

Victor A. Sowa, Ph.D., P.Eng., P.Geo.¹

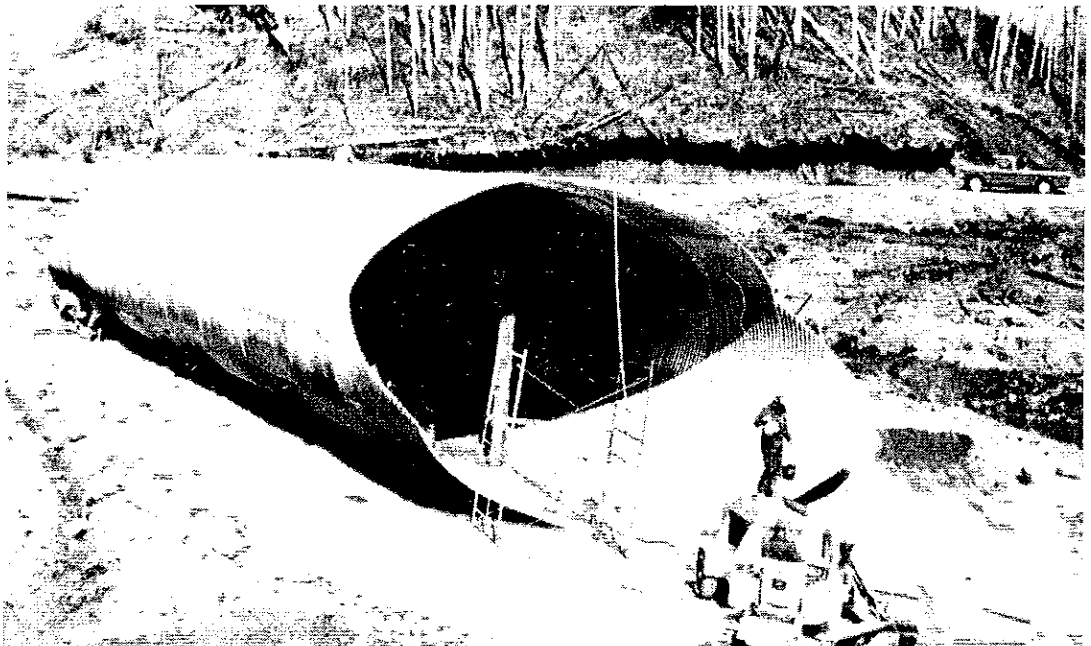
Figure 1. Big Mountain Creek culvert - assembly of culvert.

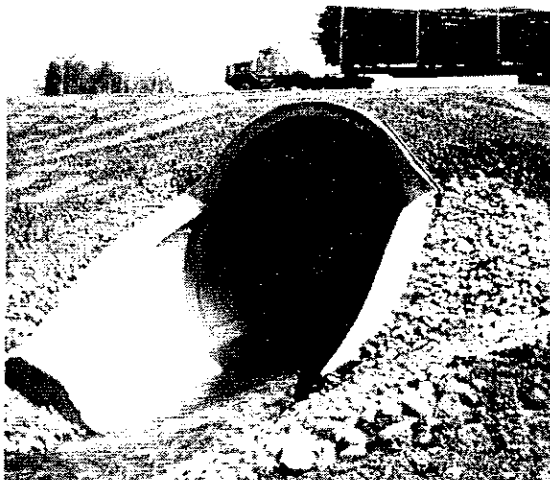
Figure 2. Bald Mountain Creek culvert - after completion of construction.

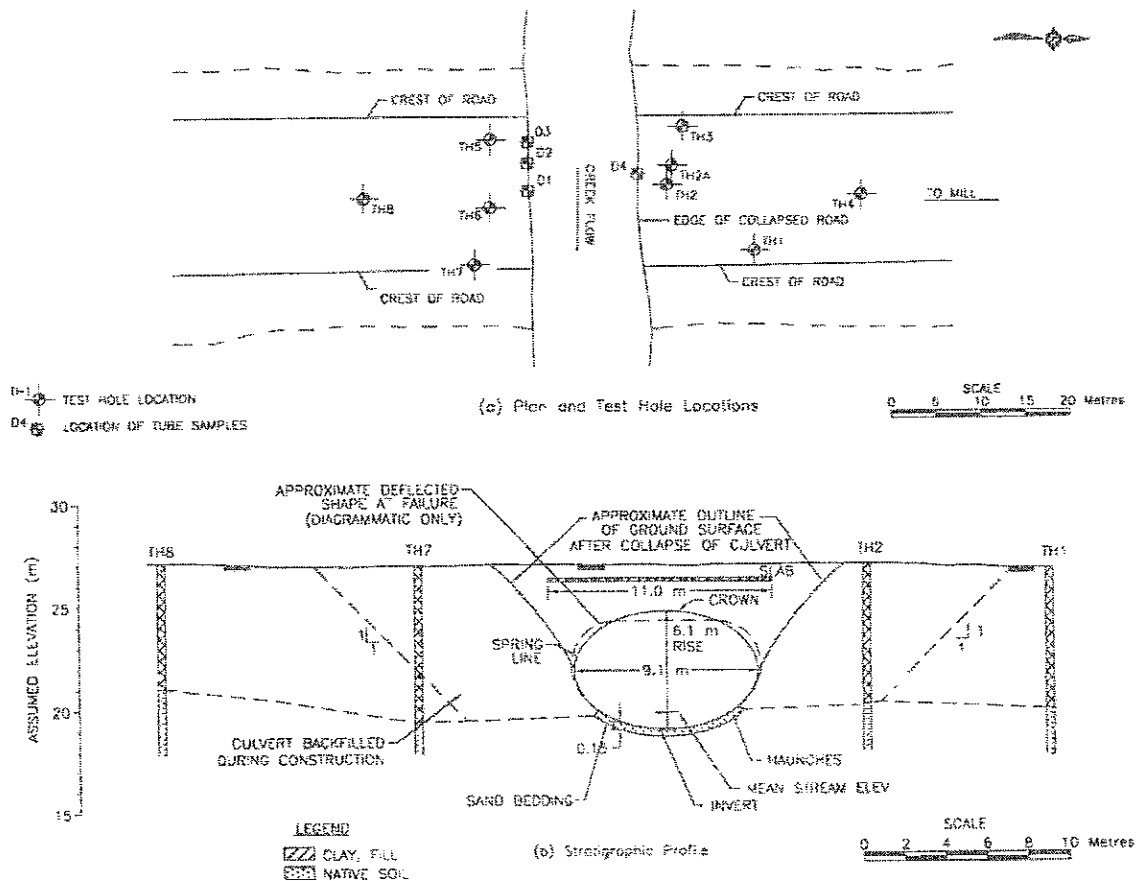
The field investigation included drilling of eight test holes at the locations shown on Figure 7a using a truck mounted hollow stem drill rig. Three test holes were drilled parallel to and as close as possible to the spring line on each side of the culvert. However, because the culvert had collapsed and the remaining collapsed fill sloped up from the culvert to the crest of the road as shown on Figure 7b, the location of the closest test hole was about 5 m from the spring line. Information available later established that these test holes were not close enough to provide information on the specific condition of the culvert clay backfill adjacent to the culvert. Three other test holes were drilled some distance from the culvert to provide information on the condition of the general clay backfill far enough away not to be influenced by the presence of the culvert. Continuous undisturbed sampling using Shelby tubes was undertaken in Test Holes 2 and 6. Undisturbed Shelby tube samples were obtained in the remaining test holes at 1.5 m intervals followed by a standard penetration test.

Figure 7. Big Mountain Creek culvert - plan, test hole locations and soil stratigraphic profile.

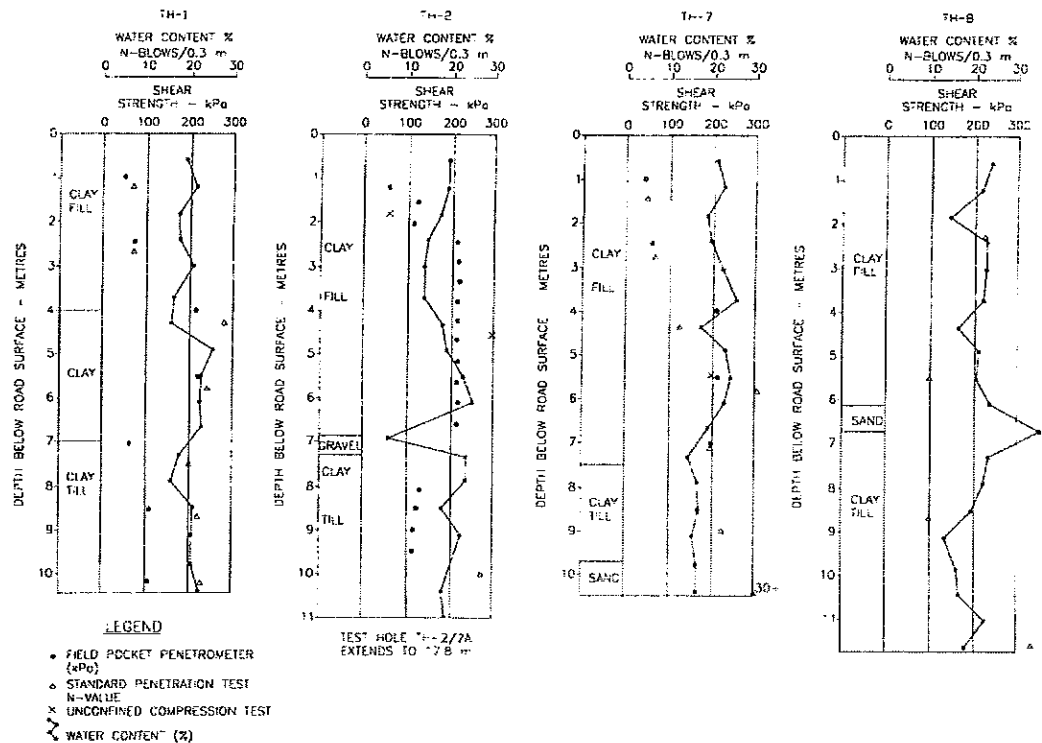
Figure 8. Big Mountain Creek culvert - test hole logs and test results.

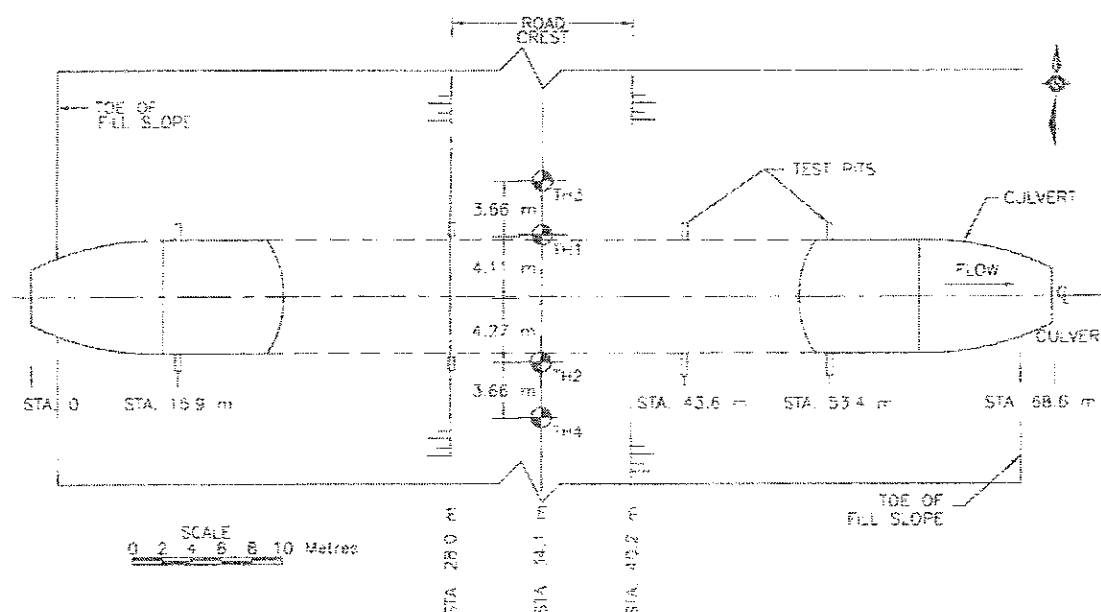
Figure 9. Bald Mountain Creek culvert - plan and test hole locations.

The field investigation included drilling of four test holes from April 16 to 18, 1977 with a hollow stem auger on the road centerline at the locations shown on Figure 9. Two test holes were drilled as close as possible to the culvert, without penetrating the culvert, with one test hole on each side. The other two test holes were drilled 3.66 m further from the culvert. Test Holes 1 and 2 were drilled so that at the closest point, the test holes were 0.22 m and 0.38 m respectively from the culvert spring line. These two test holes were drilled adjacent to the culvert to provide information on the quality of the compacted culvert clay backfill adjacent to the culvert. The other two test holes were drilled further from the culvert to provide information on the general clay backfill.

Eight test pits were excavated adjacent to the culvert at the locations shown on Figure 9 while the culvert backfill was being excavated. Detailed soil sampling and testing was undertaken at various levels in the test pits. Pocket penetrometer tests were undertaken to determine the strength of the

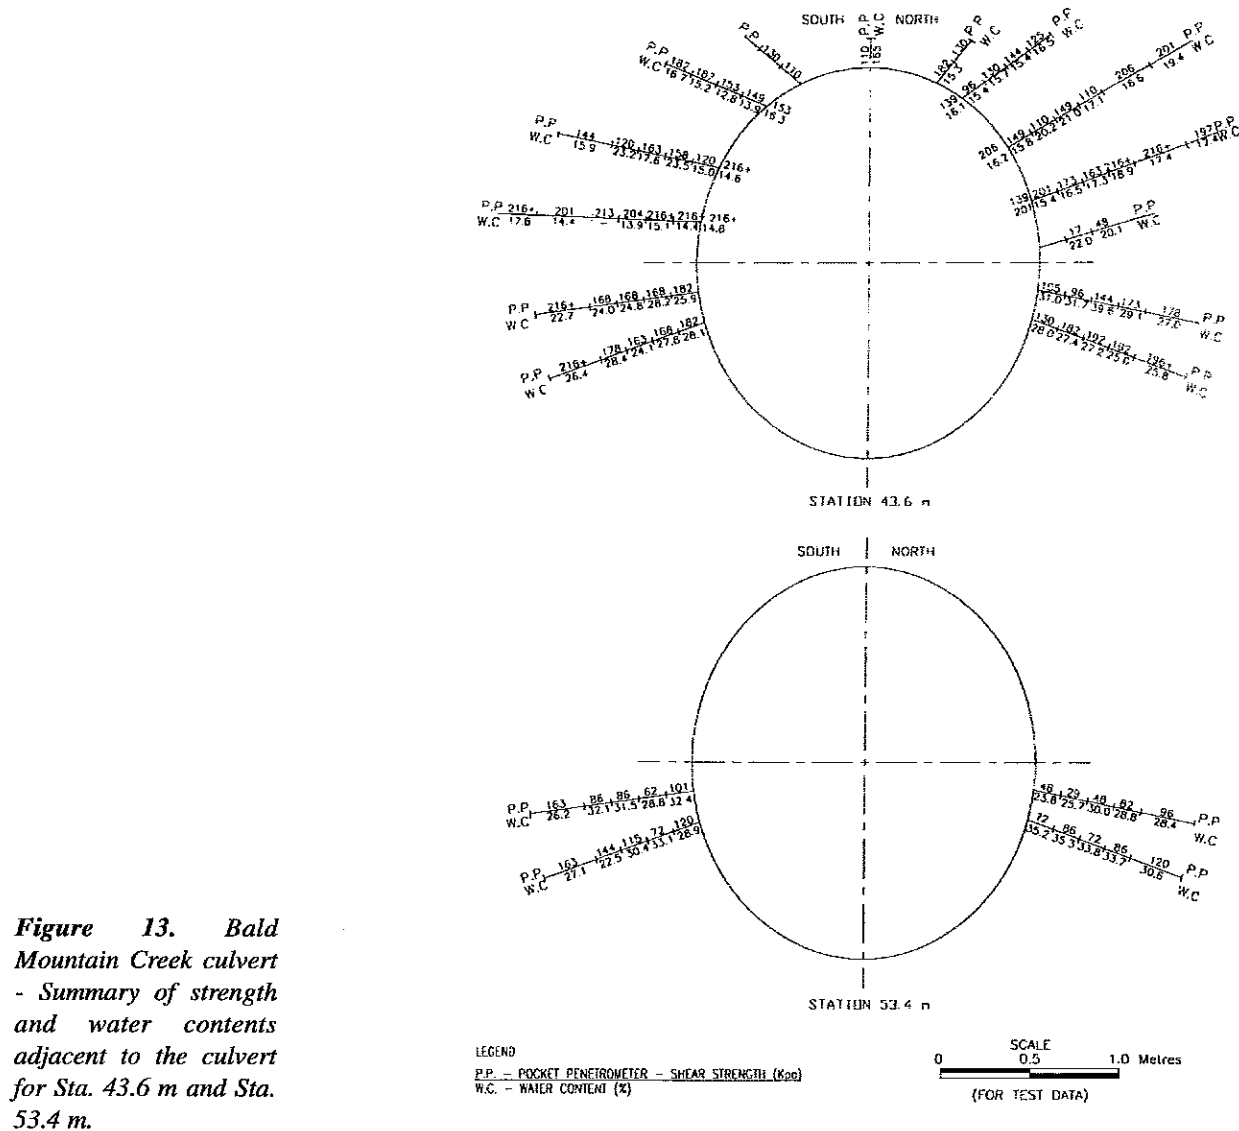
Figure 12. Bald Mountain Creek culvert - Summary of strength and water contents adjacent to the culvert for Sta. 15.9 m and Sta. 28.0 m.

The results given on Figures 12 and 13 for the test pits adjacent to the culvert indicate that even if the soil is frozen or partly frozen, the undrained shear strength obtained from the pocket penetrometer was less than for the unfrozen soil in Test Holes 3 and 4. The undrained shear strength from the pocket penetrometer tests on Test Holes 3 and 4 was generally 200 kPa or larger, while only a few results in the test pits reached 200 kPa. Most of the results in the test pits were in the 100 to 200 kPa range, but there are localized areas where the shear strength was less than 100 kPa. There are other examples when the shear strength determined from the pocket penetrometer tests was so low that the

High water content values given on Figures 12 and 13 may be an indication that the actual shear strength after thawing will be less. The term high water content is a relative term. A water content of about 25 percent for a medium plastic clay with an optimum water content of about 17 percent may be relatively high, but for a high plastic clay with an optimum water content of 23 percent, a water content of 25 percent is not high. However, within the range of the type of clay soil used for the backfill, it is almost certain that regardless of the soil type, that when the water content is larger than 30 percent, the shear strength is likely to be low. Either the water content was initially too high to allow suitable compaction during construction, or there has been deterioration of the backfill since construction, and the water content has increased. As can be seen from Figures 12 and 13, water content values higher than 30 percent were found at several localized areas.

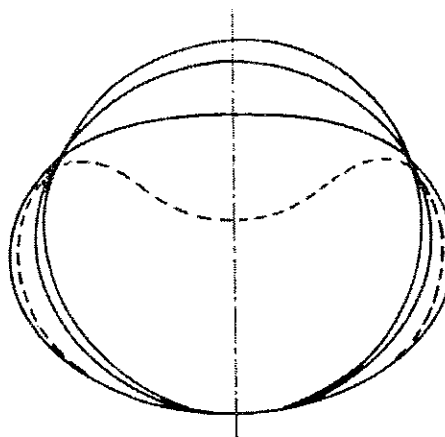
The information available from the photographs, such as those shown on Figures 3, 4, and 5, taken of the Big Mountain Creek culvert before and after failure, and the measured deformations given on Figure 14 indicated that the culvert probably failed by excessive deformation similar to the manner illustrated on Figure 15. High horizontal pressures were transmitted to the compacted clay backfill along the sides of the culvert as the culvert deformed vertically. Compacted clay backfill material tends to deform with time under these horizontal pressures, and because of the deterioration of the quality of the backfill with time, the amount of deformation increased. This behavior resulted in downward deflection of the crown of the culvert. Ultimately, plastic hinges developed in the steel walls of the culvert due to the excessive deformation and complete collapse occurred. Providing that the deformation is symmetrical about the centreline of the culvert, plastic hinges will form near the 10:00 and the 2:00 o'clock positions on the culvert.

Figure 15. Stages during the deformation of a flexible culvert.
