Emergency geotechnical instrumentation for a burning landfill to monitor the impacts of fire-fighting and post-fire reclamation

Abstract: A state of local emergency was declared at the Delta Shake and Shingle landfill on November 27, 1999. The landfill is situated in Delta, British Columbia within an area referred to as Burns Bog. Surficial soils consist of very soft to soft peats, silts and clays. Two large diameter high pressure gas pipelines as well as a 500KV transmission tower border the landfill to the south while a set of railroad tracks, a 1.0m diameter forced sewer main and a 1.0m diameter high pressure water main border the north side. Previous movements of some of the side slopes of this landfill have shown the sensitivity of the stability of the landfill to the strength and deformation properties of the subsurface soils as well as the landfill materials. One particular event caused the movement of one of the high pressure gas pipelines of the order of 1.5m.

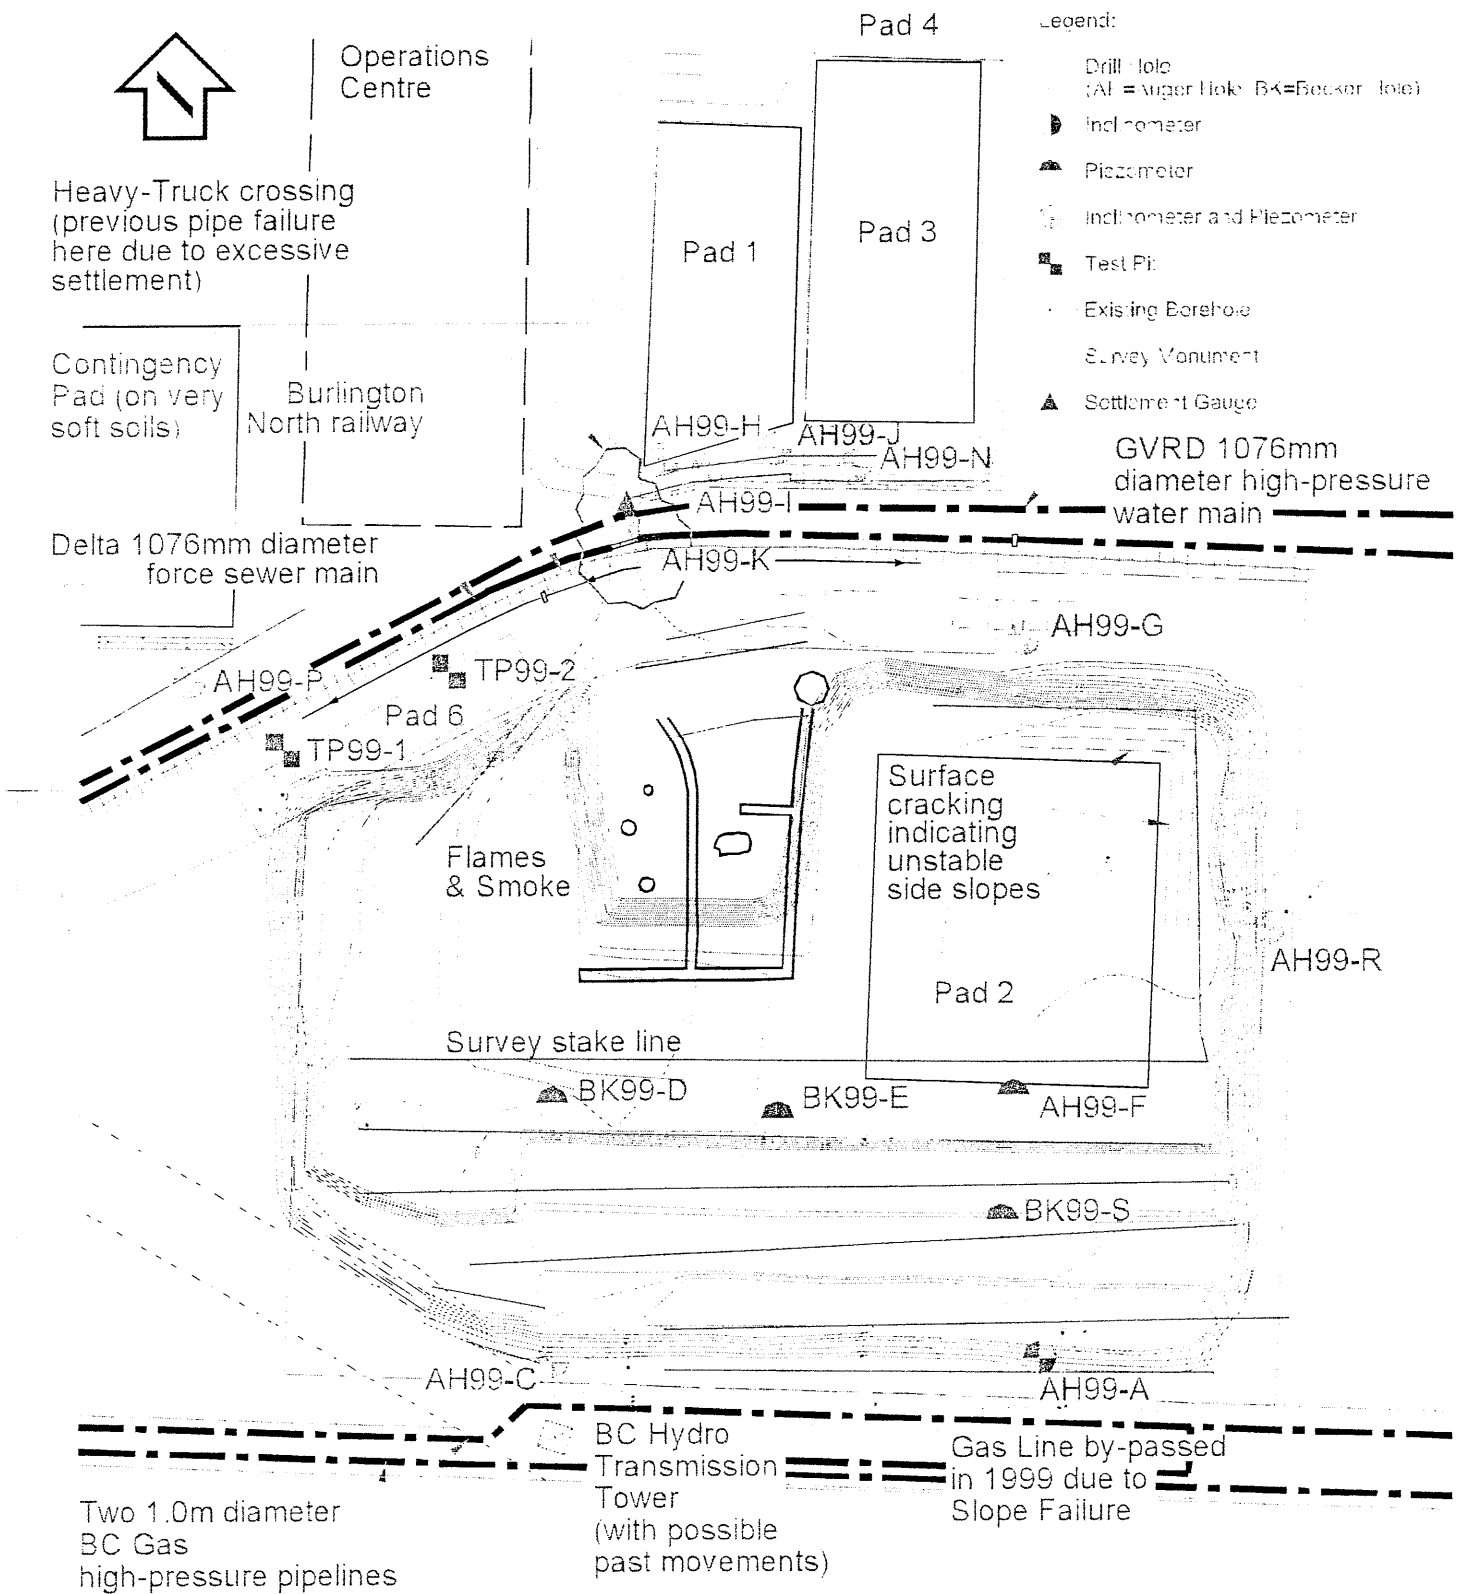
FIGURE: 1 SITE PLAN

The Delta Shake and Shingle Landfill is generally located at the northern edge of Burns Bog and south of River Road in Delta, BC as shown on Figure 1. The landfill is about 18m high and is bounded to the north by a set of railway tracks, a 1076mm high pressure water main, a 1076mm force sewer main, in turn bounded by a property occupied by a trucking company and River Road, respectively. In this area, River Road acts as a dyke for the adjacent south arm of the Fraser River. A drainage ditch is located immediately north of the water and sewer mains. Both water and sewer mains have already undergone large settlements and have ruptured in the past. To the south, the landfill is bounded by two high pressure gas lines (813mm diameter and 914mm, one of which has been locally replaced with a 406mm diameter bypass subsequent to a 1994 displacement) as well as one 500kV transmission tower. A perimeter access road is located on the west, south and east sides of the landfill. At the time that the Local State of Emergency was declared, the fire was located at the northern central portion of the landfill, referred to as the Horseshoe area.

The firefighting strategy required that material affected by the fire be excavated from the landfill and trucked to predetermined locations called 'pads', away from the burning area. These pads were located on nearby properties adjacent to, as well as on top of, the landfill as shown on Figure 1. The burning material removed from the landfill was placed

Figure 1 shows the locations of the above and pre-existing borehole locations (with the inclinometers and piezometers noted), and survey stake lines.
