# Identifying Pre-Existing Shear Surfaces and Slope Stabilization - A Case History Spanning Almost 30 Years

**ABSTRACT** The Bear Creek Village in Grande Prairie, Alberta is located adjacent to the east crest of Bear Creek valley. The apparent problem was related to the location of top-of-bank line and building foundation setbacks from the slope crest running along the western half of the development site and assessment of the risk of slope instability and its potential impact on the safety of the residents at Bear Creek Village. However, the main problem was later identified to be something much more critical. Closer look and review of some of the boreholes that were drilled for previous studies, prior to 1995, showed evidence of slickensides within the clay deposits. An extensive geotechnical borehole investigation program and CPT testing was initiated to confirm the extent of pre-existing shear zones and/or failure surfaces. The investigation program confirmed the presence of pre-existing shear zones and failure surfaces, which were later incorporated into slope stability analysis that indicated instability was along a non-circular slip surface. Setback distances corresponding

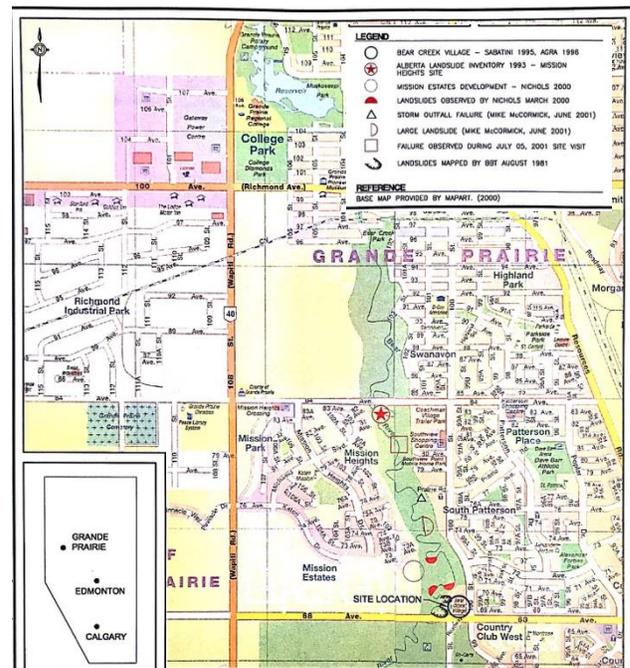
Fig. 1. Key Plan

Borehole logs indicate the presence of slickensides within lacustrine clay deposits in a new development north of Bear Creek Village Condominiums (refer to Figure 1). Figure 7 is a stratigraphic cross-section of subsurface conditions at the site. The slickenside depths are included in Figure 7.
