**REVIEW AND CASE EXAMPLES OF ROCKFALL PROTECTION MEASURES  
IN THE MOUNTAIN REGION OF  
CANADIAN NATIONAL RAILWAY**

**Michael H. Theodore**

**Construction Department, CN Rail, Edmonton**

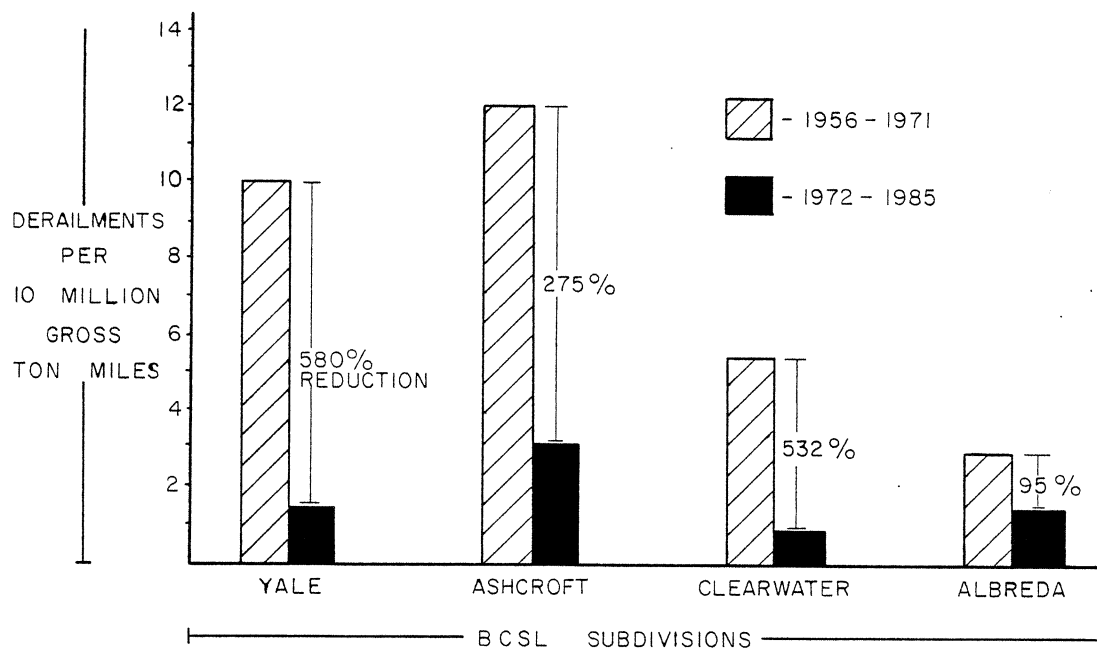
Since the inception of CNR's rock fall protection program in 1971 derailments caused by avalanches, mudslides and rock fall have been reduced significantly. For the route from Jasper to Vancouver records show that between 1956 - 71 a total of 41 derailments caused by track obstructions occurred. Only 25 derailments related to these factors occurred between 1972 - 85. Rail traffic density on this line has increased dramatically from an average of 8.6 million gross ton miles in 1956 to 45.3 million in 1985. To fully represent the effectiveness of rockfall protection measures carried out since 1971 on the 4 subdivisions of the B.C.S.L. a comparison of derailments per 10 million gross ton miles using the average rail traffic densities for the time frames 1956-71 and 1972-85 is shown graphically in Figure 1.

Figure 1. Comparison of derailments relative to average traffic densities - Jasper - Vancouver.

1956-71 vs. 1972-85
