Geotechnical Studies for Reclamation of the Nickel Plate Mine Tailings Facility

Abstract: Reclamation activities at the Nickel Plate Mine tailings facility included tailings cover construction, post-closure seepage control and surface water management. Several geotechnical studies were carried out for these reclamation activities. These studies included the development of a tailings consolidation model, post-closure seepage estimates, tailings cover settlement predictions and on-going assessment of embankment stability.

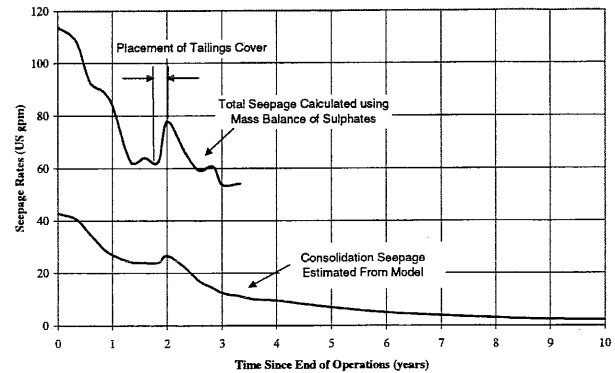
Fig. 3. Estimated seepage rates since the end of operations.

An independent analysis was also conducted to predict the magnitude and trend of total seepage flows from the tailings facility. This was carried out by examining sulphate concentrations recorded in seepage recovery wells and natural creeks downstream of the facility. Sulphate concentrations in the tailings pore water and background water were determined from historical water quality data for the site. Using these data and considering the mass balance of sulphates, the seepage emanating from the tailings facility was estimated. The estimated total seepage rates since the end of operations are included in Figure 3.

The total seepage rates inferred from the mass balance calculation are approximately two to three times the predicted consolidation seepage rates. This indicates that a significant proportion of the total seepage is due to steady state seepage flows. Both analyses show a trend of decreasing seepage flows over time. Similar to the consolidation analysis, the mass balance calculation clearly shows a short term increase in seepage as a result of the placement of the tailings cover in the late summer of 1998.

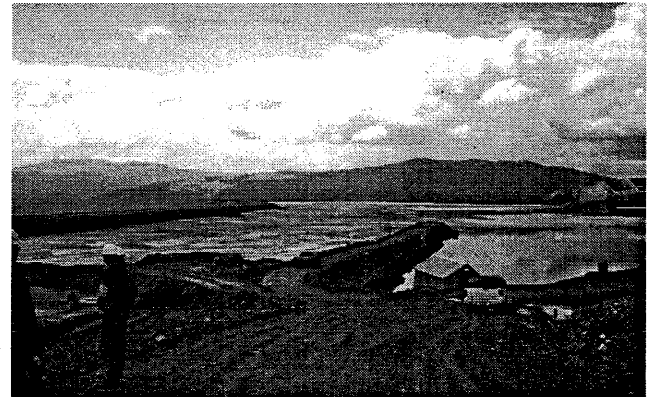
Fig. 5. Start of tailings cover construction.

The tailings cover was constructed by advancing a rockfill causeway from the northeast corner of the facility, along a line approximately 300 feet from the facility perimeter to the south west, as shown by Figure 5. The area between the causeway and the tailings facility perimeter was progressively covered with rockfill to an average depth of 2 feet. Once the rockfill cover was established in an area, a 2 feet thick layer of soil comprising till and loamy topsoil was placed on the rockfill. The condition of the tailings surface and pond area prior to any fill placement for cover construction can be seen on Figure 5.

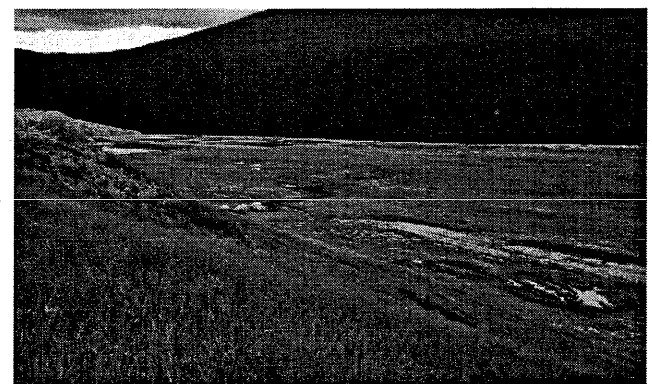
Fig. 6. Reclaimed tailings surface with vegetated cover.

observed, the area was left for a brief period of time and the excess pore pressures rapidly dissipated, allowing construction to continue. Where soft tailings contaminated the rockfill cover, this material was removed to waste and replaced with clean rockfill. By the end of the 1998 construction season approximately 80% of the cover had been placed. A view of the revegetated tailings cover is shown in Figure 6.
