Geotechnical Design Challenges Associated with the Lower Fraser River Dikes

Neil Peters, M.A.Sc., P. Eng.

Inspector of Dikes, BC Ministry of Forests Lands and Natural Resource Operations

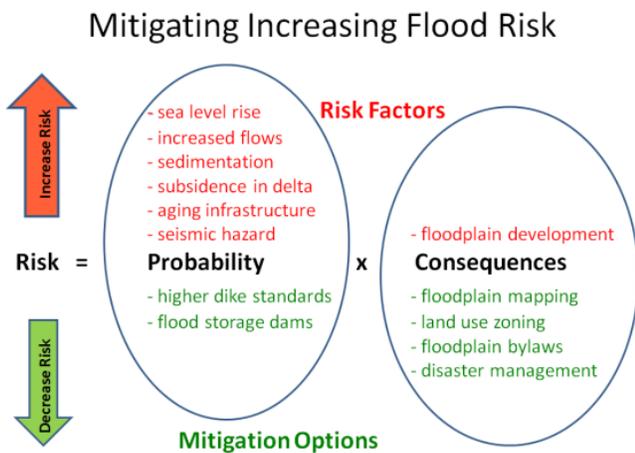
Risk is commonly defined as the product of the probability of hazard occurrence multiplied by the consequences of that event. Several risk factors that increase both the probability and consequences of flooding are shown in Fig. 1. While many factors are increasing the probability of flooding, intensified floodplain development and urbanization is the primary cause of increased risk, simply through increased exposure to the hazard. It is likely that this ongoing floodplain development will continue because of the large economic benefits generated by the use of flood hazard lands.

Possible means of reducing risk are also shown in Fig. 1. below the “Risk = Probability x Consequences” equation. In the absence of effective policies to minimize the “consequences” through control of floodplain development, the principal means of reducing risk, by default, is that the dikes be upgraded to a very high standard.

Figure 1. Mitigating Increasing Flood Risk
