Design and Construction of the New Coal Harbour Shoreline in Downtown Vancouver

This paper describes the geotechnical aspects of the design and analyses of the Phase 2 portion of the Coal Harbour Shoreline Development. This includes the various ground improvement techniques adopted including the rationale for their selection. Results of the ground improvement work along with results of the slope monitoring work during the construction are presented. Challenges encountered during construction and lessons learned are also presented.

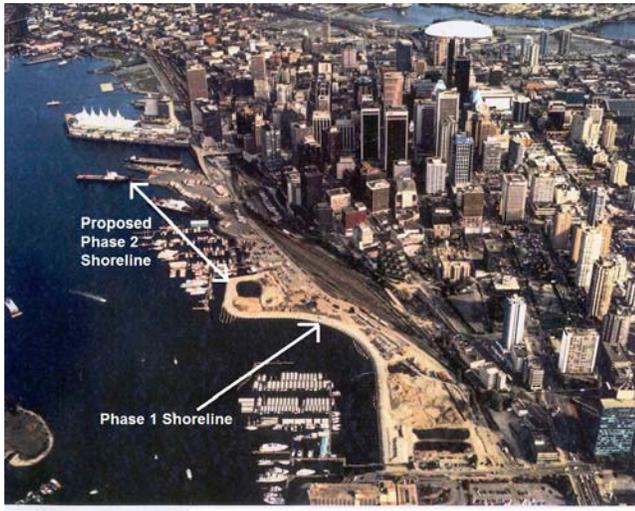
Fig. 1. Extent of Phase 2 Coal Harbour Development.

The overall development was carried out in several phases. Fig. #1 shows the overall Coal Harbour project site and shoreline in April 1994 with the pile supported Phase 1 seawall substantially complete.

Phase 2 development consisted about 0.6 km of seawall extending east from the eastern end of the Phase 1 seawall. The extent of the Phase 2 Coal Harbour development is also shown in Fig. #1.

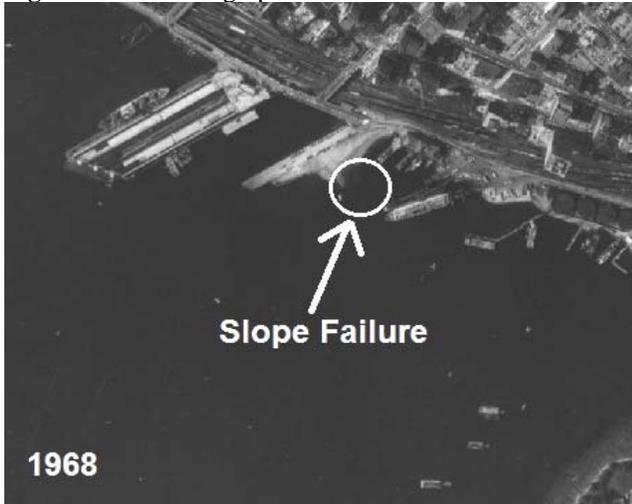
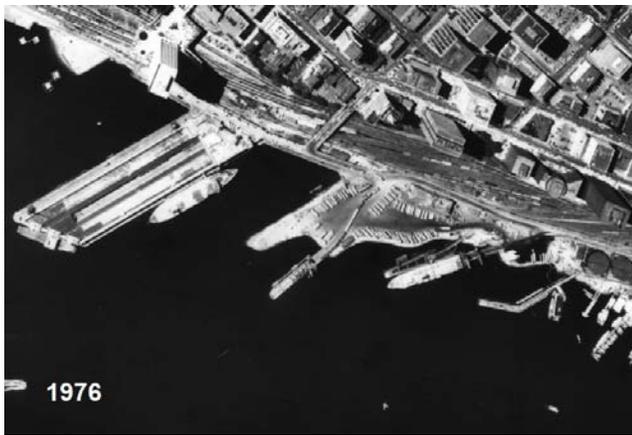
Fig. 2. Aerial Photographs of Coal Harbour.

The development of the Coal Harbour area started in the 1880s. Examination of aerial photographs indicates that between 1946 and the 1990s, several changes to the shoreline took place within the Phase 2 development area. Aerial photographs showing reclamation of land and developments at Coal Harbour between 1968 and 1976 are shown in Fig. #2. The aerial photographs show that by

As can be seen in the 1968 aerial photograph, the uncontrolled filling had lead to a major slope failure. This slope failure and other observations associated with the performance of the existing major facilities within the general Coal Harbour area emphasized the importance of the care needed in the land reclamation for the new Phase 2 shoreline.

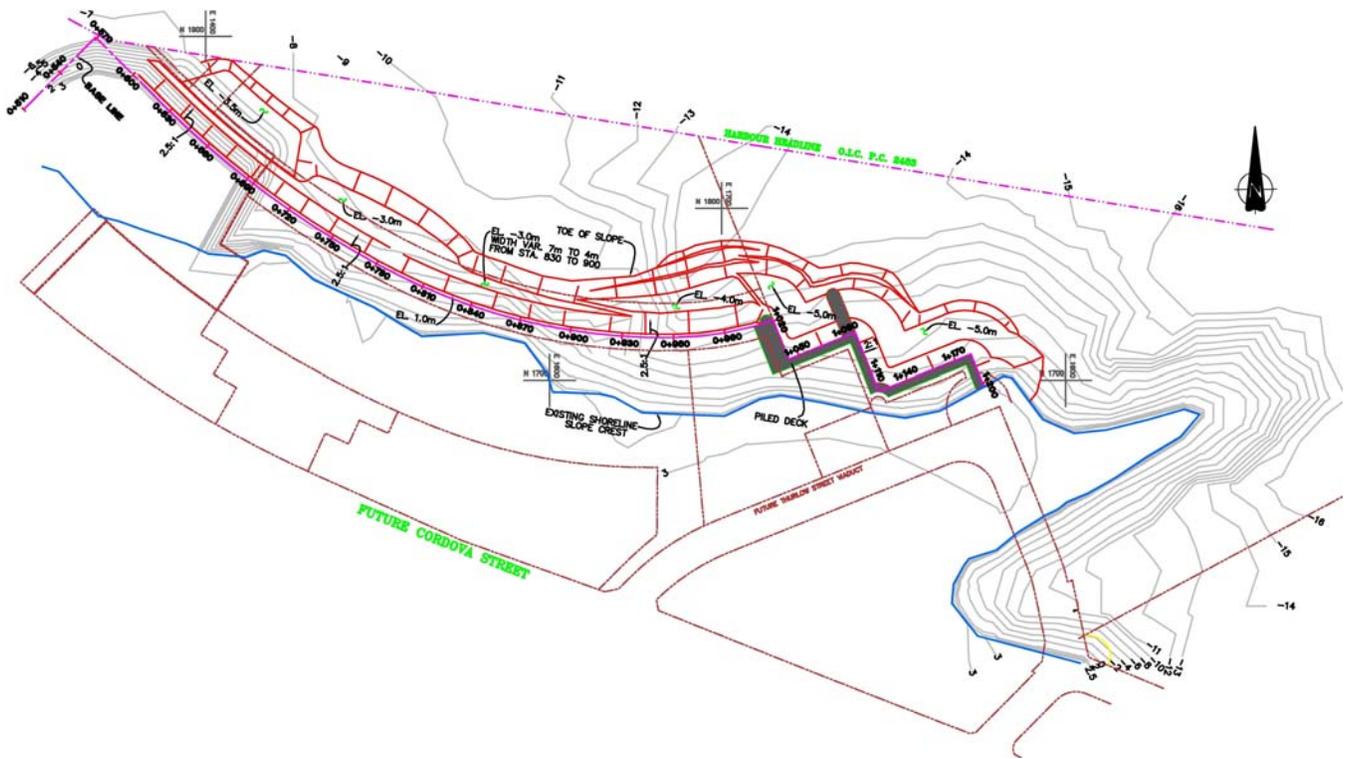
Fig. 3. Proposed New Shoreline in the Phase 2 Area.

Fig. #3 shows the plan view of the new shoreline within the Phase 2 area. The development plan for the near shore infrastructure in the Phase 2 area consisted of the following:

- The new shoreline was to be extended about 15 m to 50 m north of the shoreline that existed in 1994.
- A fill supported walkway at the about elevation 3 m (Geodetic datum) was to be provided along the relocated shoreline.
- The outer edge of the walkway was to be supported by a retaining wall with an exposed height of about 2 m.
- The slope below the retaining wall was to be provided with benches and protected with rock.
- The new shoreline slope would be constructed generally at 2.5 horizontal to 1 vertical.
- Benches were to be provided generally at elevation -3 m or -4 m for fisheries habitat with a width of generally about 4 m.
- A 100 m long floating walkway was to be constructed with the concrete float platform located at a distance of about 30 m from the seawall. Ramps were to be provided between seawall and the float platform for pedestrian access.

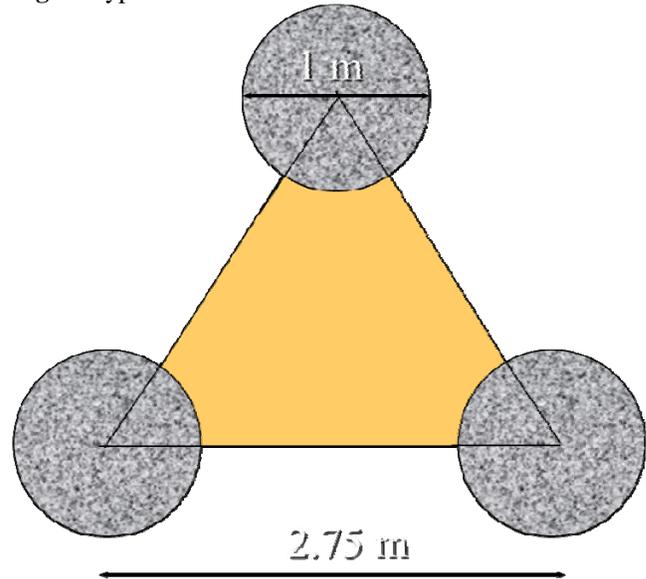
Fig. 4. Typical Stone Columns Pattern.

Because of the presence of the extensive soft to firm and loose marine deposits, improving the shear strength of these deposits to an appropriate target strength was critical to the short-term and long-term performance of the new shoreline. Vibro-replacement with approximately 1 m diameter stone columns in a triangular pattern at a maximum center to center spacing of 2.75 m was selected. This represented replacement ratio of about 14 percent. Fig. #4 shows the typical pattern adopted for the design.

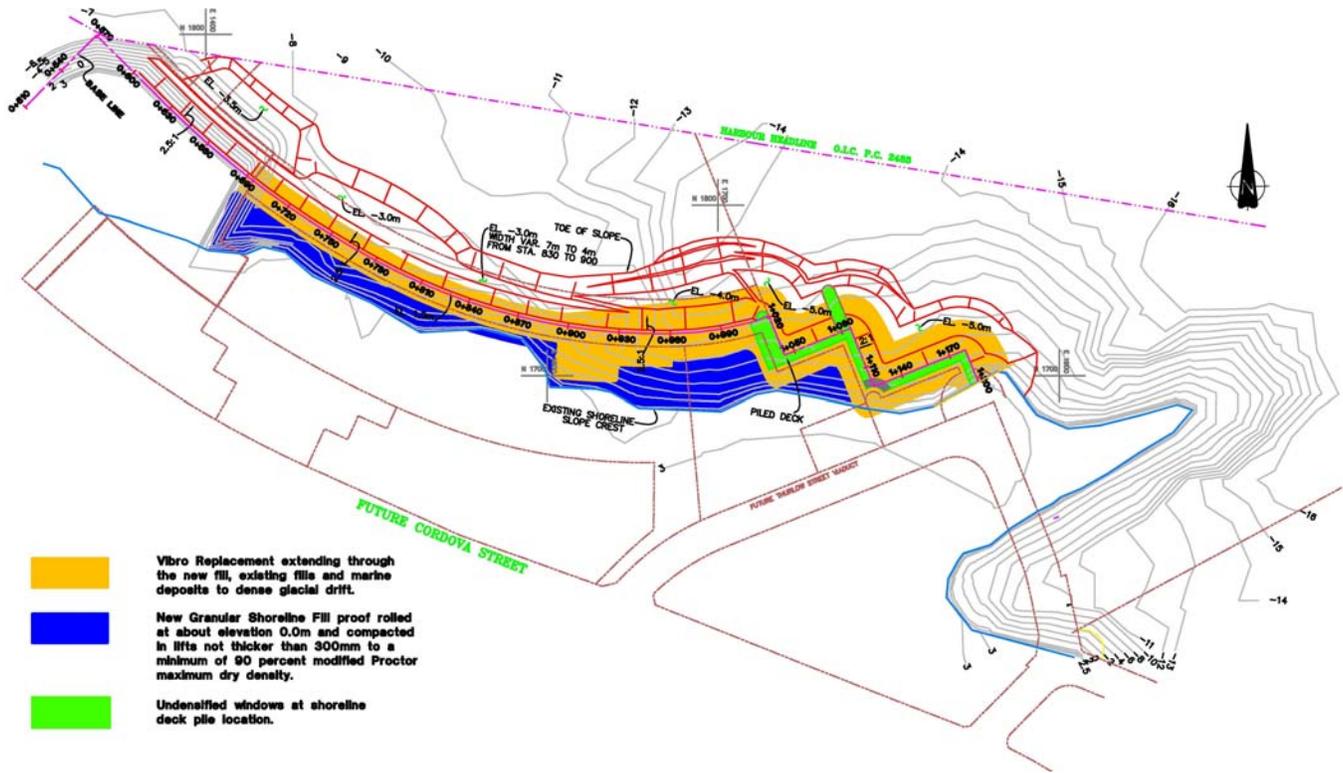
Fig. 5. Recommended Ground Treatment for the Phase 2 Shoreline.

For the new shoreline slope configuration, slope stability analyses were carried out to optimize the ground improvement zone. The landward extent of the ground improvement zone was kept generally about 15 m south of the new shoreline crest to ensure adequate long term performance of the settlement sensitive walkway and cycle paths in this area.

The recommended ground improvement zone for the new shoreline in the Phase 2 development area is shown in Fig. #5.

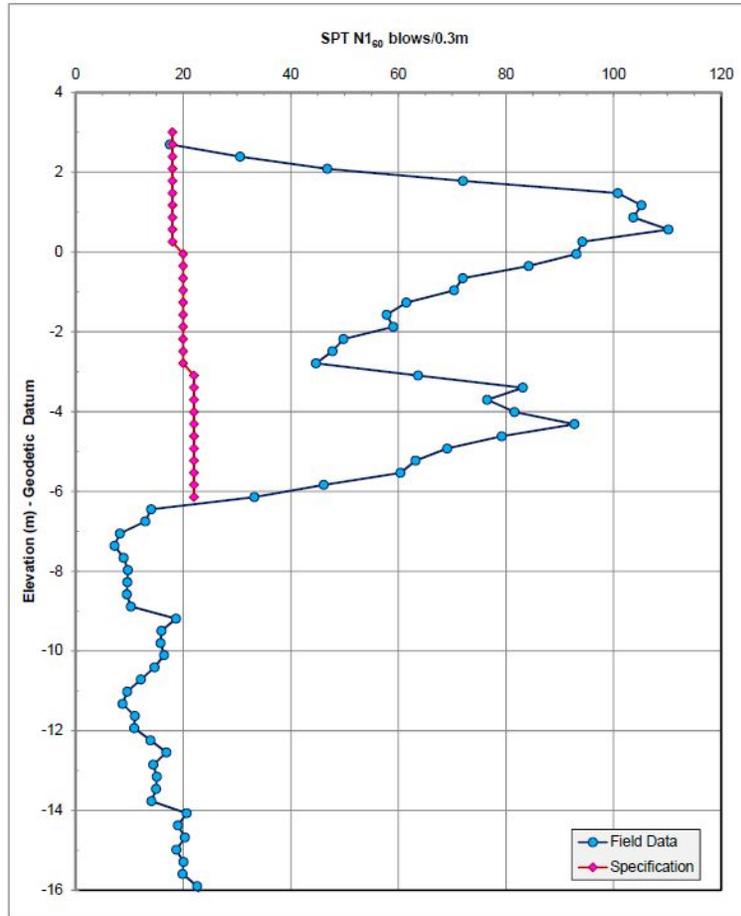
Fig. 6. Results of Verification Test – Test Section.

A procedural specification was used for the stone column installation within marine deposits and the existing heterogeneous fills. For the new granular shoreline fill, performance based specification was used. Fig. #6 shows results for the first of many Becker Penetration Tests (BPT) carried out to verify that the new shoreline fills were being densified adequately. Since the test trial produced adequate response, the spacing of stone columns, infill material and other operator related variables such as time spent, amperages achieved, etc. were used as base measure for the subsequent production work.

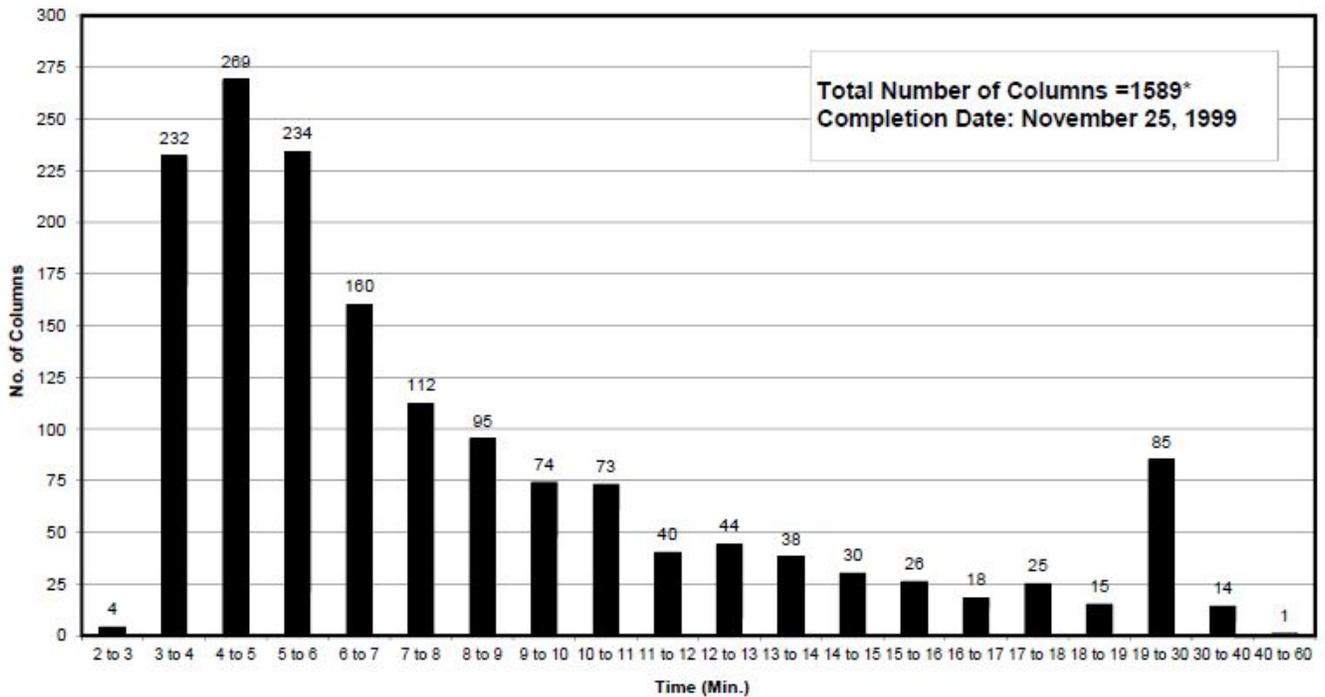
Fig. 7. Penetration Time for Production Stone Columns.

The ground improvement work was completed in an approximately eight month period with over 1600 stone columns installed. Fig. #7 shows a plot of penetration time versus number of stone columns. This is one of the measures of how well the site was prepared including the adequacy of the removal of potential obstructions for the ground improvement work.

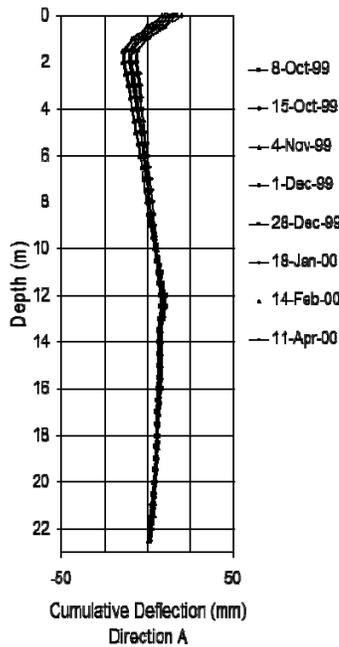
Fig. 8. Summary of Inclinometer Data.

Following completion of the ground improvement work, the new shoreline area was preloaded to ensure that the walkway and cycle paths met the stringent post construction settlement requirements. During the preloading period, the shoreline slope was monitored for lateral movements using a slope inclinometer installed near the new shoreline crest. A summary of the inclinometer data is shown in Fig. #8. Only minimal lateral movements were observed during preload phase indicating that the shoreline treatment was adequate.

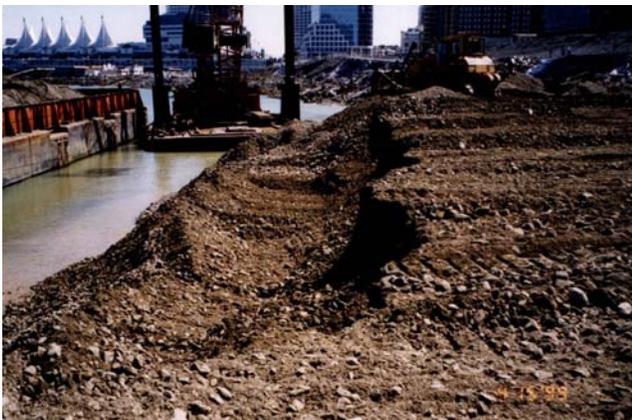
Fig. 9. Minor Slope Failure during Shoreline Fill Placement.

Although for most part the land reclamation went without major problems initially, a minor slope failure of the overbuilt portion occurred in an area where the filling was of significant height. Fig. #9 shows the slope failure in the overbuilt portion during land reclamation. Further examination, including survey of the seabed offshore and as-built of the temporary slope of the overbuilt portion, indicated that the failure was not deep seated but rather a shallow one. Based on this incident, revisions were made to the temporary slope angle and the delay period between filling stages to ensure that there was no further slope instability during filling.

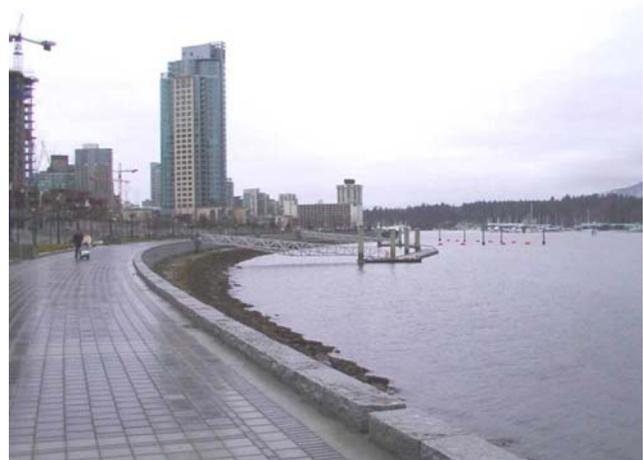
Fig. 10. Completed Phase 2 Shoreline.

Fig. #10 shows the completed Phase 2 shoreline area with the seawall and associated walkway, cycle path and the floating walkway.
